**Year 3 Annual Report**  
**Massachusetts Small MS4 General Permit**  
**Reporting Period: July 1, 2020-June 30, 2021**

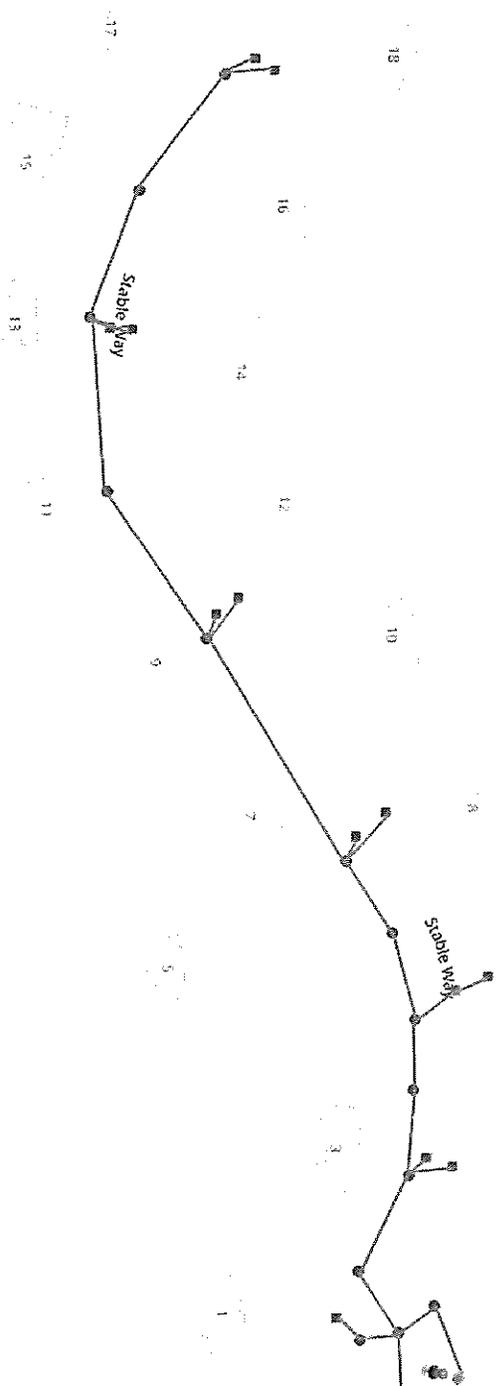
6-21

- No infiltration on Stable sewer line
- 5 Stable new sewer tap
- All other properties factory when sewer was installed

No files under Board of Health for any past or present septic in this area of question

Talked with Curtis 4/22/2021→follow up drain line cameraing when time permits

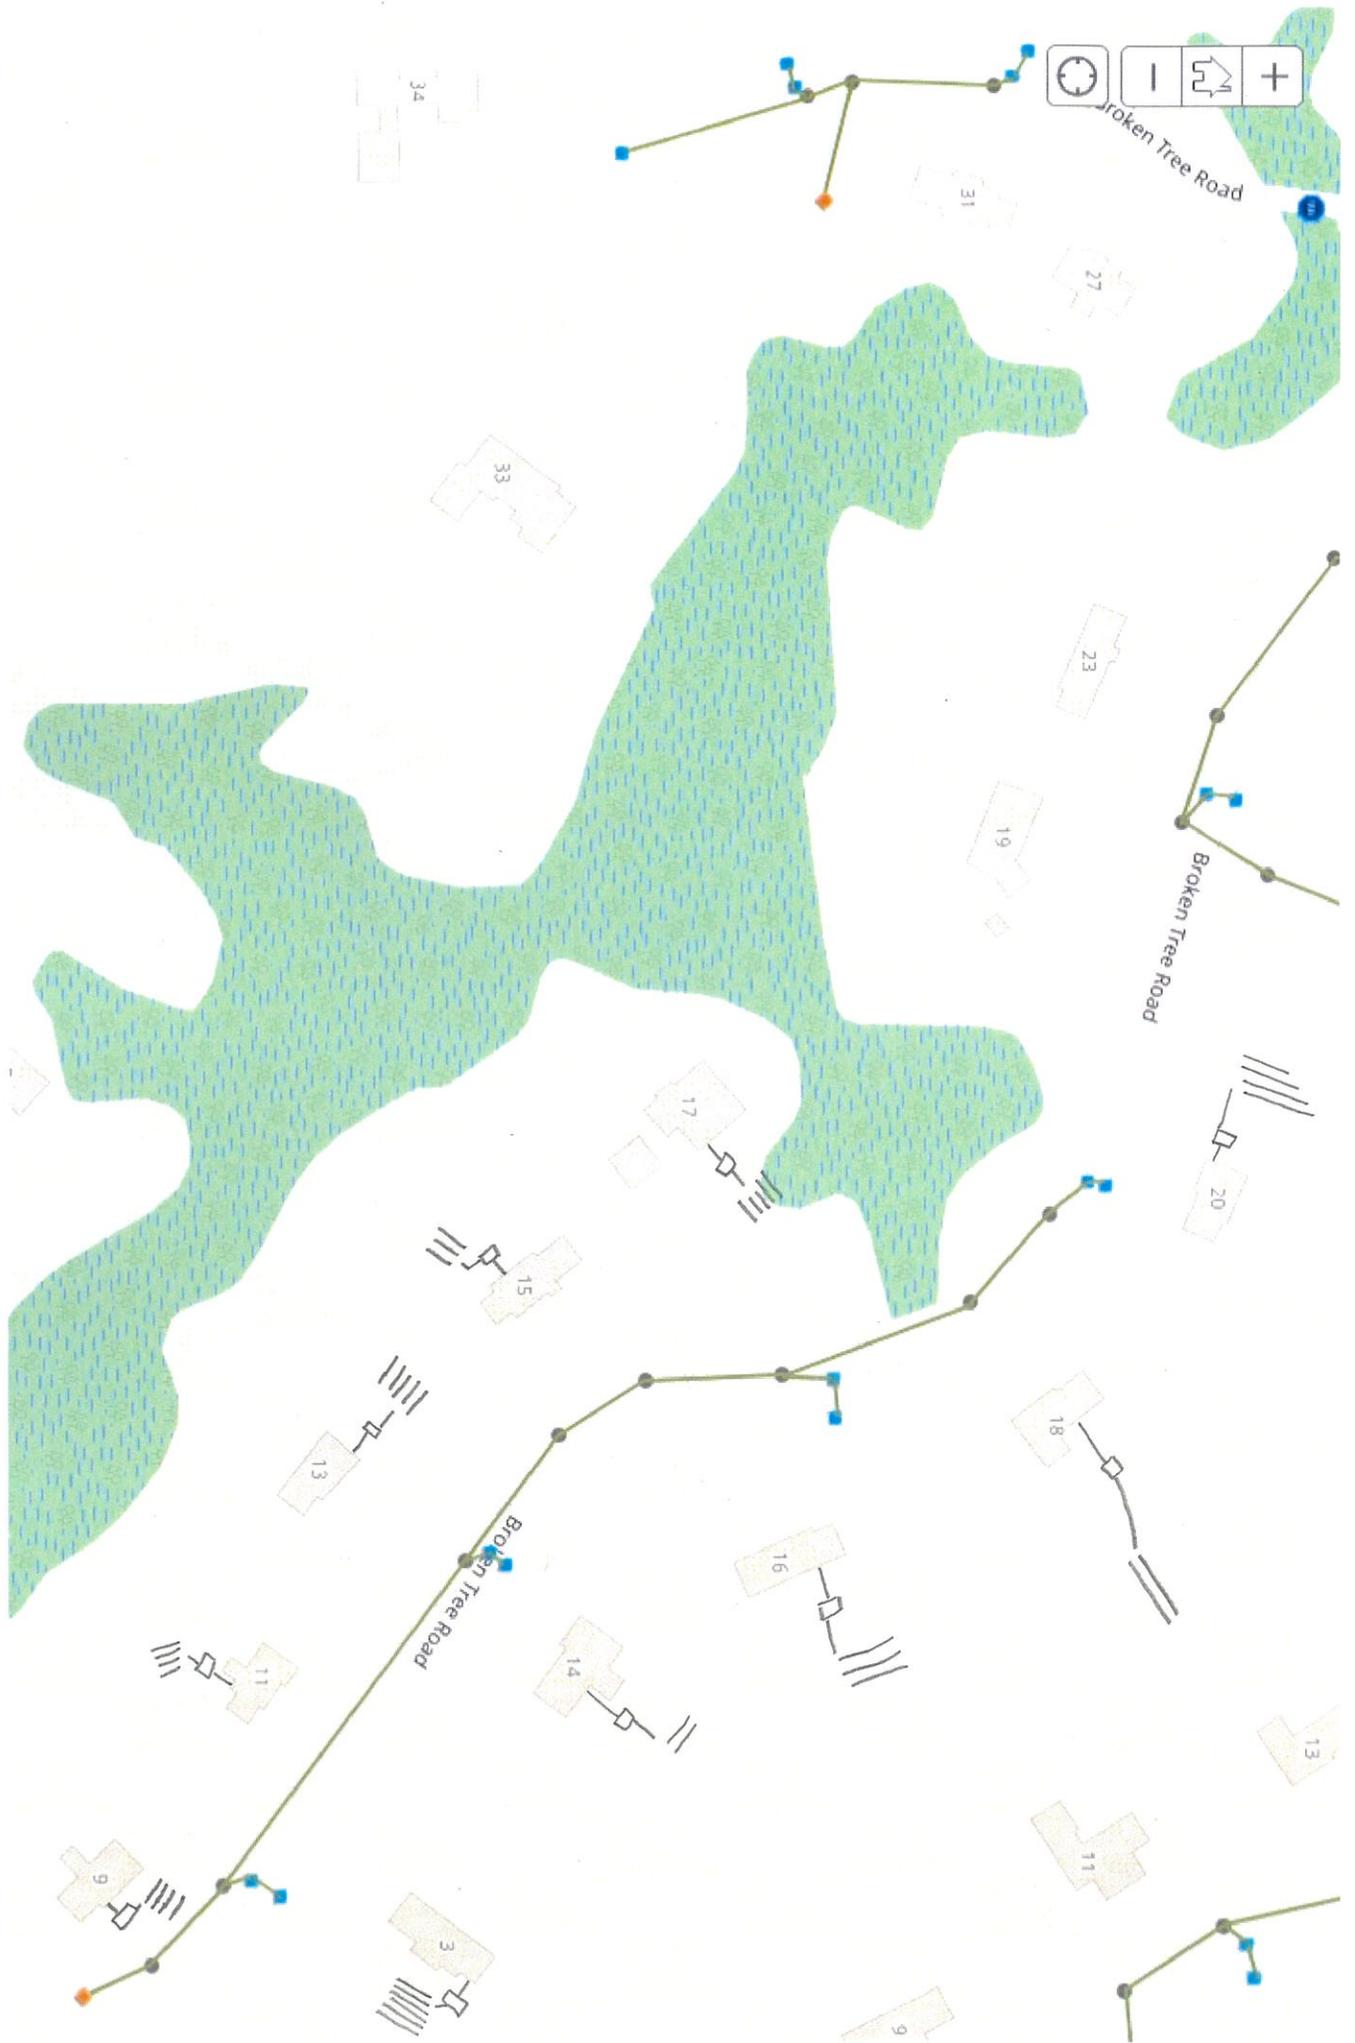
#### 20 Broken Tree- 4 Bedroom

- Passed Title 5 2018
- Laundry included
- Septic tank, D bx, soil absorption system (leaching trenches 4 40')
- Last pumped 2 years previously
- Built 12-8-1998
- Pumped 2004,2006,2020

- Passed Title 5 2012
- Laundry connected and sump pump
- System last pumped 2011
- Septic tank (1500 gallon), D box, soil absorption system (leaching trenches 3 40')
- Installed 1998
- D box in fair condition- signs of deterioration
- Installed 1997
- Pumped 2001,2005,2005,2014,2019

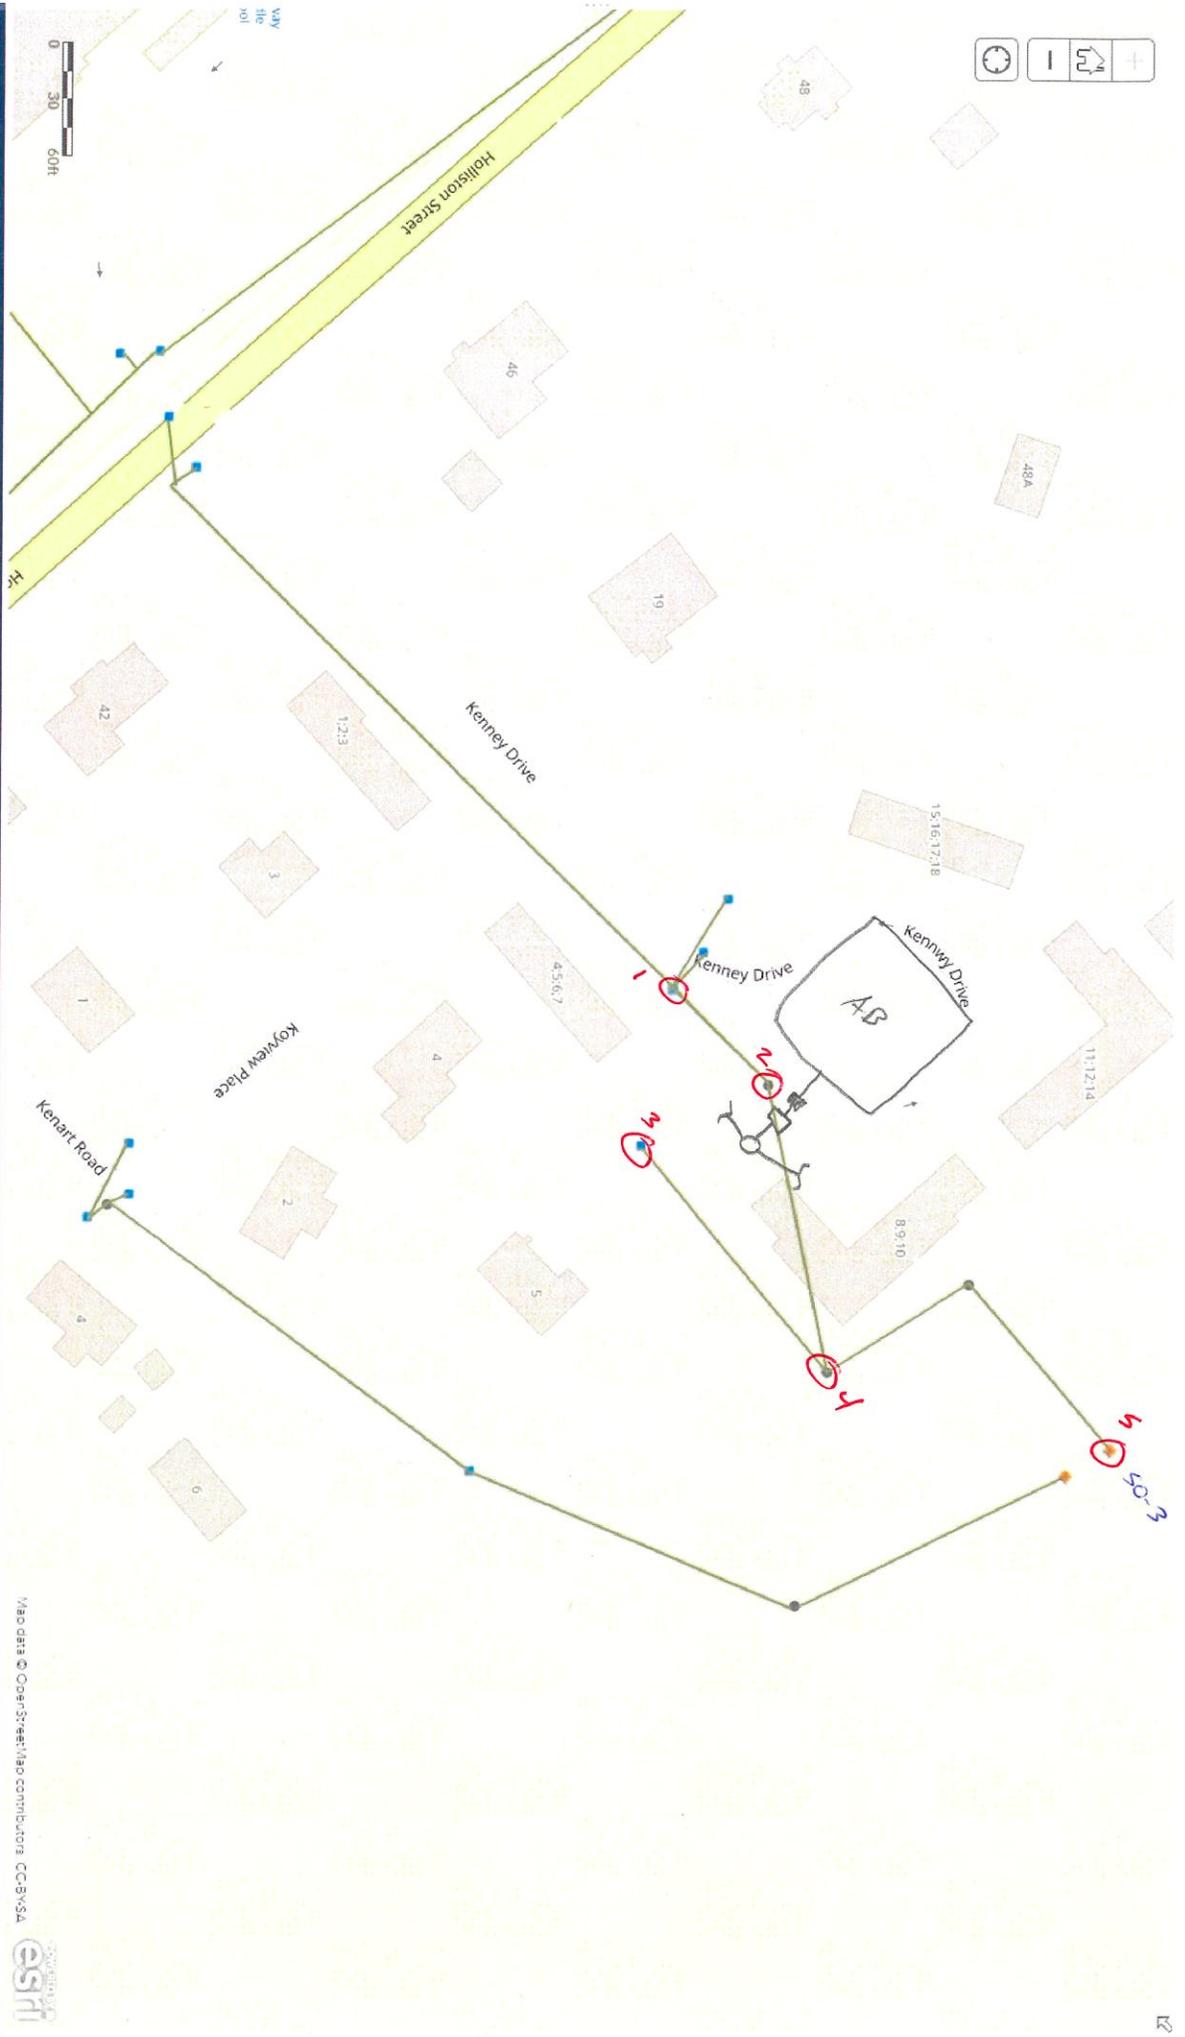
Septic AS Built 1992  
 Pump Out 2020

- Septic tank, D Box, leaching trenches (3x50')
