**Re: Request for More Information – NOI
Landfill Cap Investigation
46 Broad Street
Medway, Massachusetts**

Wetland Delineation Report

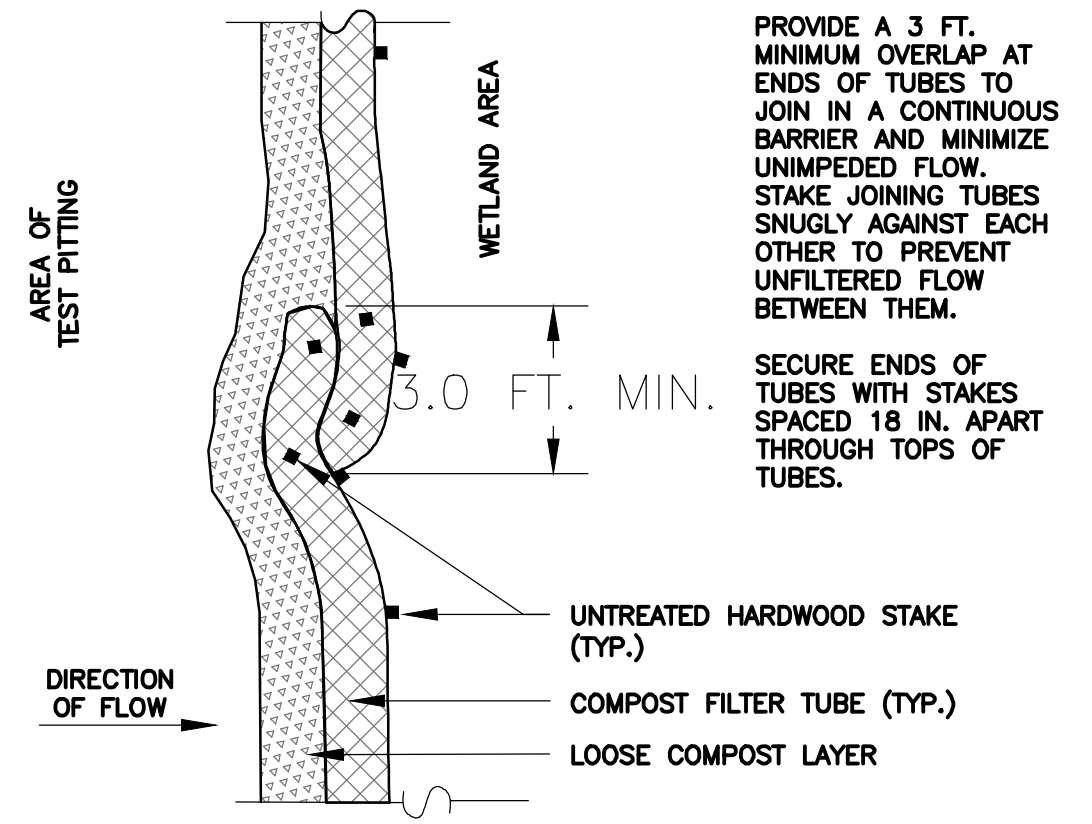
FIGURE 5
MEDWAY LANDFILL
MEDWAY, MASSACHUSETTS
COMPOST FILTER TUBE DETAILS
NOT TO SCALE

PLAN VIEW

1. PROVIDE A MINIMUM TUBE DIAMETER OF 12 INCHES FOR SLOPES UP TO 50 FEET IN LENGTH WITH A SLOPE RATIO OF 3H:1V OR STEEPER. LONGER SLOPES OF 3H:1V MAY REQUIRE LARGER TUBE DIAMETER OR ADDITIONAL COURSEING OF FILTER TUBES TO CREATE A FILTER BERM. REFER TO MANUFACTURER'S RECOMMENDATIONS FOR SITUATIONS WITH LONGER OR STEEPER SLOPES.
2. INSTALL TUBES ALONG CONTOURS AND PERPENDICULAR TO SHEET OR CONCENTRATED FLOW.
3. DO NOT INSTALL IN PERENNIAL, EPHEMERAL OR INTERMITTENT STREAMS.
4. CONFIGURE TUBES AROUND EXISTING SITE FEATURES TO MINIMIZE SITE DISTURBANCE AND MAXIMIZE CAPTURE AREA OF STORMWATER RUN-OFF.

PLAN VIEW - JOIN DETAIL

- A. Compost material inside the filter tube shall meet M1.06.0, except for the following: no peat, manure or bio-solids shall be used; no kiln-dried wood or construction debris shall be allowed; material shall pass through a 2-inch sieve; and the C:N ratio shall be disregarded.
- B. Outer tube fabric shall be made of 100% biodegradable materials (i.e., cotton, hemp or jute) and shall have a knitted mesh with openings that allow for sufficient water flow and effective sediment capture.
- C. Tubes shall be tamped, but not trenched, to ensure good contact with soil.

- A. Tubes shall be tamped, but not trenched, to ensure good contact with soil.
- B. The compost filter tubes shall be regularly inspected and before and after every forecasted major weather event. All deposited sediment shall be removed and not allowed to accumulate to the top of the tubes. Compost filter tubes damaged during construction shall be repaired or replaced as required by the Engineer at no additional cost to the Owner.

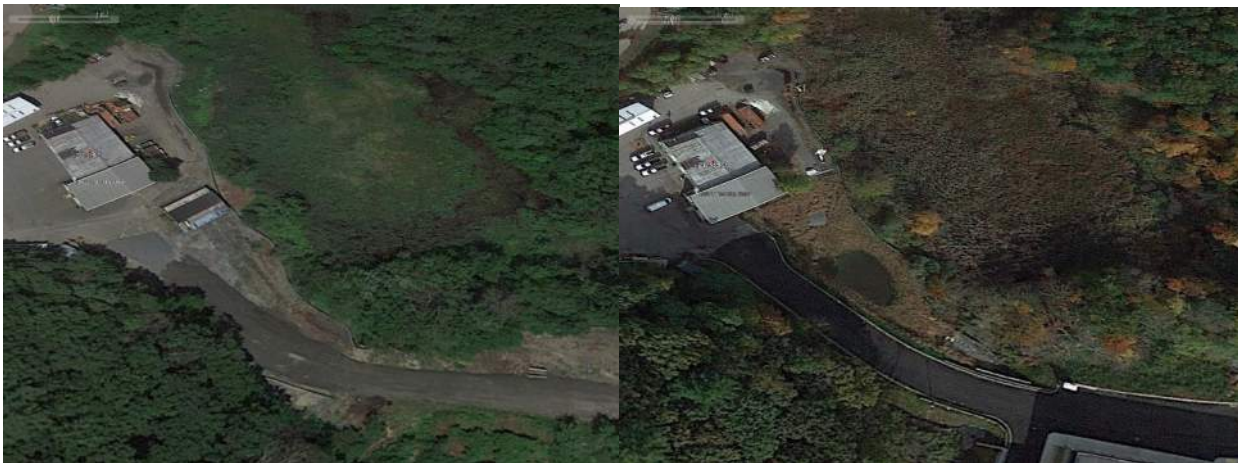
The left image displays the absence of a stormwater basin in 2019 and the presence of the stormwater basin in 2020 on the right image.

Based on a review of available aerial imagery, SW A is located on the investigation area property and appears to have been constructed between 2019 and 2020 (please see aerial imagery below).

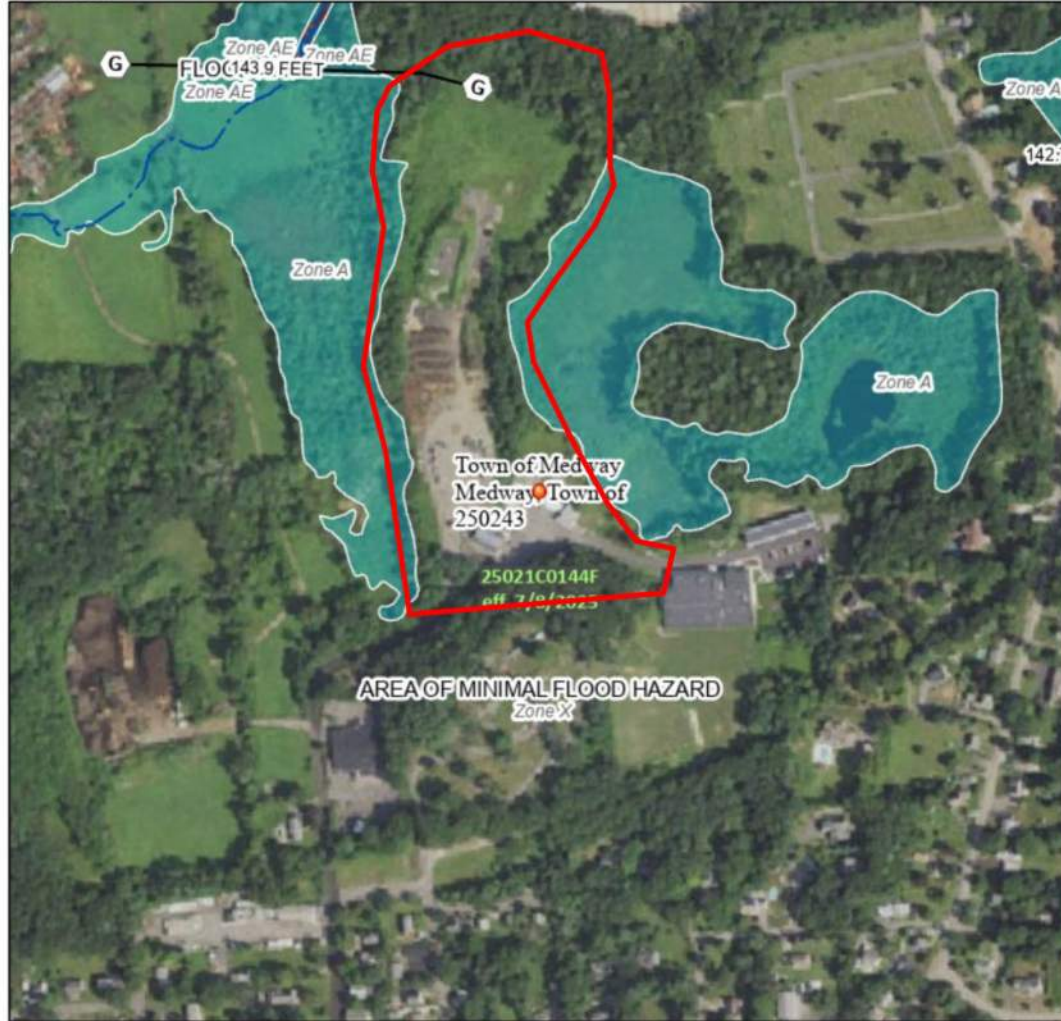
National Flood Hazard Layer FIRMette

The flood hazard information is derived directly from the authoritative NFHL web services provided by FEMA. This map was exported on 8/14/2025 at 6:38 PM and does not reflect changes or amendments subsequent to this date and time. The NFHL and effective information may change or become superseded by new data over time.
