# Village of Saranac Lake

## **Performance Venue Facilities Assessment** for the Village of Saranac Lake Arts and Cultural Master Plan

Ref: Village of Saranac Lake Arts and Culture Master Plan, Facility Analysis

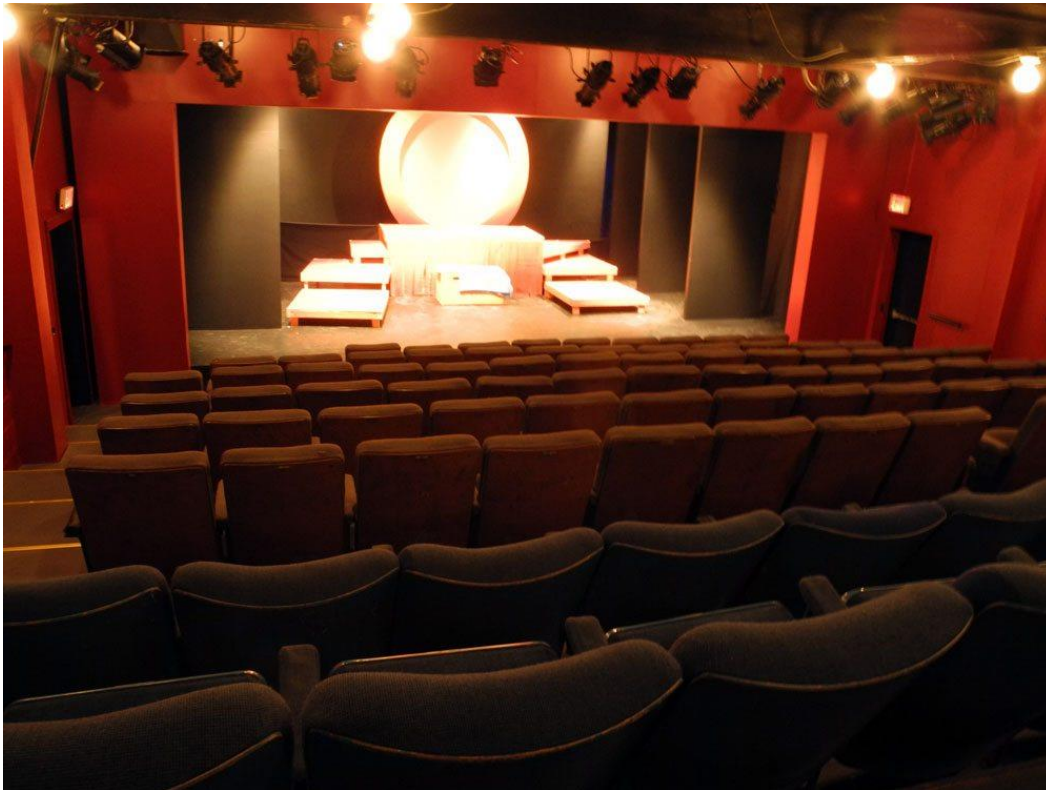
## PENDRAGON THEATRE

VENUE	PENDRAGON THEATRE
Current Activities	Producer and presenter of professional and amateur works Drama / Musical Theatre, and music incl. some space for visual arts presentations/visual arts displayed in lobby
Qty of Programs	6 summer + 3-4 year round
Qty of Performances	12-15 per production, 130 total
State of the Facility	Facility is a repurposed barn / carriage house that is proving ill-suited to the work of the organization. While Pendragon has done very well with this found space for the past four decades, the facility provides little support or opportunity for the organization to flourish and grow. Lack of insulation and type/age of heating systems lead to high ongoing utility costs.
Planning: Performance Space & Audience Area	<p><u>Existing:</u> Endstage configuration works well for performance style, but lack of wing space severely limits production possibilities for actors, as well as stage designers. Audience seating is adequate with reasonable sightlines, however limited access into and out of the theatre. A constrained lobby size, and only two restrooms for 125 people, mean that many patrons choose to stay in their seats during intermission.</p> <p><u>Recommendation:</u> It is difficult to imagine improving the existing facilities, as the problems are fundamental to the building and would require significant reconstruction to address. The organization has outgrown the facility and should be seeking a replacement. Additionally, the seat count, stage size, and lack of wing space work against the institution's ideals of becoming a regional theatre, as co-productions with peers are a mainstay of this form.</p>

Stage and audience area

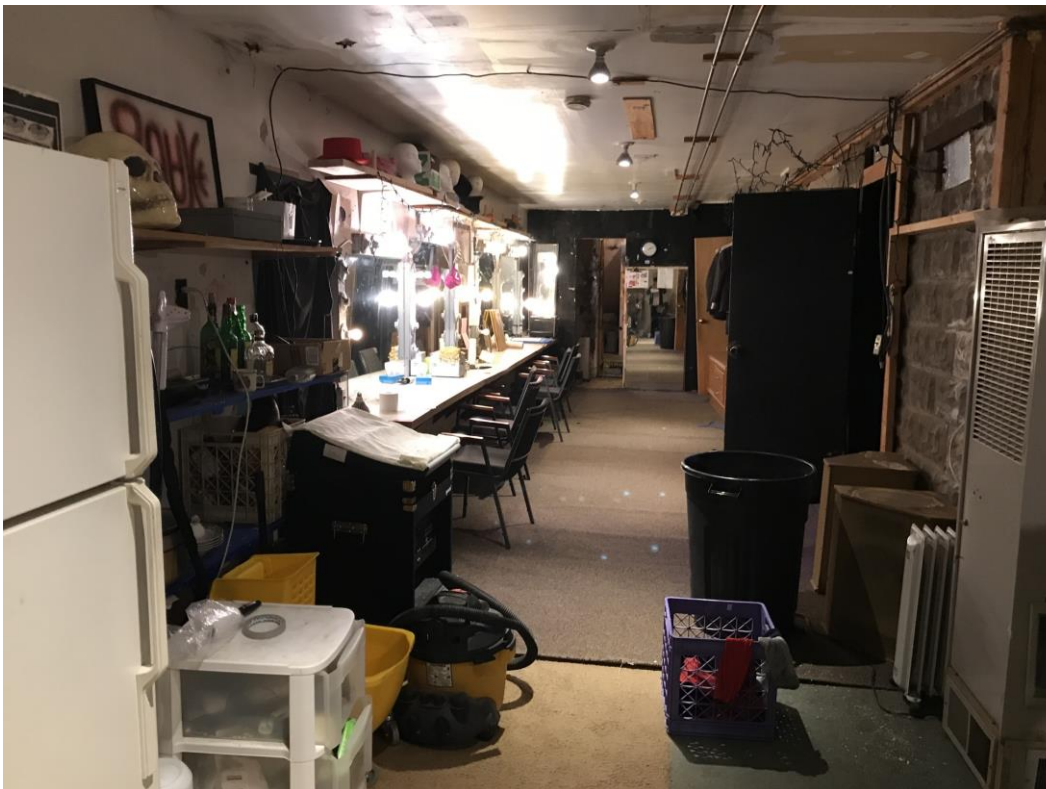
Planning: Back-of-house	<p><u>Existing:</u> BOH area is limited. Dressing room is co-ed with a single restroom for all cast. No rehearsal space. Single office is located in theatre wing. No sound and light locks to stage. Scenic, lighting, and costumes facilities are onsite.</p> <p><u>Recommendation:</u> See above.</p>
Disabled or Limited Mobility Access	<p><u>Existing:</u> Performance space has minimal accommodations, but does provide ramped access to the auditorium, lobby, and restrooms. Dressing rooms and restroom are at a different level than the stage without an accessible connection. No accommodations for disabled technicians (such as control booth access) exist.</p> <p><u>Recommendation:</u> Per above, significant reconstruction would be required to address the lobby and performance space. Dressing room level could be raised to match the stage with ramped access to this level. However, this would have an impact on useable area. Technician access would require adding an elevator to access the booth and costume shop currently located in the attic.</p>

Dressing Room

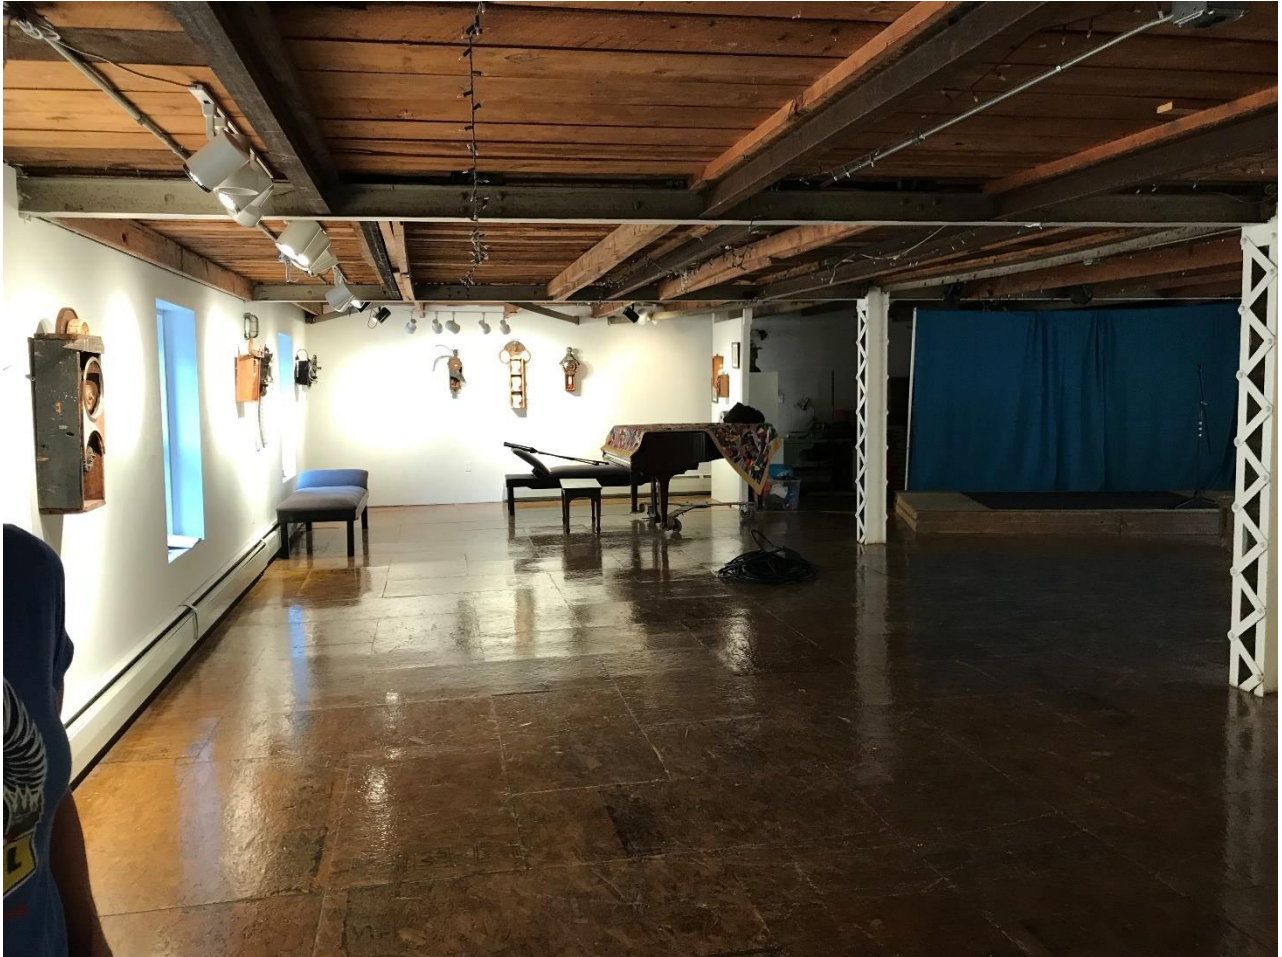
**BLUSEED STUDIOS**

Planning: Performance Space & Audience Area	<p><u>Existing:</u> The upper level performance space is a flat-floor venue, which allows for the multiple uses listed above. Due to its flat, long nature, sightlines to the stage can be difficult, especially with a standing room audience. The walls, floor, and ceiling are all hard surfaces causing some concern about acoustic intelligibility and harshness.</p> <p><u>Recommendation:</u> Seldom have there been complaints about seeing within the space, so the audience is accepting of the sightline issues. Although, these could be addressed for seated performances with some portable risers or platforming for a limited number of rows of seats (limited due to the head height available). The hard surfaces in the room, which likely work well for acoustic music and the spoken word, could be tempered for amplified events by adding temporary absorptive materials on the two long walls.</p>

Upstairs event space with art exhibit, stage in the right corner

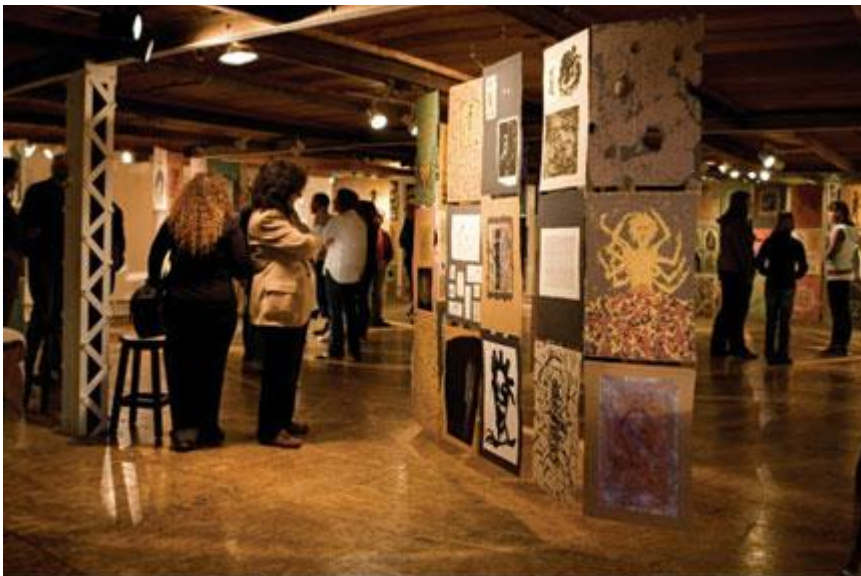
A recent exhibition opening at BluSeed Studios. Photo by Shaun Ondak

Same space used as a gallery

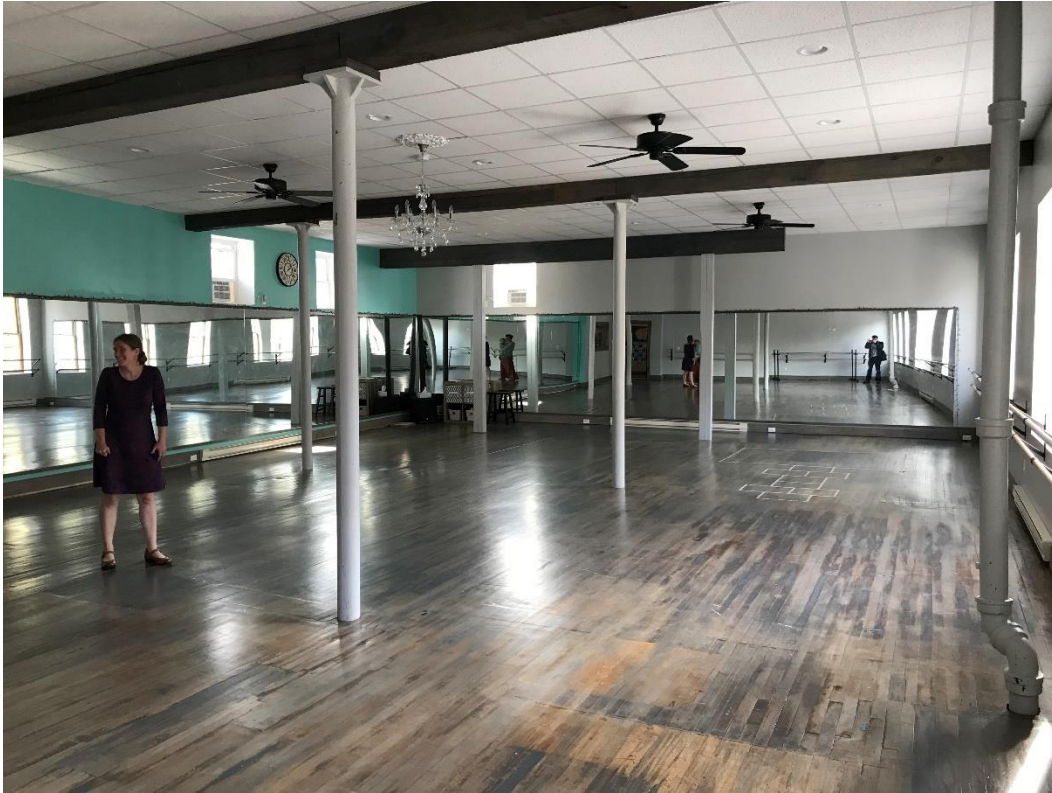
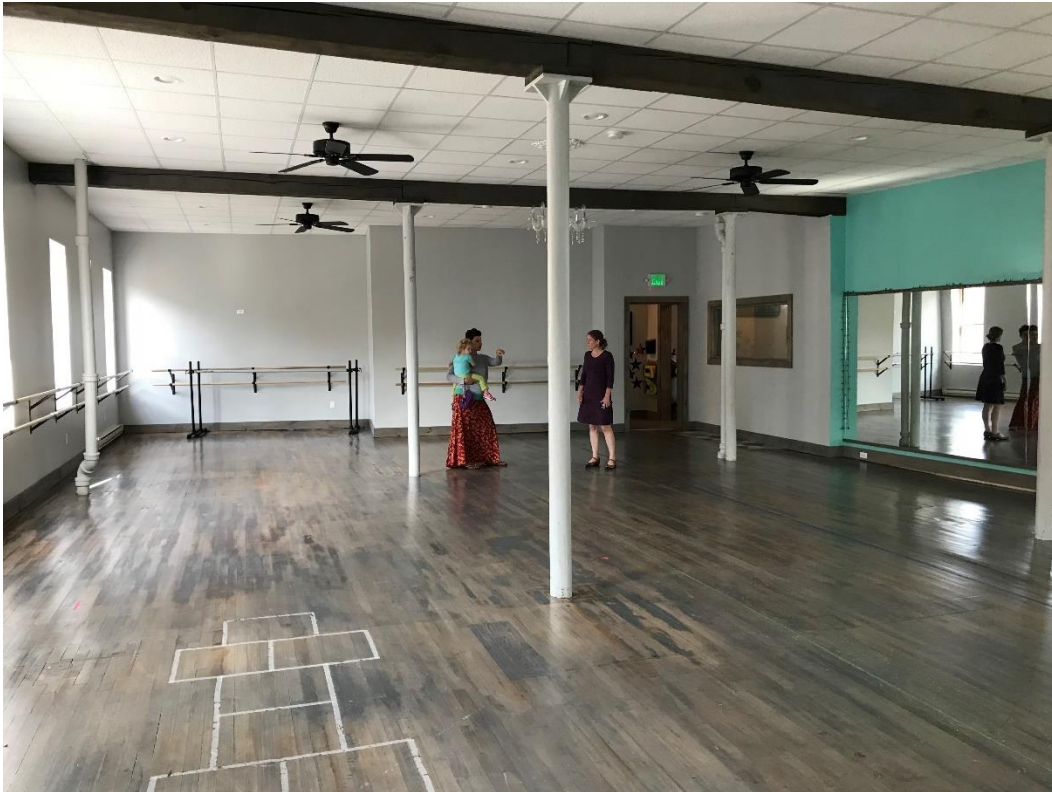
### DANCE SANCTUARY

VENUE	DANCE SANTUARY
Current Activities	Somewhat recently leased and renovated space has reinvigorated the dance scene in the Village. Currently teaches classes, some of them culminating in a recital, but no formal performances as of yet. Location on Main Street across from café drives foot traffic.
Qty of Programs	Classes daily
State of the Facility	Newly renovated
Planning: Performance Space & Audience Area	<p><u>Existing:</u> Facility consists of the main dance studio, waiting room, changing rooms, and an office. Studio is a somewhat asymmetrical, with columns in the room, a constrained ceiling height (for dance), and insufficient length for some styles of dance. The space works well for the types of programs currently on offer.</p> <p><u>Recommendation:</u> As the space has been recently leased, it is unlikely to be modified in the short term. In the long term, the organization should be on the lookout for a space with a more suitable footprint in the neighborhood of 40x60', column-free.</p>

Planning: Back-of-house	<p><u>Existing:</u> No separate BOH facilities. Studio is not set up for performance.</p> <p><u>Recommendation:</u> Nothing in current space, due to limitations of the building.</p>
Disabled or Limited Mobility Access	<p><u>Existing:</u> Studio is on the second floor up a steep flight of stairs. No elevator access.</p> <p><u>Recommendation:</u> Concerns about accessibility include both patrons and students with disabilities. If dance performance is desired, an alternate space should be sought at the end of the lease term.</p>
Technical Systems	<p><u>Existing:</u> No permanently installed stage lighting, rigging, or A/V. Musical accompaniment provided by portable equipment.</p> <p><u>Recommendation:</u> No lighting or rigging is recommended for current use. Strong points would be beneficial for certain dance and movement work such as aerials or silks, but those are not in the current program. Portable audio system is typical of dance studios and easier to upgrade than permanent infrastructure, so no changes are necessary.</p>

Looking South

Looking North

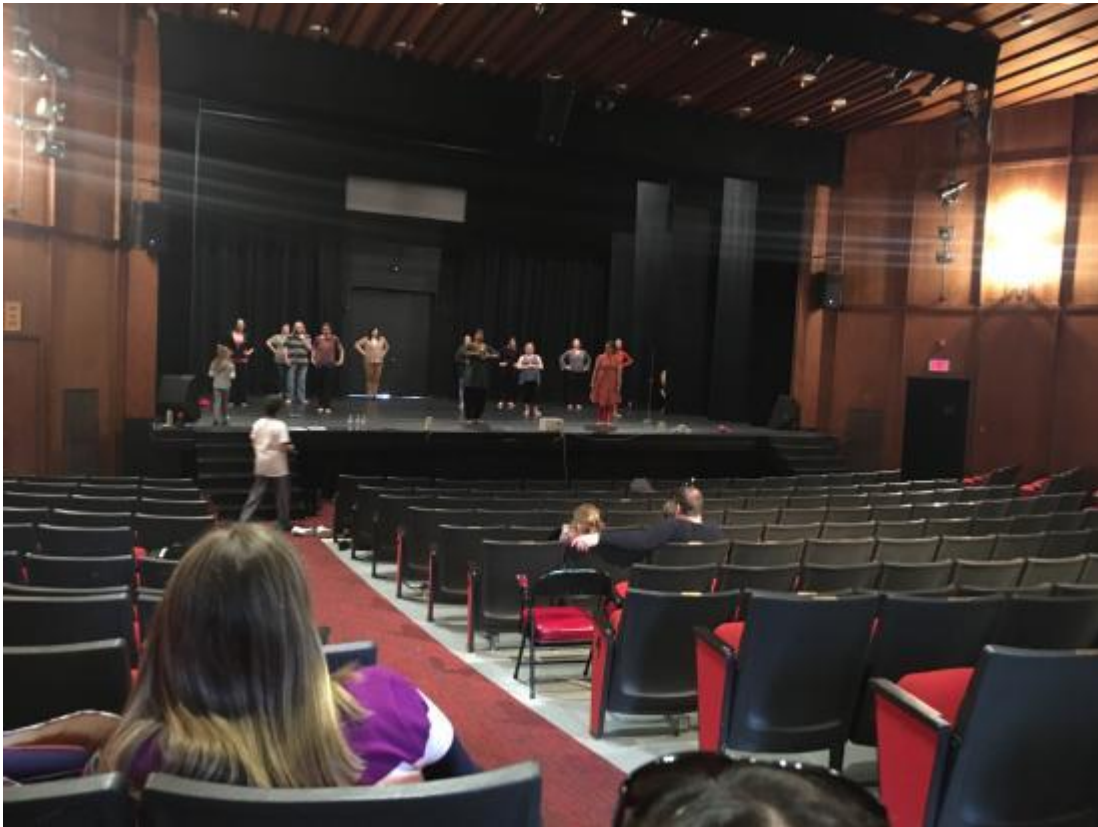
## LAKE PLACID ARTS CENTER

Planning: Back-of-house	<p><u>Existing:</u> Formal dressing rooms and green room are available for performers. Stagehouse is slightly too low for some aerial work that has gained popularity in the past few decades; however, raising the stagehouse height is a substantial undertaking and not recommended unless ROI from aerial events makes this feasible.</p> <p><u>Recommendation:</u> Not part of VSL inventory, included for comparison so no recommendations other than observations above.</p>
Disabled or Limited Mobility Access	<p><u>Existing:</u> The facility is approximately 4 decades old and therefore does not have adequate disabled access. Performer areas are a particular concern, but the facility does its best to accommodate needs when they arise. The public facing spaces have been addressed piecemeal with plans to include ADA restrooms in the near future.</p> <p><u>Recommendation:</u> Not part of VSL inventory, included for comparison so no recommendations other than observations above.</p>

Technical Systems	<p><u>Existing:</u> Stagehouse with counterweight fly system in the proscenium theatre. System is generally in decent shape, but the age of the system means that yearly safety inspections are mandated. Stage lighting has recently been supplemented with LED fixtures. A/V systems are available for amplification and presentation of HD video content.</p> <p><u>Recommendation:</u> Not part of VSL inventory, included for comparison so no recommendations.</p>

Auditorium

Stage

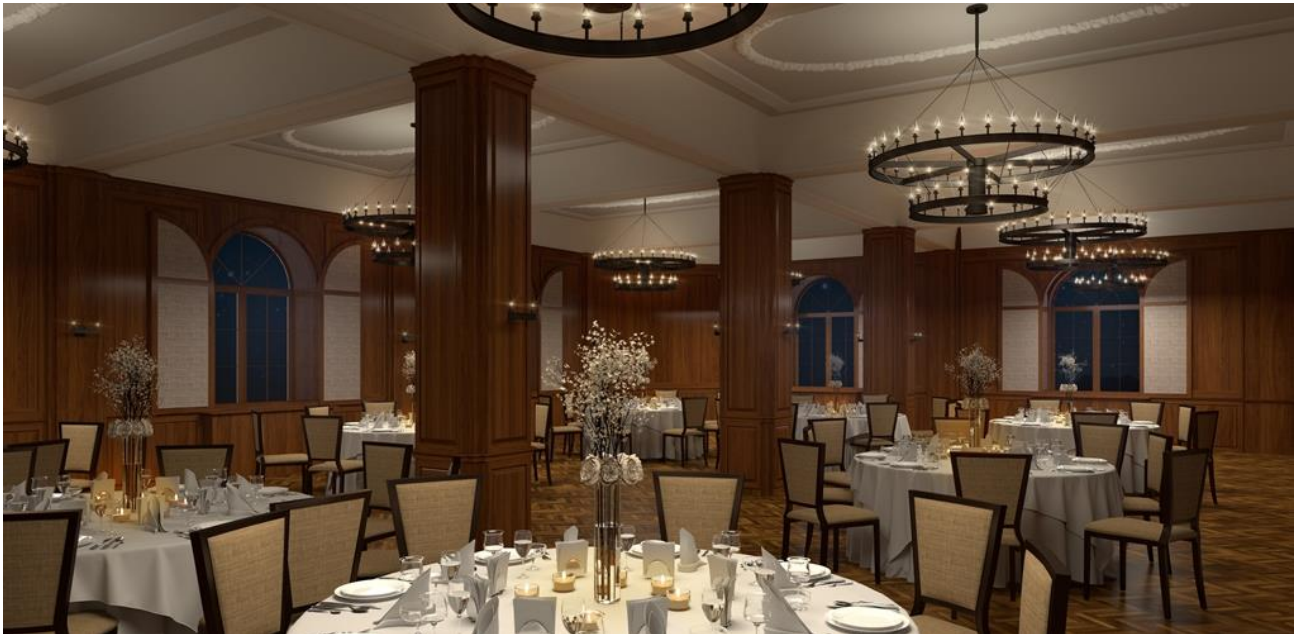
Event Room (rendering)

Disabled or Limited Mobility Access	<p><u>Existing:</u> Renovations include upgrades to egress and making all spaces fully accessible/compliant.</p> <p><u>Recommendation:</u> None</p>
Technical Systems	<p><u>Existing:</u> Up-to-date A/V is scheduled to be provided.</p> <p><u>Recommendation:</u> None, typical of a ballroom rental</p>

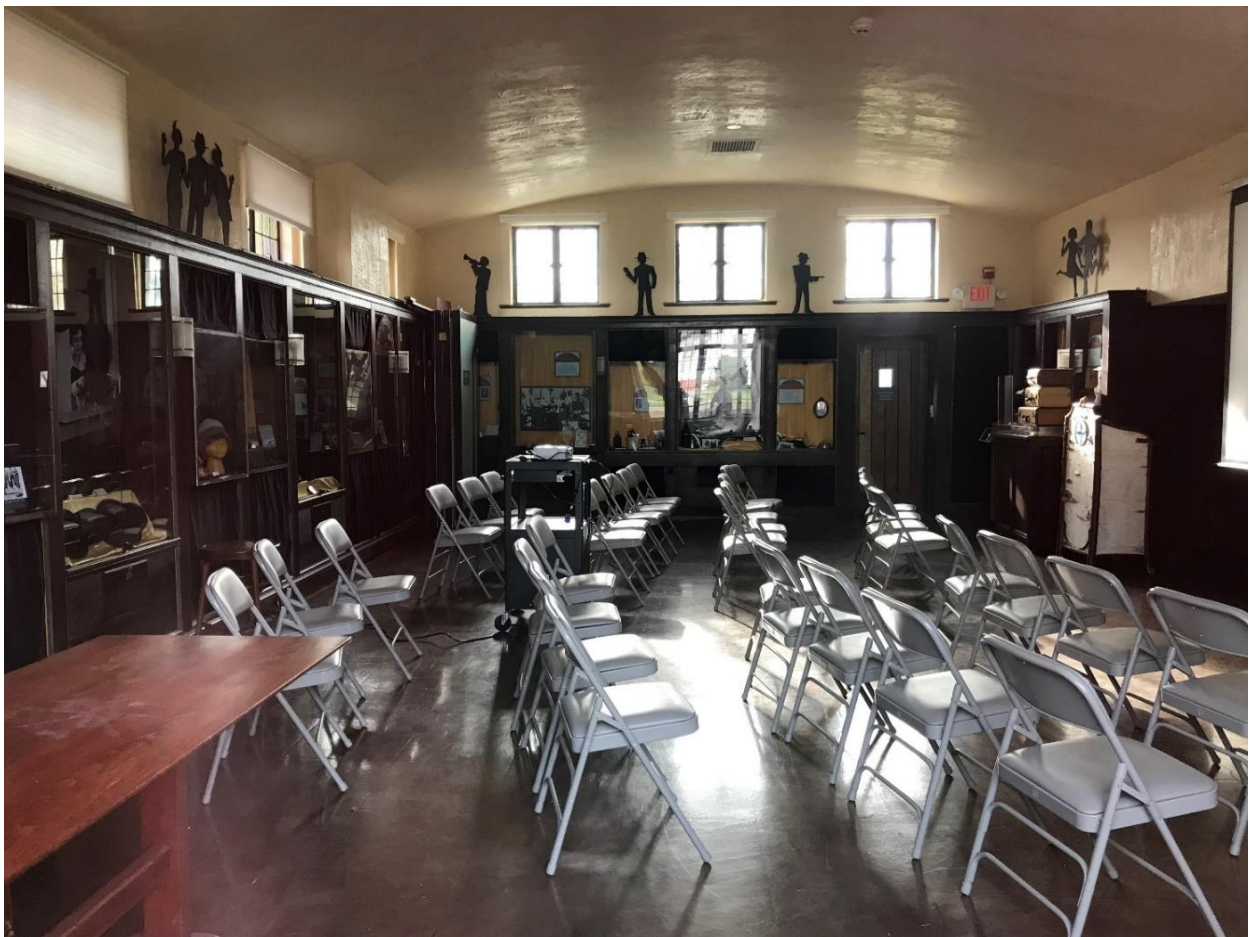
VENUE	JOHN BLACK ROOM
Current Activities	This space is a community room typically used for lecture or presentation, but occasionally used for small live music.
Qty of Performances	Unknown, no survey materials
State of the Facility	Appears to be well-maintained in a historic building.
Planning: Performance Space & Audience Area	<p><u>Existing:</u> The space is one medium sized room for +/- 40 people in folding chairs. Provisions for any performance are temporary in nature.</p> <p><u>Recommendation:</u> None, meets audience expectation for community room with historic atmosphere.</p>
Planning: Back-of-house	<p><u>Existing:</u> While the building was unavailable for a tour, it is understood that no additional BOH spaces exist.</p> <p><u>Recommendation:</u> None, meets audience expectation for community room</p>
Disabled or Limited Mobility Access	<u>Existing:</u> The space was unavailable for tour and the parties accompanying the tour did not know if the space was accessible.

Technical Systems	<p><u>Existing:</u> No stage lighting or rigging, A/V is portable equipment.</p> <p><u>Recommendation:</u> It was difficult to tell, but the space did not appear to have permanent overhead lighting, which would seem to limit usage. With the stated use for presentation, blackout shades (vs the visible solar shades) would be a prudent upgrade, as would dimmable lighting.</p>

Looking in through the window

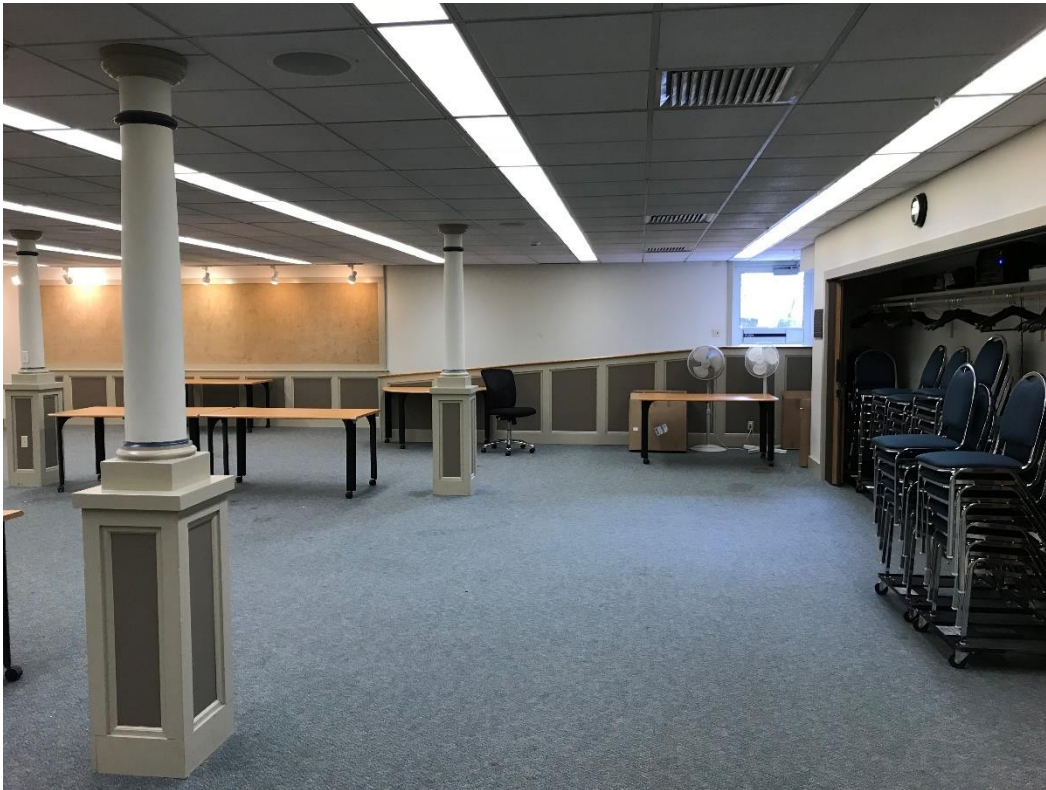
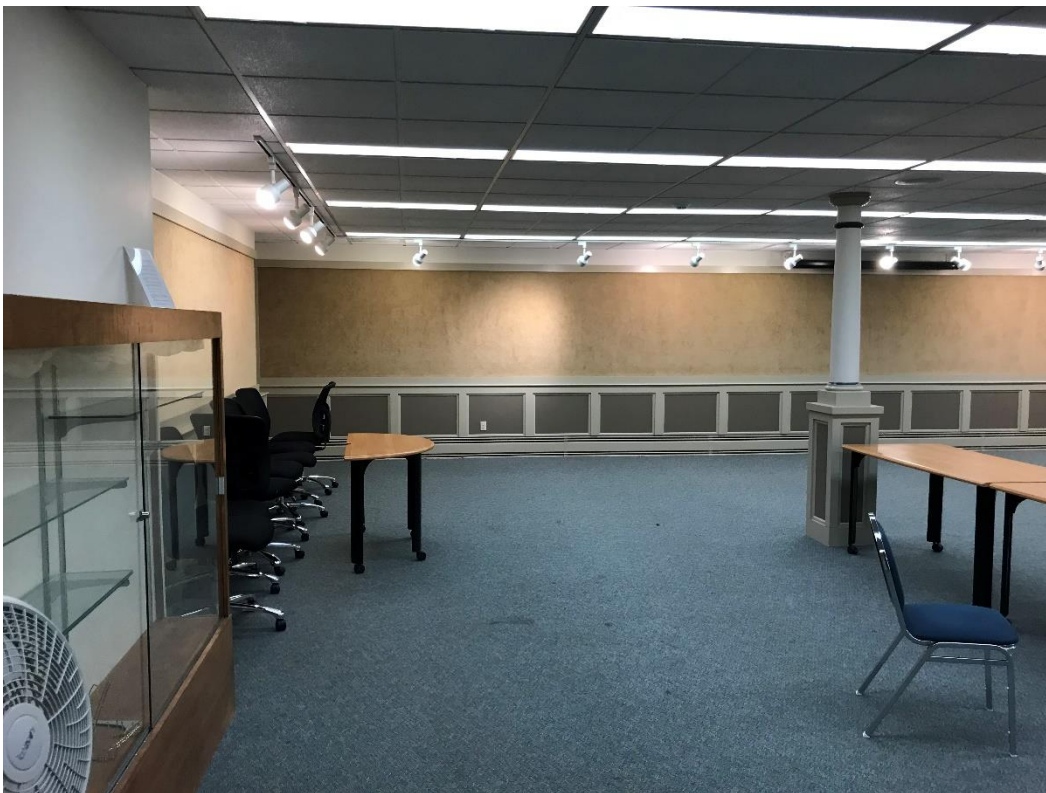
**CANTWELL ROOM**

VENUE	CANTWELL ROOM
Current Activities	This is a library community room accommodating about 120 people on the lower level, used for cultural and educational events.
Qty of Programs	Used nearly every day of the year.
Qty of Performances	Not typically used for traditional performance.
State of the Facility	Reasonable condition, well-kempt. Columns limit configurations.
Planning: Performance Space & Audience Area	<p><u>Existing:</u> No audience amenities, but meets most expectations for a community room.</p> <p><u>Recommendation:</u> None</p>
Planning: Back-of-house	<p><u>Existing:</u> No performer amenities, but meets most expectations for a community room. Includes adjacent kitchenette.</p> <p><u>Recommendation:</u> None</p>
Disabled or Limited Mobility Access	<p><u>Existing:</u> Lower level is accessible via elevator. Flat floor means no barriers.</p> <p><u>Recommendation:</u> None</p>
Technical Systems	<p><u>Existing:</u> Sound system, projector, and smart board are available.</p> <p><u>Recommendation:</u> None</p>

Looking West

Looking South

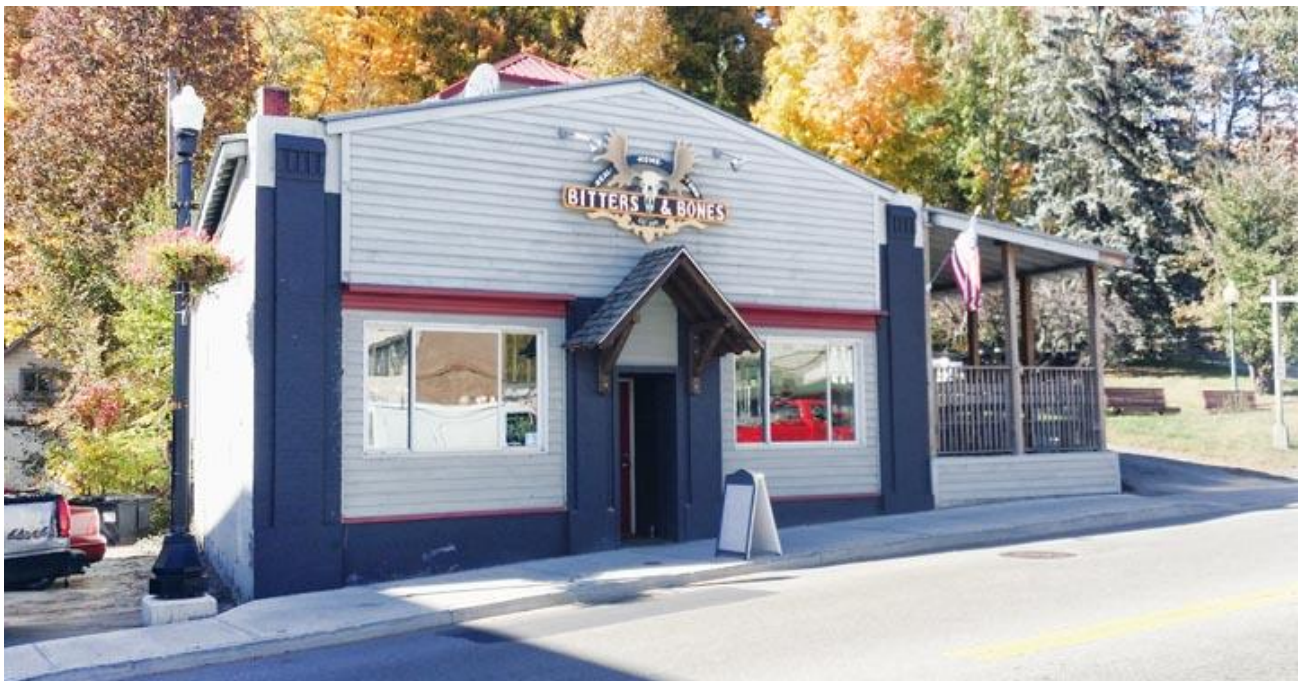
VENUE	BITTERS AND BONES
Current Activities	The facility is a bar that occasionally presents live music.
Qty of Performances	Approximately 2 per month
State of the Facility	Modern renovation of the facility into its current form, which is well-kempt.
Planning: Performance Space & Audience Area	<p><u>Existing:</u> Atmosphere suits live music. As a bar, patron amenities are typical of this.</p> <p><u>Recommendation:</u> None</p>
Planning: Back-of-house	<p><u>Existing:</u> Nothing specific for performers when onstage. Did not visit “upstairs” or “downstairs” spaces on tour, but it is mentioned in the survey for performer accommodations.</p> <p><u>Recommendation:</u> None recommended for current use.</p>
Disabled or Limited Mobility Access	<p><u>Existing:</u> Performance area is in the back, up a set of steps, prohibiting disabled access. However, music fills the bar.</p> <p><u>Recommendation:</u> Facility should evaluate accessibility - simply relocating the performer for certain events maybe the least intrusive solution.</p>

Technical Systems	<p><u>Existing:</u> Amplification provided</p> <p><u>Recommendation:</u> It was noted on the survey that a lighting upgrade would be welcome.</p>

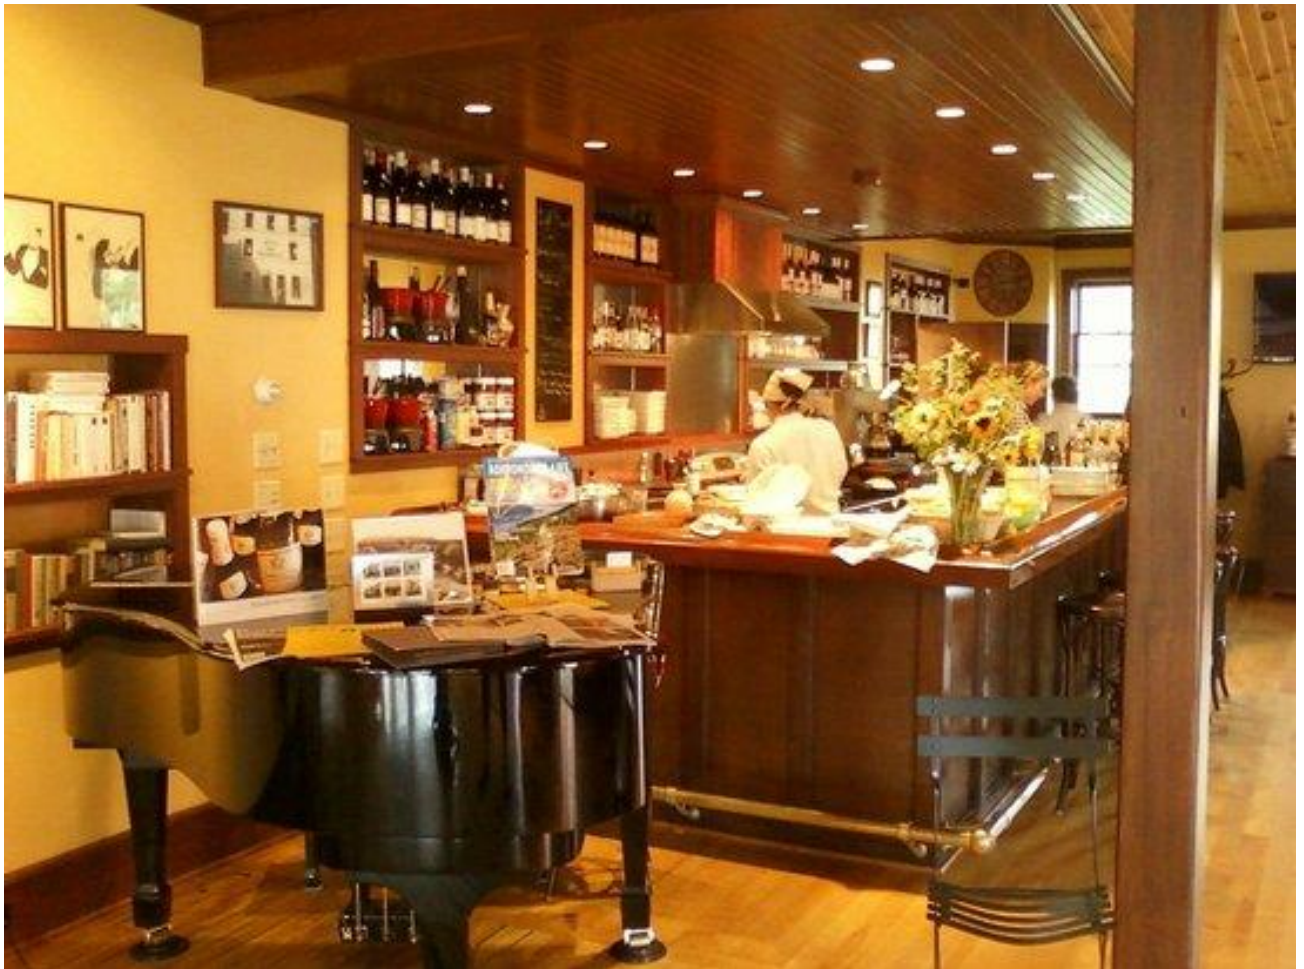
VENUE	LEFT BANK CAFÉ
Current Activities	Café space that serves food and wine, with occasional live and acoustic music and spoken word events.
Qty of Performances	Unknown
State of the Facility	Modern renovation that is well-maintained
Planning: Performance Space & Audience Area	<u>Existing:</u> Performance “area” in the middle of the space with baby grand piano.  <u>Recommendation:</u> None, fits expectations for café with light entertainment
Planning: Back-of-house	<u>Existing:</u> None  <u>Recommendation:</u> None, fits expectations for café with light entertainment
Disabled or Limited Mobility Access	<u>Existing:</u> Accessible from the street for patron or performer access.  <u>Recommendation:</u> None
Technical Systems	<u>Existing:</u> None apparent. It is unknown if a sound system is present.  <u>Recommendation:</u> Current use does not indicate technical needs.

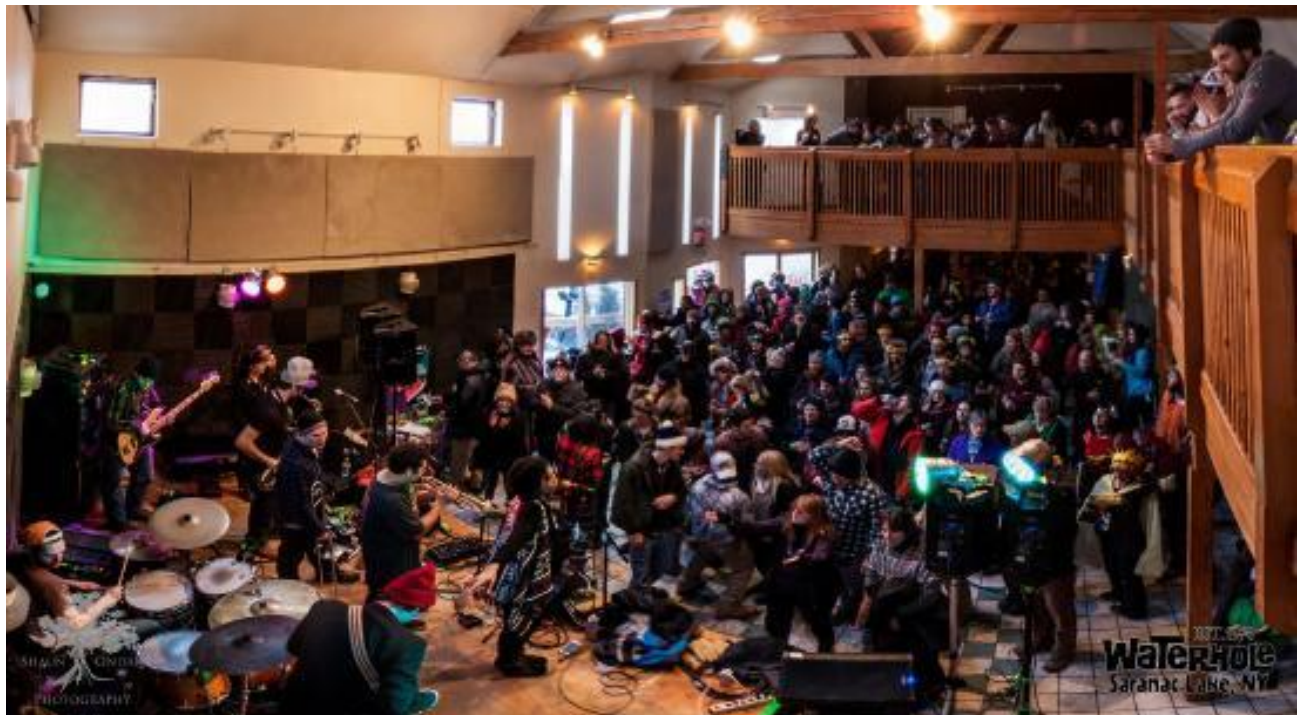
VENUE	WATERHOLE UPSTAIRS
Current Activities	This is the music room of a bar on Main Street. The bar presents local and regional amplified live music.
Qty of Performances	Weekly
State of the Facility	Upstairs space is in reasonable shape, but bears the wear and tear that bar patrons can have. Facility was inaccessible at the time of the site visit, but visible through the windows.
Planning: Performance Space & Audience Area	<p><u>Existing:</u> The performance area is a large flat floor with L-shaped balcony above and a raised stage. The flat floor makes it possible to use for other types of events, but these are not common.</p> <p><u>Recommendation:</u> No changes are suggested as the current configuration appears to work well for the acts and facility.</p>
Planning: Back-of-house	<p><u>Existing:</u> Unknown, but no specific areas mentioned.</p> <p><u>Recommendation:</u> None, stage area only is typical for a bar.</p>

Disabled or Limited Mobility Access	<p><u>Existing:</u> Unknown if an elevator exists in the building, as a site visit was not possible. The performance space is located upstairs. Stage is raised.</p> <p><u>Recommendation:</u> Verify conditions.</p>
Technical Systems	<p><u>Existing:</u> Limited permanent lighting, no rigging, it is understood that the sound system is provided by the act.</p> <p><u>Recommendation:</u> A modest lighting system upgrade would be an improvement, but not a necessity.</p>

Looking East

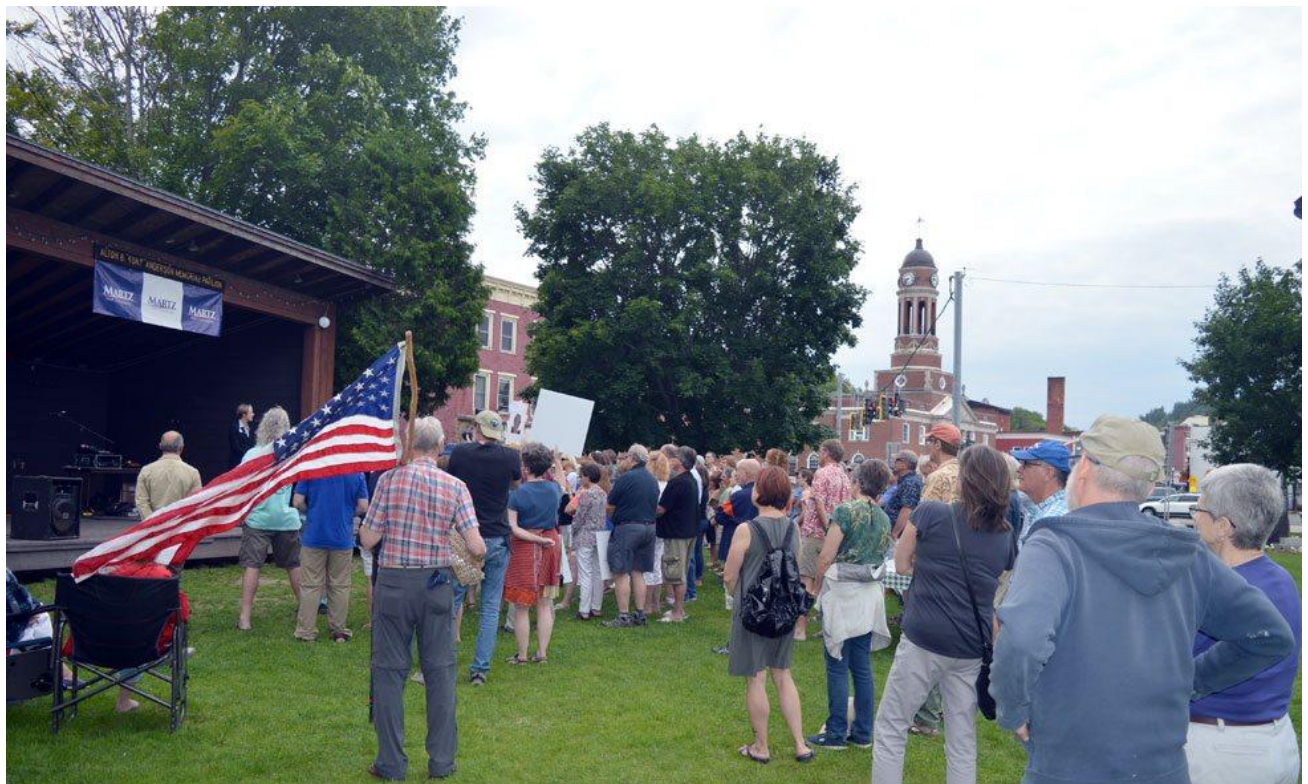
VENUE	ANDERSON BANDSHELL
Current Activities	The bandshell on the lower tip of Lake Flower is used during the temperate summer months for outdoor music, as well as part of various fairs and festivals.
State of the Facility	Mostly wooden structure is exposed to the elements year-round and so has seen some weathering, but appears reasonably maintained.
Planning: Performance Space & Audience Area	<p><u>Existing:</u> Stage area is enclosed by the bandshell and partially protected from the elements. Audience seating is entirely on the adjacent lawn, with no protection other than what people bring themselves.</p> <p><u>Recommendation:</u> Arrangement works well for existing uses.</p>
Planning: Back-of-house	<p><u>Existing:</u> No back of house or staging exists within a structure. Events are staged in the area behind the bandshell. It is understood that rental portable toilets are available.</p> <p><u>Recommendation:</u> None, no concerns about the current conditions were expressed.</p>

Disabled or Limited Mobility Access	<p><u>Existing:</u> Lawn is accessible from the street. Bandshell is raised with steps from the lawn.</p> <p><u>Recommendation:</u> The raised stage would require a ramp for disabled performers, and adequate space appears to exist for the ramp to be added on an as needed basis.</p>
Technical Systems	<p><u>Existing:</u> Power only, no lighting, rigging or A/V provided.</p> <p><u>Recommendation:</u> Use of the shell could be extended into the nighttime hours by including a modest system of lighting, if desired. Rigging does not appear to be a concern and audio is provided by the act.</p>

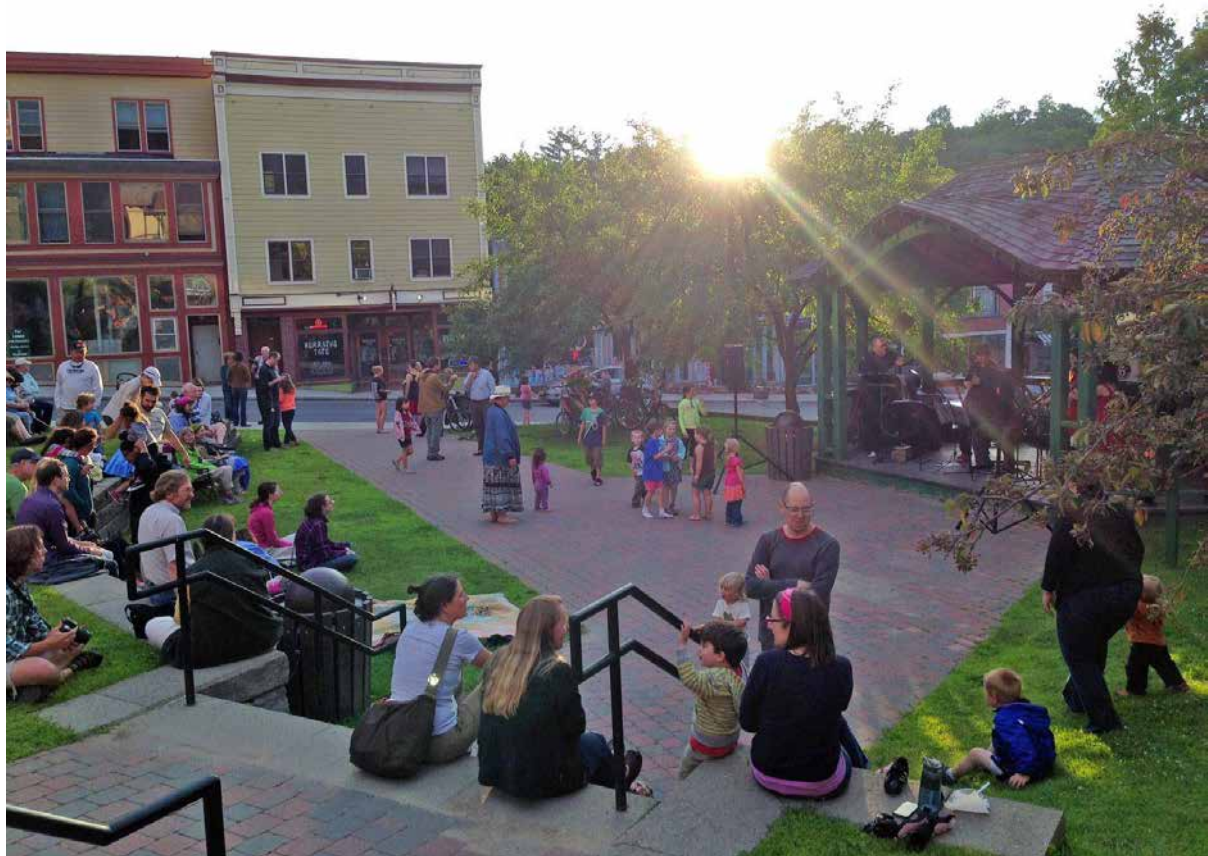
VENUE	BERKLEY GREEN
Current Activities	The facility consists of an open-air pavilion adjacent to a paved area and tiered lawn seating. The green primarily hosts live music or spoken word events. When not used for performances, space is used for public gathering, picnicking, as well as housing the 6er Challenge Bell.
Qty of Performances	Unknown, but used seasonally during temperate weather
State of the Facility	Structure appears to be in good condition with lawn and pavers well-maintained.
Planning: Performance Space & Audience Area	<p><u>Existing:</u> Slightly raised stage as part of covered pavilion structure provides modest protection from weather.</p> <p><u>Recommendation:</u> None, functions as intended and expected.</p>
Planning: Back-of-house	<p><u>Existing:</u> None</p> <p><u>Recommendation:</u> None</p>
Disabled or Limited Mobility Access	<p><u>Existing:</u> Audience seating area is accessible from Main Street sidewalk. Stage is raised by a single step, but is currently not accessible.</p> <p><u>Recommendation:</u> Ramp could be added to stage in a temporary or permanent manner.</p>

Technical Systems	<p><u>Existing:</u> Power provided, but no lighting or A/V support. Portable equipment seems to suit the informal character of the space.</p> <p><u>Recommendation:</u> None</p>

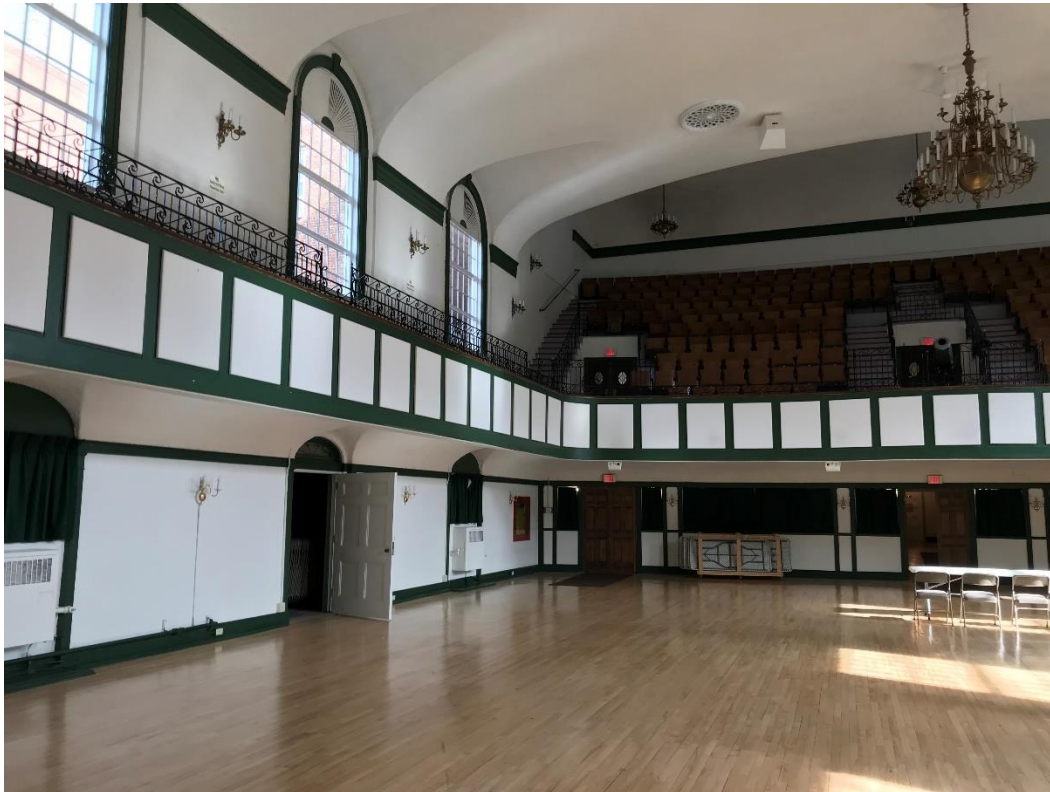
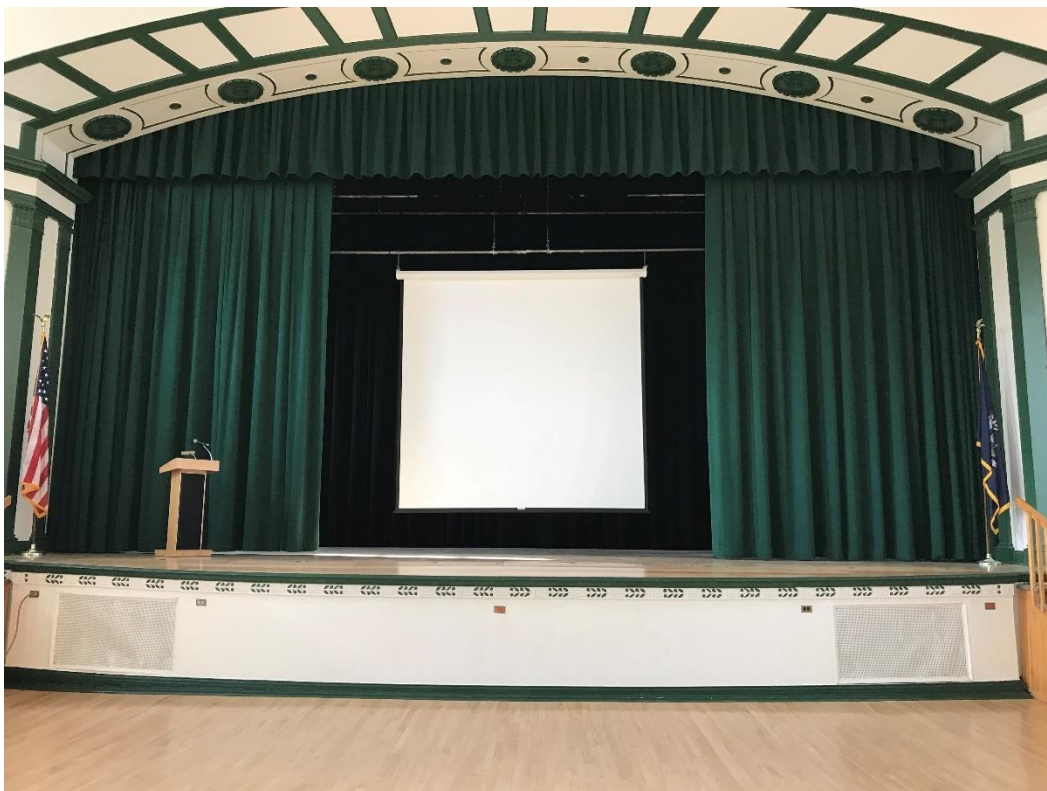
## TOWN HALL AUDITORIUM

VENUE	HARRIETSTOWN TOWN HALL AUDITORIUM
Current Activities	The Town Hall Auditorium is used for any rental opportunity that thinks it can use the space – from traditional performances of drama or dance to craft shows and exhibitions.
Qty of Programs	Unknown, but reportedly events weekly during summer months and sporadic during the colder months.
State of the Facility	Well-maintained auditorium within the town administrative office building.
Planning: Performance Space & Audience Area	<p><u>Existing:</u> The flat floor in the auditorium is the feature that allows its use for non-performance events and in that way is an amenity. However, it does compromise the sightlines to the event on the stage. The original designers of the space took this into account with a highly raised stage. Unfortunately, this high stage makes certain events, such as dance, difficult as being able to see a dancer's feet is considered a prerequisite. The balcony does not have that concern.</p> <p><u>Recommendation:</u> The stage height and sightline concern is original to the structure and would likely be untenable to modify.</p>

Planning: Back-of-house	<p><u>Existing:</u> It is understood that no back-of-house spaces specific to the auditorium exist, but that some spaces can be pressed into service when necessary. Stage access is difficult.</p> <p><u>Recommendation:</u> The sense was that the users' needs for the limited number of performances could be accommodated within the existing inventory of rooms.</p>
Disabled or Limited Mobility Access	<p><u>Existing:</u> The town hall building has an elevator access to the various levels including the main audience level and the balcony. However, the stage is raised from the audience area and not accessible. Portable stairs are used to connect the audience to the stage, but an equal means of access was not available.</p> <p><u>Recommendation:</u> A portable wheelchair access lift should be considered by the town to satisfy accessibility to the stage.</p>
Technical Systems	<p><u>Existing:</u> Permanent speaker locations were noted, as well as stage draperies in the stage area, but there did not appear to be stage lighting from the front-of-house to the stage.</p> <p><u>Recommendation:</u> The primary users of the auditorium have modest technical requirements, so the town purchasing equipment is not advised. Permanent hanging locations for stage lighting should be considered.</p>

Auditorium

Stage
