# Village of Saranac Lake

## **Performance Venue Facilities Assessment** for the Village of Saranac Lake Arts and Cultural Master Plan

Ref: Village of Saranac Lake Arts and Culture Master Plan, Facility Analysis

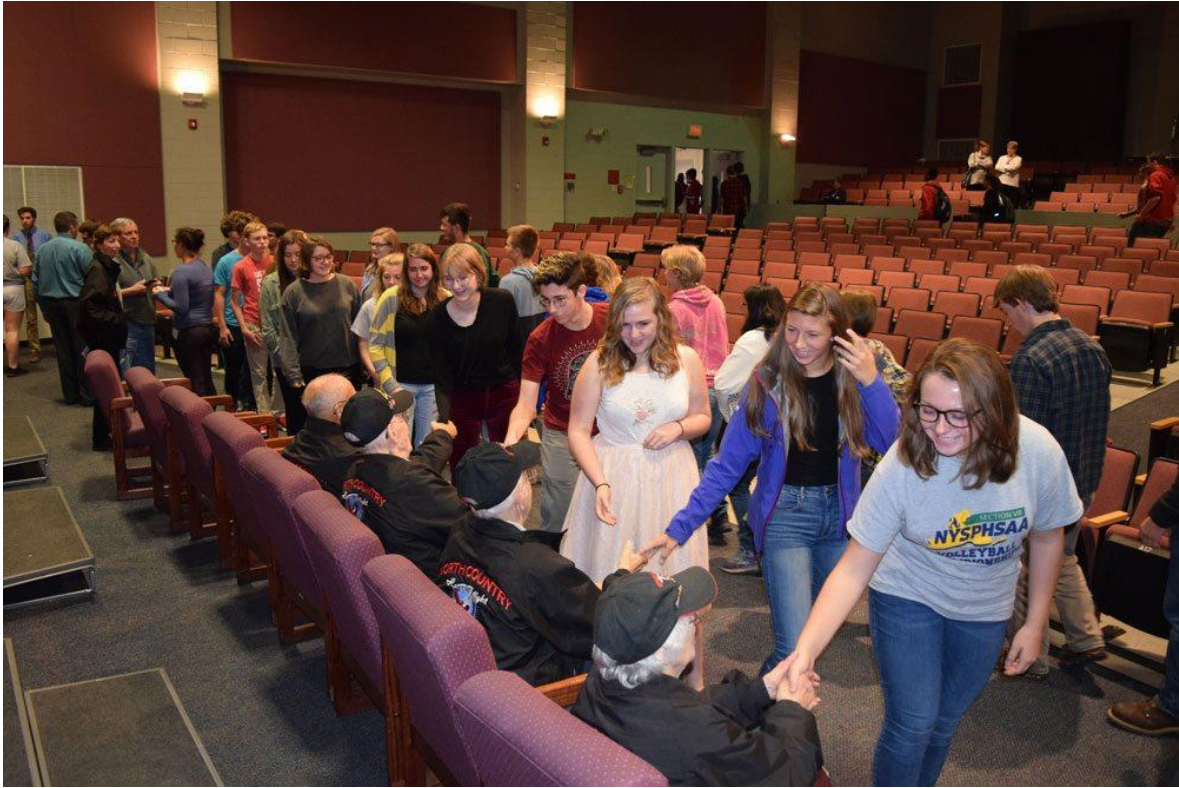
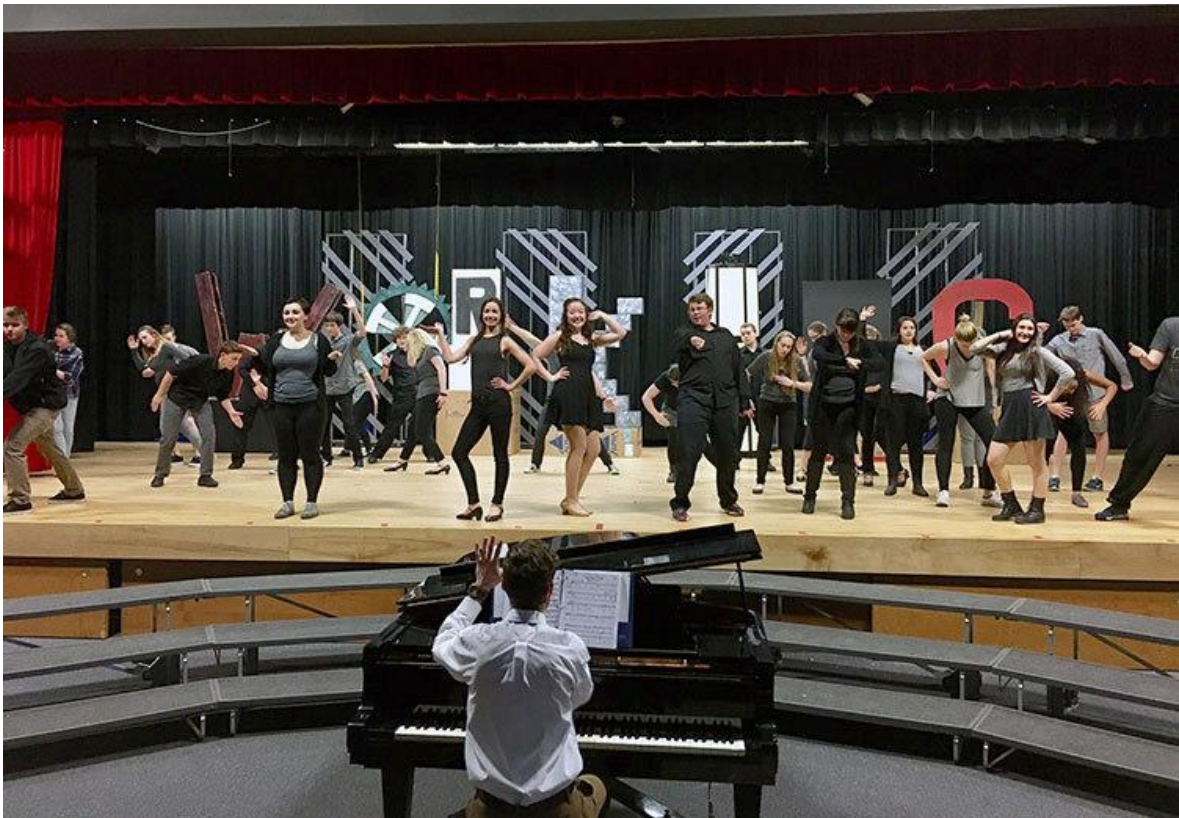
## HIGH SCHOOL AUDITORIUM

VENUE	HIGH SCHOOL AUDITORIUM
Current Activities	The high school auditorium is a workhorse of the school and the community, presenting a wide variety of events, including drama, dance, ballet, musical theatre, opera, symphony, chorus, chamber music, recitals, and contemporary music events. Its 933 seated/standing capacity is the largest of all the venues surveyed.
Qty of Programs	11 school related
Qty of Performances	15-20 / yr
State of the Facility	As an educational facility, the auditorium is built with durable materials, so it appears to be holding up well to the wear and tear of the student body.
Planning: Performance Space & Audience Area	<p><u>Existing:</u> Stage size adequately covers the current uses by the student body, as well as outside groups. The tiered seating in the audience has decent sightlines to the stage and the chairs are in good shape and reasonably comfortable. There are no sound and light locks into the audience chamber or the stage, making entry/exit during a performance noticeable to others.</p> <p><u>Recommendation:</u> While it would be ideal to add sound and light locks, the physical area required would be difficult or impossible to incorporate into this existing building.</p>

Planning: Back-of-house	<p><u>Existing:</u> There are no dedicated dressing or holding rooms for the auditorium. When a production requires space, negotiations with the music department to make practice rooms, storage rooms, and/or offices available are necessary. Storage of stage equipment appears to be in the stage wings.</p> <p><u>Recommendation:</u> None. Providing rooms as needed is reported to work well for the school and balances classroom needs with the auditorium.</p>
Disabled or Limited Mobility Access	<p><u>Existing:</u> Stage and auditorium are accessible via corridors. Control booth is not accessible.</p> <p><u>Recommendation:</u> An in-the-house control position could be used if a technician with a disability were part of the student body.</p>
Technical Systems	<p><u>Existing:</u> Newer audio and projection equipment is an excellent amenity and in good working order. 20-year-old stage lighting system is in need of refreshing (fixtures and controls). Onstage rigging consists of dead-hung pipes, although space exists to allow a modest fly system if ever desired. Student use argues for simple and safe systems, hence omitting a manual fly system, although this would certainly enhance productions.</p> <p><u>Recommendation:</u> Plan for lighting system upgrades within the next half decade utilizing LED fixtures for energy efficiency, as well as exposure of current tech to students.</p>

The audience chamber with students meeting veterans

A view of the stage from the first row of the house

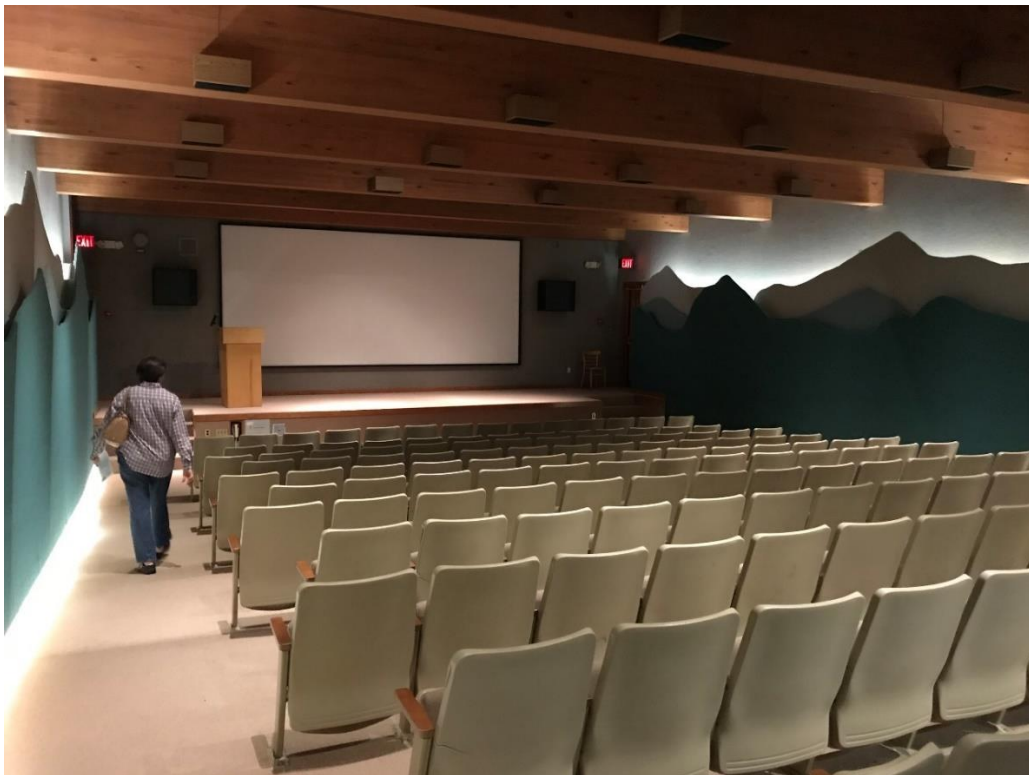
VENUE	PAUL SMITH'S COLLEGE VISTOR'S INTERPRETIVE CENTER
Current Activities	The theatre at the VIC is used daily when the museum is open for film screenings. It is also available for community uses such as meetings, films, live music, and drama.
Qty of Programs	Daily museum events
Qty of Performances	Approximately 20 outside events per year
State of the Facility	Very well maintained by dedicated staff and college facilities department
Planning: Performance Space & Audience Area	<p><u>Existing:</u> Modern, straightforward hall with decent sightlines and comfortable seats.</p> <p><u>Recommendation:</u> None. Current facilities meet users' expectations.</p>
Planning: Back-of-house	<p><u>Existing:</u> No back of house. Control booth in the theatre.</p> <p><u>Recommendation:</u> None. Current facilities meet users' expectations.</p>
Disabled or Limited Mobility Access	<p><u>Existing:</u> Ramped access from museum lobby to audience seating. Stage is a raised platform with level or ramped access from the audience. Stage is accessible via door leading directly to the outside.</p> <p><u>Recommendation:</u> The current building code does not allow for separate routes for able-bodied (stairs within the room) and disabled access (outside entry) to the stage. A portable wheelchair access lift may want to be considered for full compliance.</p>

Technical Systems	<p><u>Existing:</u> Limited stage lighting, no stage rigging, but well-equipped A/V with provisions for distance learning and live-streaming of presentations.</p> <p><u>Recommendation:</u> None. Current equipment appears to fit the needs of the various users' expectations.</p>

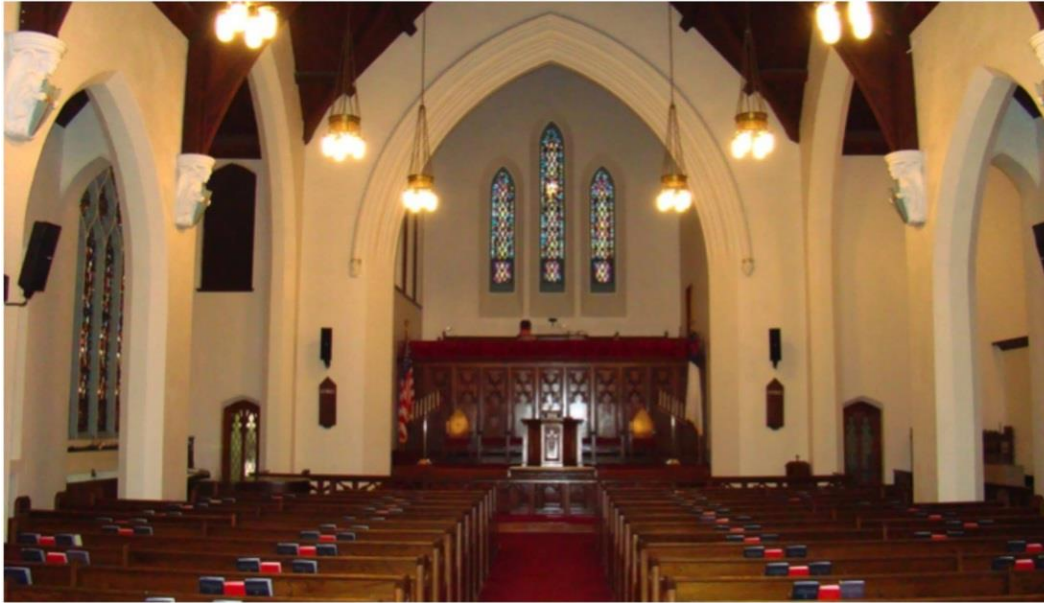
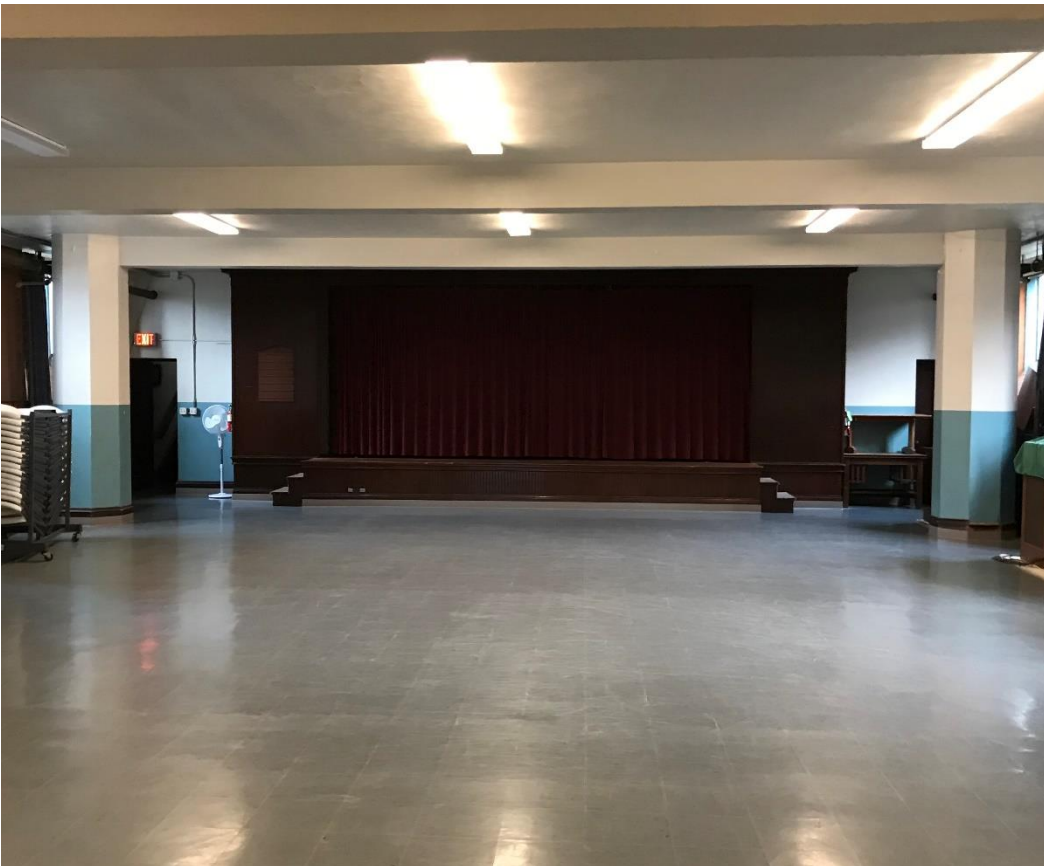
## UNITED METHODIST CHURCH

VENUE	UNITED METHODIST CHURCH
Current Activities	Main Hall of the church is used by musical, choral, and drama groups throughout the warmer months. During winter, congregation moves downstairs to the fellowship hall, which is typically not used for performance.
Qty of Performances	Sporadic, but generally events every other month
State of the Facility	Aging historic facility is struggling with upkeep, but is generally in fine shape for performance.
Planning: Performance Space & Audience Area	<p><u>Existing:</u> Congregation hall has typical pews and built up deus/altar that makes performance a challenge. Main hall has larger seat count with balcony section, but this is in disuse and fairly remote/disconnected from the deus. Raised deus has good sightlines, even though main floor is flat, but most performances use the non-raised area in front of the deus, which is sightline constrained. Downstairs fellowship hall has a raised stage, which is shallow, but appears to be better suited to presentation/performance than the main hall.</p> <p><u>Recommendation:</u> No changes to the physical structure, but some renters should be directed to the fellowship hall, which might better serve their needs.</p>

Planning: Back-of-house	<p><u>Existing:</u> No adjacent back-of-house spaces to the main congregation hall, but the fellowship hall has a large catering/pantry area for events.</p> <p><u>Recommendation:</u> No recommendation that would not be disruptive to the primary use of the church</p>
Disabled or Limited Mobility Access	<p><u>Existing:</u> Elevator provides disabled access to the main congregation hall and the fellowship hall.</p> <p><u>Recommendation:</u> None</p>
Technical Systems	<p><u>Existing:</u> No apparent systems were in place. Tour guide did not know extents of systems, but PA system was assumed in both halls</p> <p><u>Recommendation:</u> Renters should supplement the space with temporary equipment as needed</p>

Main Hall

Downstairs Meeting Hall

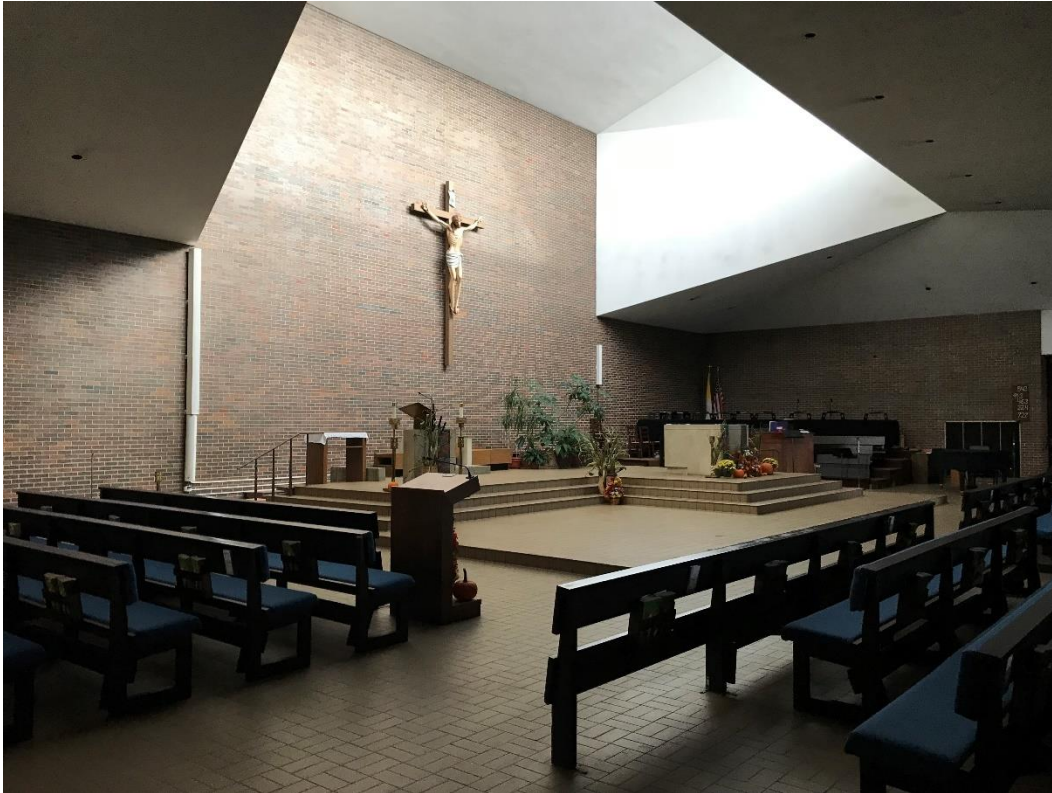
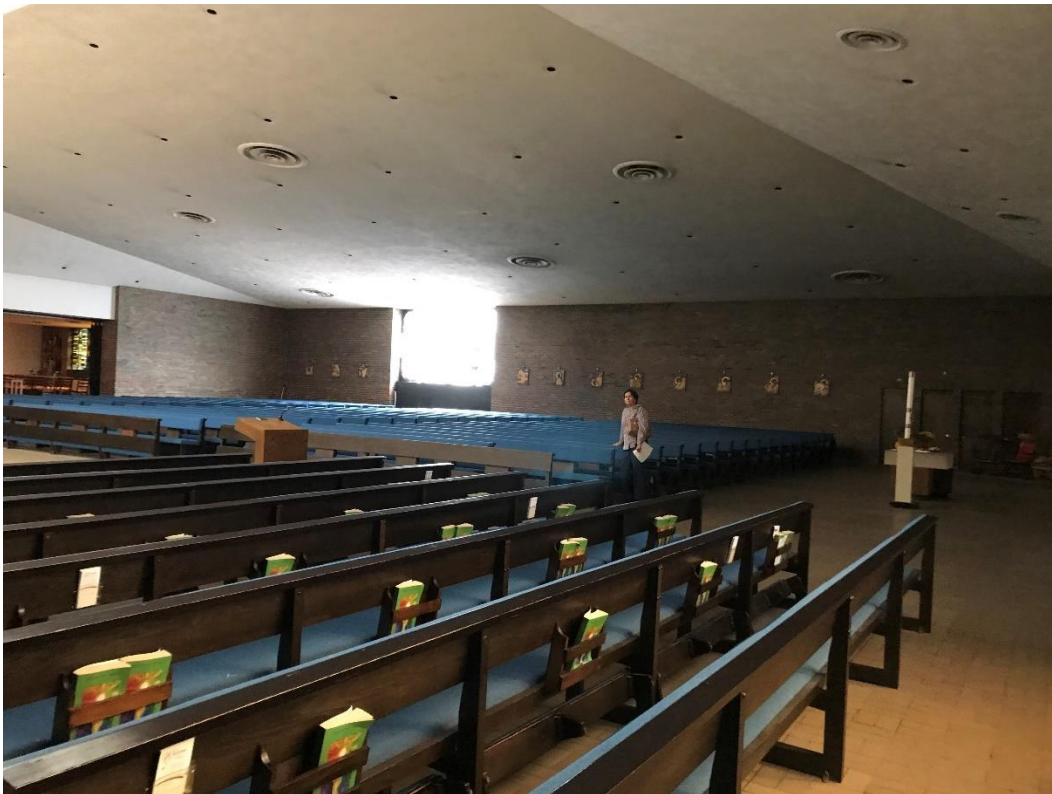
## ST. BERNARD'S CHURCH

VENUE	ST. BERNARD'S CHURCH
Current Activities	This large (~600 seat) modern church is also used for performances for choirs, school concerts, and other musical events.
Qty of Performances	Unknown
State of the Facility	The facility appears well-maintained.
Planning: Performance Space & Audience Area	<p><u>Existing:</u> The raised deus/altar makes staging events challenging. The large open space above the bema and the lower planar ceiling above the audience make the acoustics particularly challenging. Lots of natural light and large open space make the room attractive for events.</p> <p><u>Recommendation:</u> Engage an acoustical consultant to provide feedback on modest treatments to the room that could improve the acoustics of the space for more functions.</p>
Planning: Back-of-house	<p><u>Existing:</u> The only performer-specific facilities are the choir room. Restrooms are used for dressing and there is no staging area.</p> <p><u>Recommendation:</u> The primary use as a place of worship makes permanent performance specific accommodations unrealistic. "Pipe and drape" could be used to define performer areas, if needed.</p>

Disabled or Limited Mobility Access	<p><u>Existing:</u> "Stage" area is raised on steps making disabled access impossible without temporary ramping. Restrooms used for dressing, as well as choir room and chapel (used as a performers lounge), are at a different level than the audience or stage.</p> <p><u>Recommendation:</u> Permanent disabled access provisions would be a benefit to both the worship function as well as any renters.</p>
Technical Systems	<p><u>Existing:</u> Amplification is provided, but no stage lighting or rigging.</p> <p><u>Recommendation:</u> Nothing specific to the facility. Rental equipment could provide any missing support.</p>

Bema

Seating

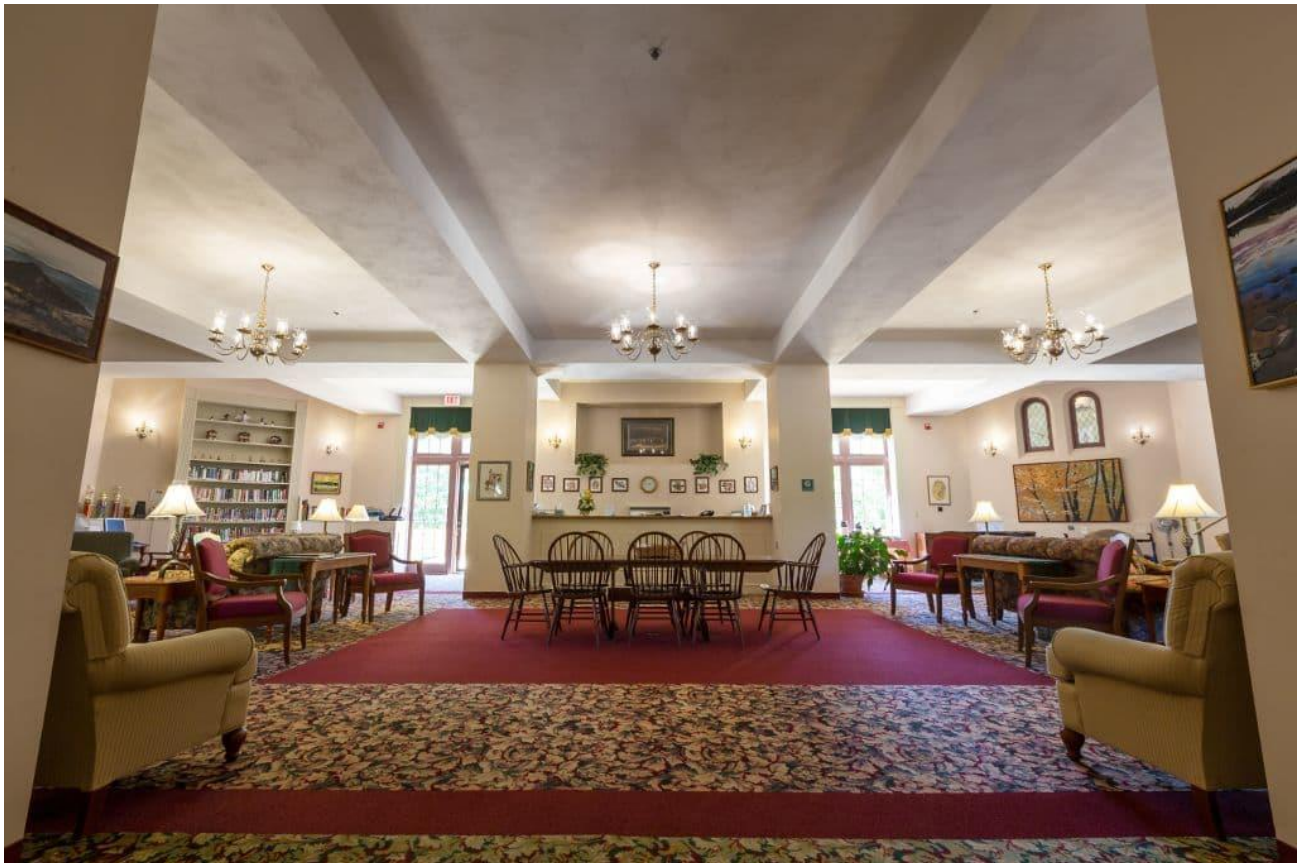
VENUE	WILL ROGERS
Current Activities	A variety of performance (mostly music and spoken word), as well as visual arts, are presented to the residents of this retirement community.
State of the Facility	Unknown, could not visit during tours
Planning: Performance Space & Audience Area	It is understood the facility's Great Room is used as multi-purpose space. Seating is ad hoc.
Planning: Back-of-house	It is understood that no back-of-house exists, including no performer accommodations, but it meets the majority of users' expectations.
Disabled or Limited Mobility Access	It is assumed that the facility is fully accessible, considering its resident population.
Technical Systems	It is understood that the facility has limited technical infrastructure, but meets the majority of the users' expectations.

Understood to be the meeting room used for performance.

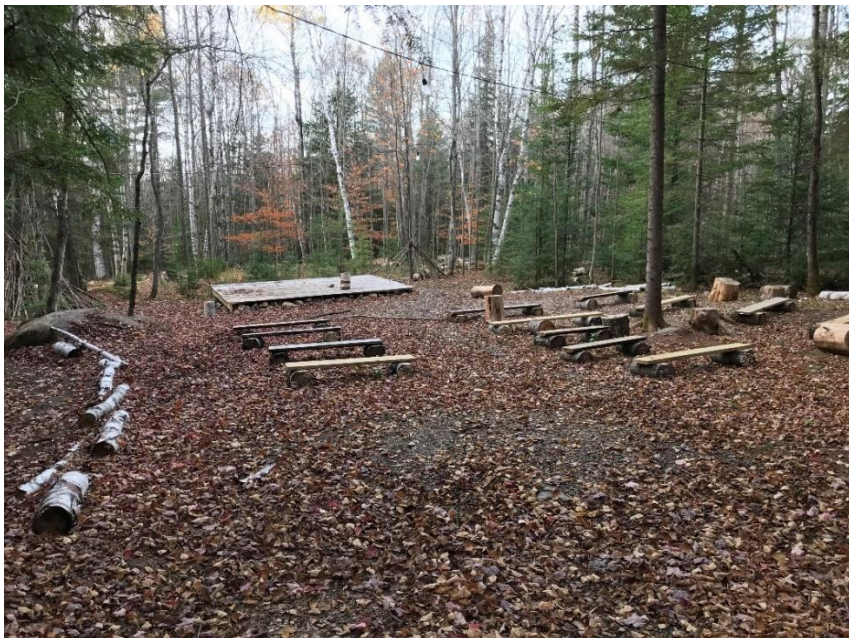
VENUE	DEWEY MOUNTAIN STAGE
Current Activities	Built as a joint venture between Pendragon and Dewey Mountain. The stage was initially built for A Midsummer Night's Dream, performed by Pendragon, but is in continuous use by Dewey Mountain for its summer programs including live music and summer camp use.
State of the Facility	The Dewey Mountain Stage is a bare-bones outdoor venue, making use of the beautiful surroundings to accentuate the performance. While in reasonable condition at the moment, aspects will deteriorate quickly over time with exposure to the elements.
Planning: Performance Space & Audience Area	<p><u>Existing:</u> Stage consists of an elevated platform. Audience seating are rough bench slabs without backs. No facilities are present for intermission gathering or restrooms.</p> <p><u>Recommendation:</u> Stage timber should be treated and sealed against the elements to keep it in good repair against the ravages of the elements.</p>

Planning: Back-of-house	<p><u>Existing:</u> No back-of-house exists. Actors are exposed for entrances to the stage.</p> <p><u>Recommendation:</u> It is not known whether a desire for better back of house facilities is necessary, as the stage is understood to meet current needs.</p>
Disabled or Limited Mobility Access	<p><u>Existing:</u> While the path to the seating is "level" from the parking area, the path is a woodland trail. It poses significant difficulty for those with mobility impairments.</p> <p><u>Recommendation:</u> The facility should carefully consider this stage's use when open to the public.</p>
Technical Systems	<p><u>Existing:</u> Technical support was provided for the single production, with the majority being removed afterwards. A string of houselighting was left in place, presumably with other electrical service.</p> <p><u>Recommendation:</u> Temporary accommodations based on the specific needs of the production.</p>
