# Julian Scott Homestead

The Julian Scott Homestead is a building of considerable historic interest, retaining an optimistic proportion of its original fabric despite subsequent alterations and adaptations. This report presents observations from a site inspection, identifying surviving historic features and assessing their contribution to the building's overall heritage significance. The assessment follows the principles outlined in Historic England's *Conservation Principles, Policies and Guidance* (2008), which provides a framework for understanding significance through four interconnected heritage values: evidential, historical, aesthetic, and communal.

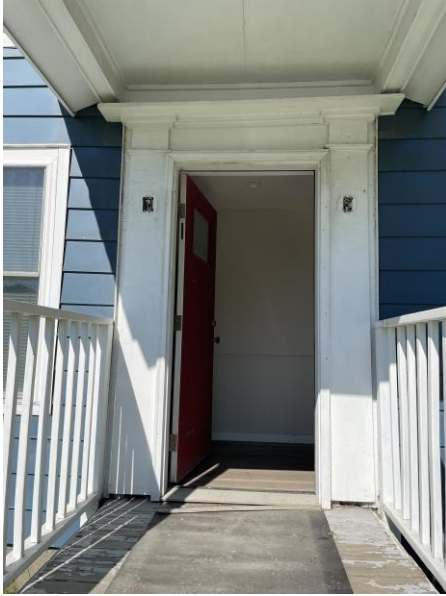
The surviving door mouldings possess **evidential value** through their ability to demonstrate historic carpentry techniques, construction methods, and phases of alteration within the homestead. They also contribute **aesthetic value** by representing the craftsmanship and architectural detailing of the building's original entrance, which is an important element in understanding its historic character. If confirmed as original fabric, the mouldings would also hold **historical value** through their association with the early occupation and development of the Julian Scott Homestead. As a prominent feature of the building's principal entrance, their preservation would support the retention and interpretation of the building's architectural identity and contribute to its wider significance within the community.

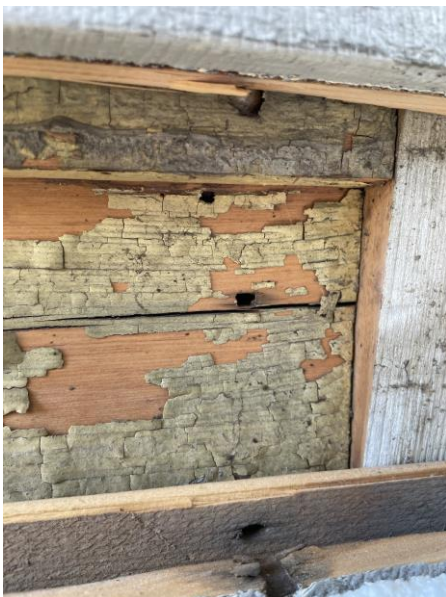
One exciting detail is the original siding hidden beneath a layer of modern siding. The extent of survival is unknown, and a large portion on the north side of the building was lost due to the latest renovation.

The surviving original siding possesses considerable evidential value through its potential to retain original tool marks, paint finishes and timber characteristics. If confirmed as locally milled timber, it would also contribute to the historical value of the building by demonstrating use of locally produced materials within Johnson during the early nineteenth century. Preservation in situ should therefore be regarded as a conservation priority.

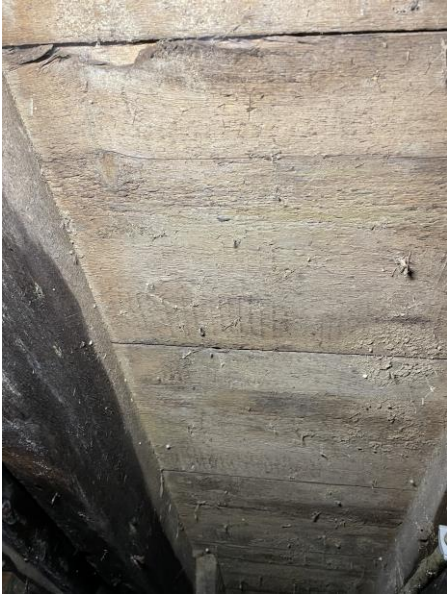
The original subflooring observed within the basement provides important evidence of early nineteenth-century timber conversion practices. The surviving saw marks are characteristic of the water-powered “up-and-down” sawmills that were abundant in the town during the period of construction, preserving direct evidence of local sawmilling technology and methods of timber processing. Although this fabric would likely remain concealed following conservation works due to its location, its retention is important as it contains valuable information regarding the methods of timber conversion employed during the building’s construction. As largely undisturbed concealed fabric, the subfloor possesses high **evidential value**, providing archaeological evidence that contributes to an understanding of the building’s material history and local industrial practices.

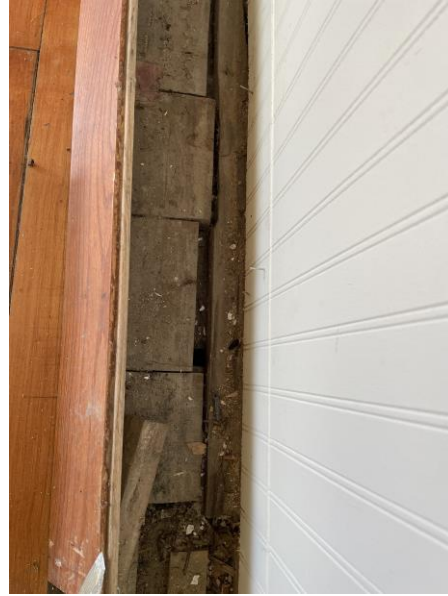
The original flooring layer located between the subfloor and the current floor covering represents a potentially significant surviving element of the homestead’s historic fabric. Its condition cannot be fully assessed until the modern flooring material is removed; however, if intact, it would likely represent the surface used during the early occupation of the building and potentially the floor with which Julian Scott himself would have had direct contact. The survival of these floorboards would therefore provide a tangible connection to the building’s historic occupants and contribute substantially to the authenticity of the interior. As a result, the original flooring would possess considerable **historical value**, with its preservation enhancing the understanding of the homestead’s domestic history and strengthening the significance of future conservation efforts.

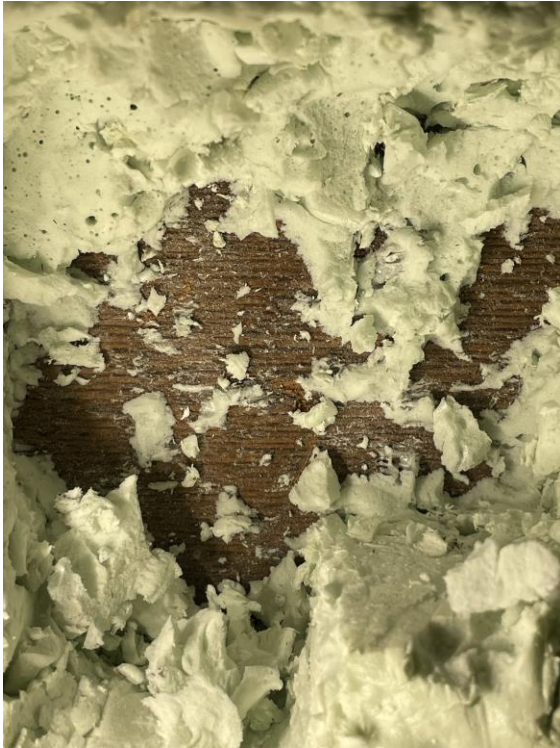
The surviving sheathing appears to consist of original horizontal barnboard, with the characteristic up-and-down saw marks providing evidence of early nineteenth-century water-powered sawmilling practices. The use of horizontal boarding reflects regional construction trends during the 1830s and 1840s, a period when builders in northern Vermont were transitioning away from vertical-plank construction towards timber-framed buildings with sawn board sheathing. A small section of the barnboard was carefully exposed by removing a limited area of spray foam insulation, allowing the historic fabric to be examined without causing damage. Although exposing the full extent of the original sheathing would be a laborious process, it remains a feasible conservation objective that could reveal further information about the building's original construction.

The removal of the original interior plaster and lath has resulted in the loss of an important layer of historic fabric; however, surviving evidence remains visible through nail holes and plaster remnants on the timber frame and studs. Further analysis of these marks may provide insight into the original lathing method employed, such as the use of accordion lath or individual wooden slats. The surviving horizontal barnboarding therefore possesses significant **evidential value**, providing direct evidence of regional building practices and the evolution of timber construction methods in northern Vermont during the early nineteenth century. Its survival contributes to an understanding of the homestead's original construction

sequence and the wider development of local building traditions.

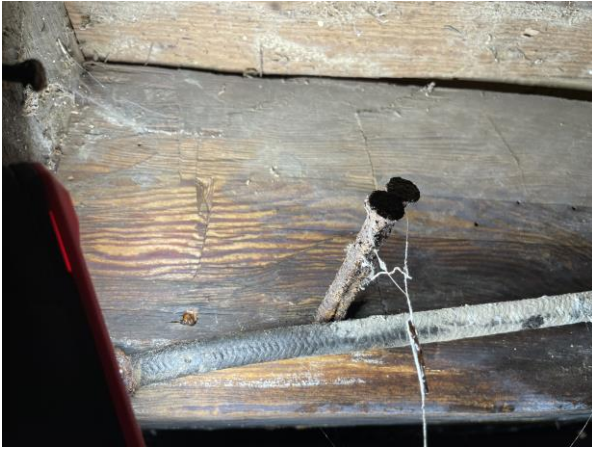
Ground-floor joist containing hewing marks. These timbers are in excellent condition, however immediate intervention is required (see next image).

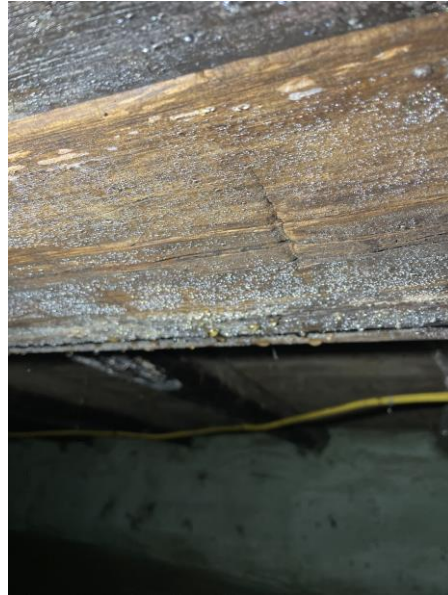
Surface moisture is collecting on the timbers and surfaces of the ceiling in the basement. This will certainly attract fungi, which will break down the heartwood and allow insect infestation if not remedied ASAP. There is no air circulation or movement due to the spray in foam. Even the windows were covered in spray-foam! This is a disaster for a timber-framed building.

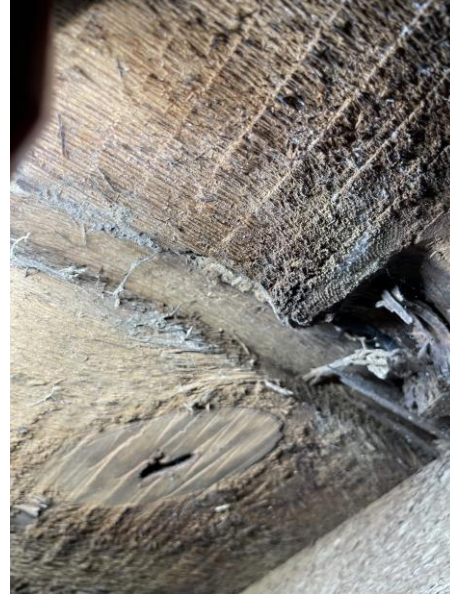
A close-up image depicting conversion marks on the subfloor.

The survival of this structure through major flood events, including the 1927 flood, the 1995 flood, and more recent flooding in Johnson, demonstrates the resilience of its historic construction and the effectiveness of traditional timber-building practices. The floor system, despite repeated exposure to flooding, has remained substantially intact due to the ability of the timber frame to dry naturally through established patterns of ventilation and air movement. Conversely, recent alterations—particularly the application of spray-foam insulation—have introduced a significant threat to the building’s heritage fabric by altering its historic environmental performance. The restriction of airflow and entrapment of moisture within the timber structure has accelerated deterioration processes, creating conditions more harmful than those caused by previous flood events. Without appropriate intervention, this loss of breathability risks the progressive decay and eventual loss of significant historic fabric, diminishing the building’s evidential and historical values.
