Town of Groton- Municipal Road Erosion and Stream Crossing Inventory and Capital Budget (2015-2019)

Prepared by: Brent Smith (Town of Groton), Doug Morton (NVDA), Jim Ryan (VT DEC), and Pat Ross (VT DEC)

Funding provided by: VTrans Better Backroads (BBR) program, with in-kind match from the Town of Groton, NVDA, and VT DEC

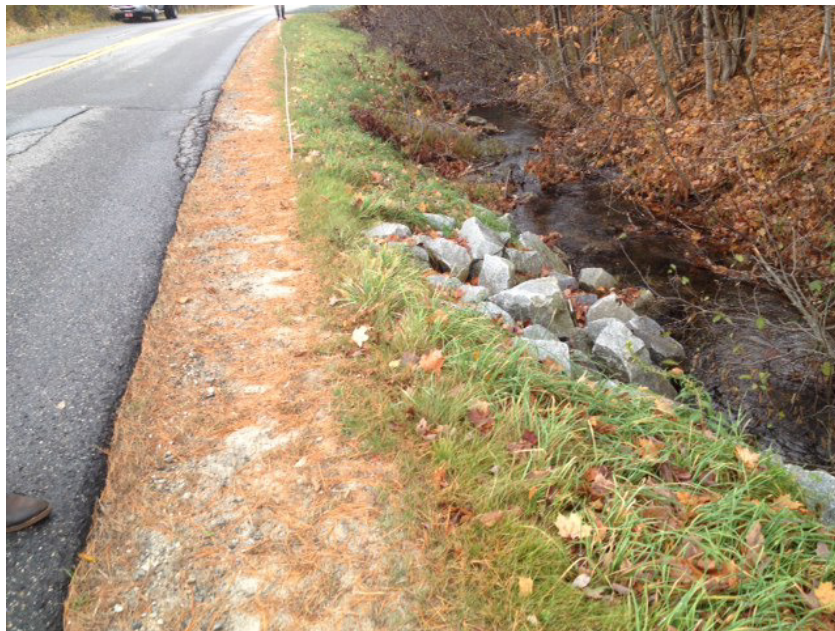
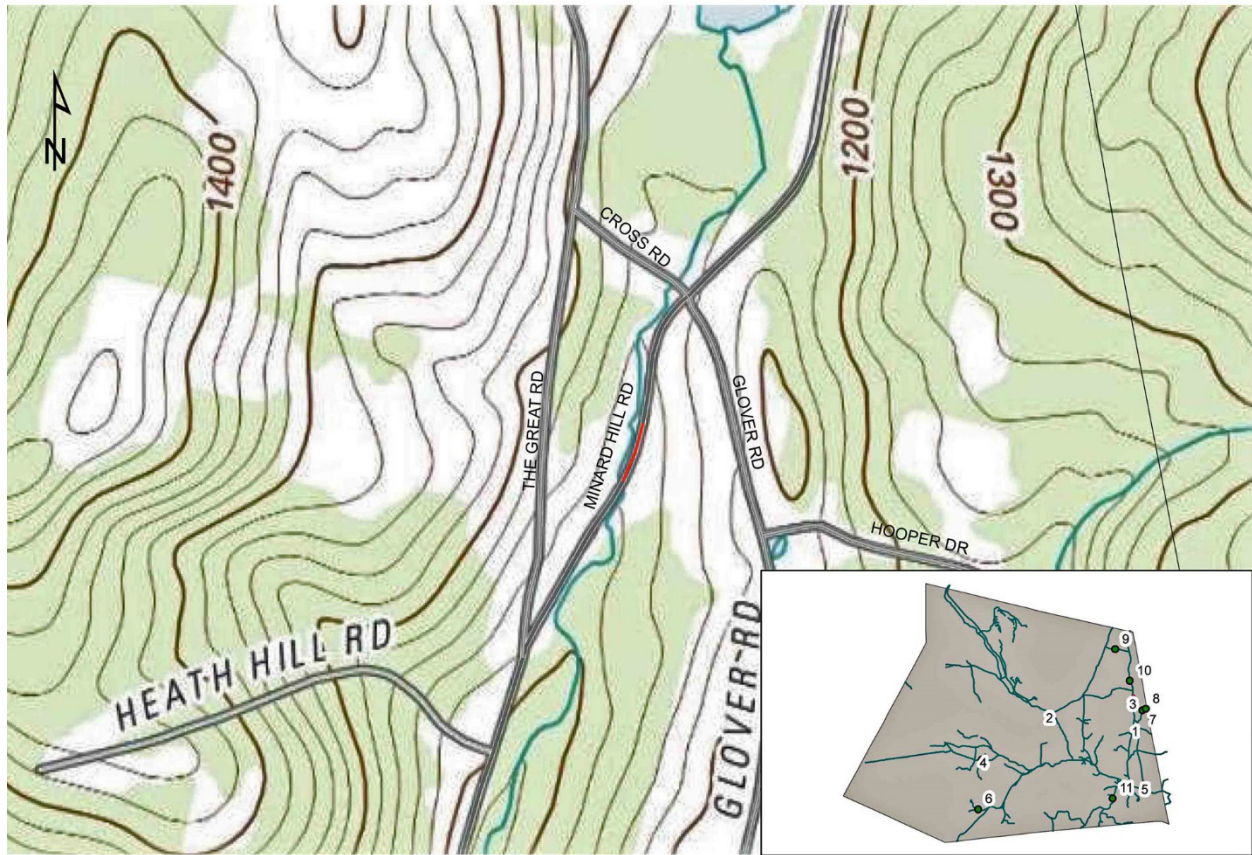
Site Location #1 Minard Hill (Lower)

The problem- River-road conflicts have reoccurred at this site on numerous occasions resulting in damage to the town highway road embankment. The road bed is acting as a floodplain encroachment limiting full access to the remaining active floodplain, pinching the brook against the road embankment. A poorly aligned and undersized stream crossing, aggravates the erosion problems. The existing culvert header is beginning to fail and erode.

The proposed treatment- Install 25 LF of road embankment riprap, replace 25 LF of failing culvert riprap, and partially restore the floodplain. The landowner should be approached to discontinue mowing up to the stream edge and to establish a woody riparian buffer. A longer term fix would be to replace this culvert with a bankfull plus crossing allowing for aquatic organism passage. (see riprap typical)

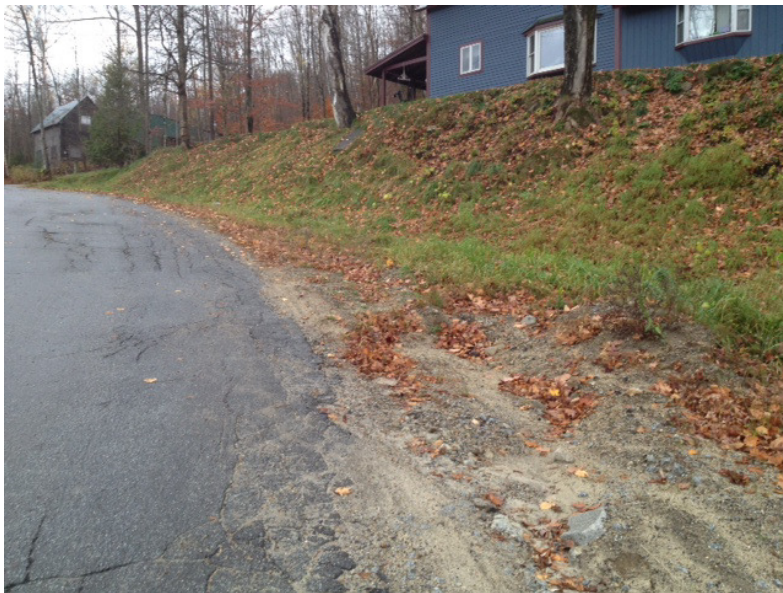
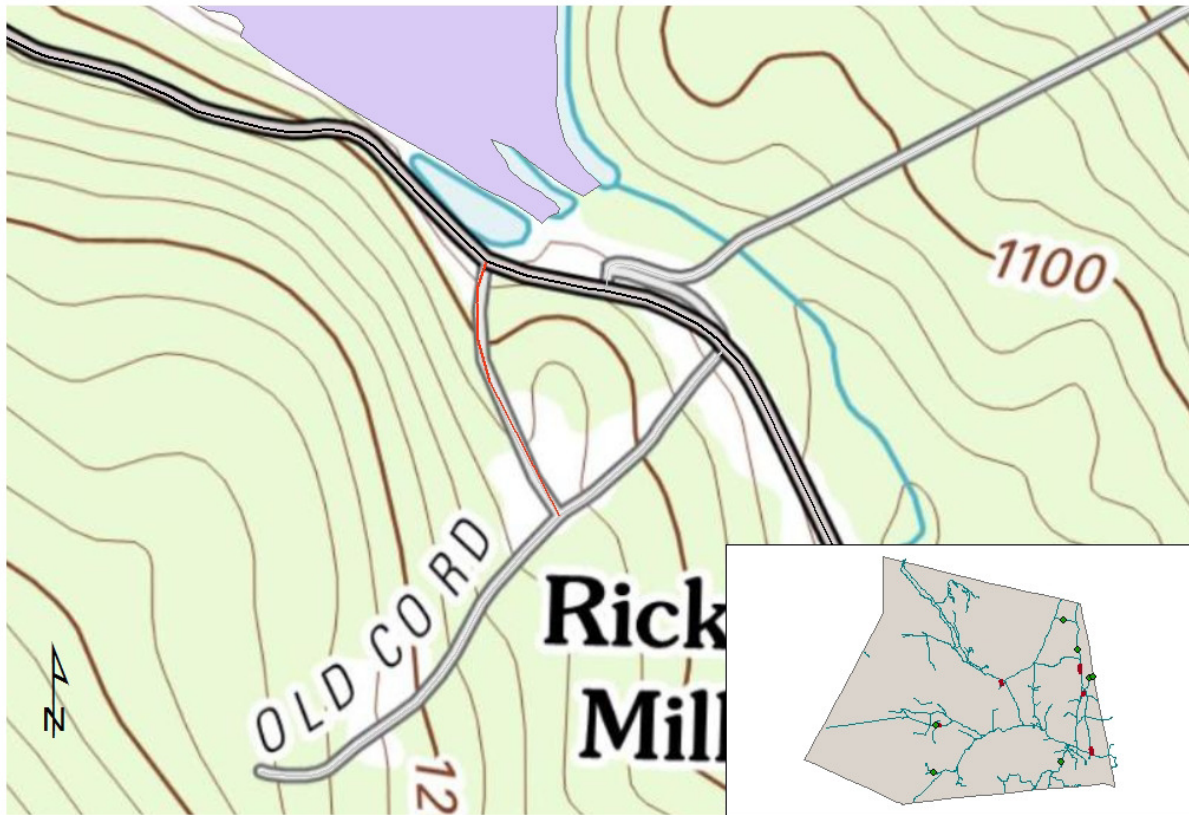
Site Location #2 Ricker Mill Rd

The problem- Ricker Mill Road is a very steep road with inadequate road drainage treatments. This is resulting in significant sedimentation entering Ricker Pond at the downhill end of the road. There is a firewood processing business at the top of the road with frequent truck traffic. The paved road surface is in poor condition.

The proposed treatment- Install 200 LF of grass-lined drainage ditch, 460 LF of stone-lined ditch, a stone-lined turnout, culvert outlet apron/splash pad, and replace a driveway culvert.

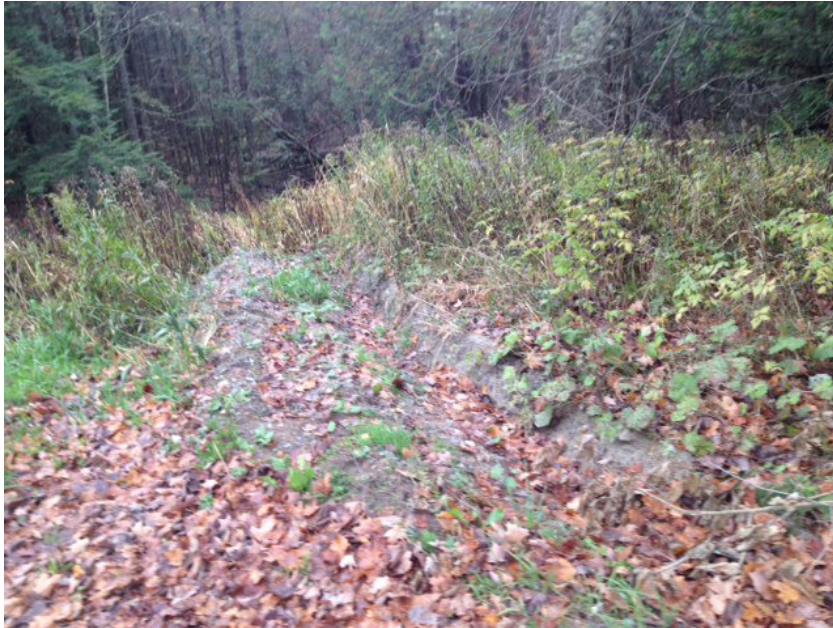
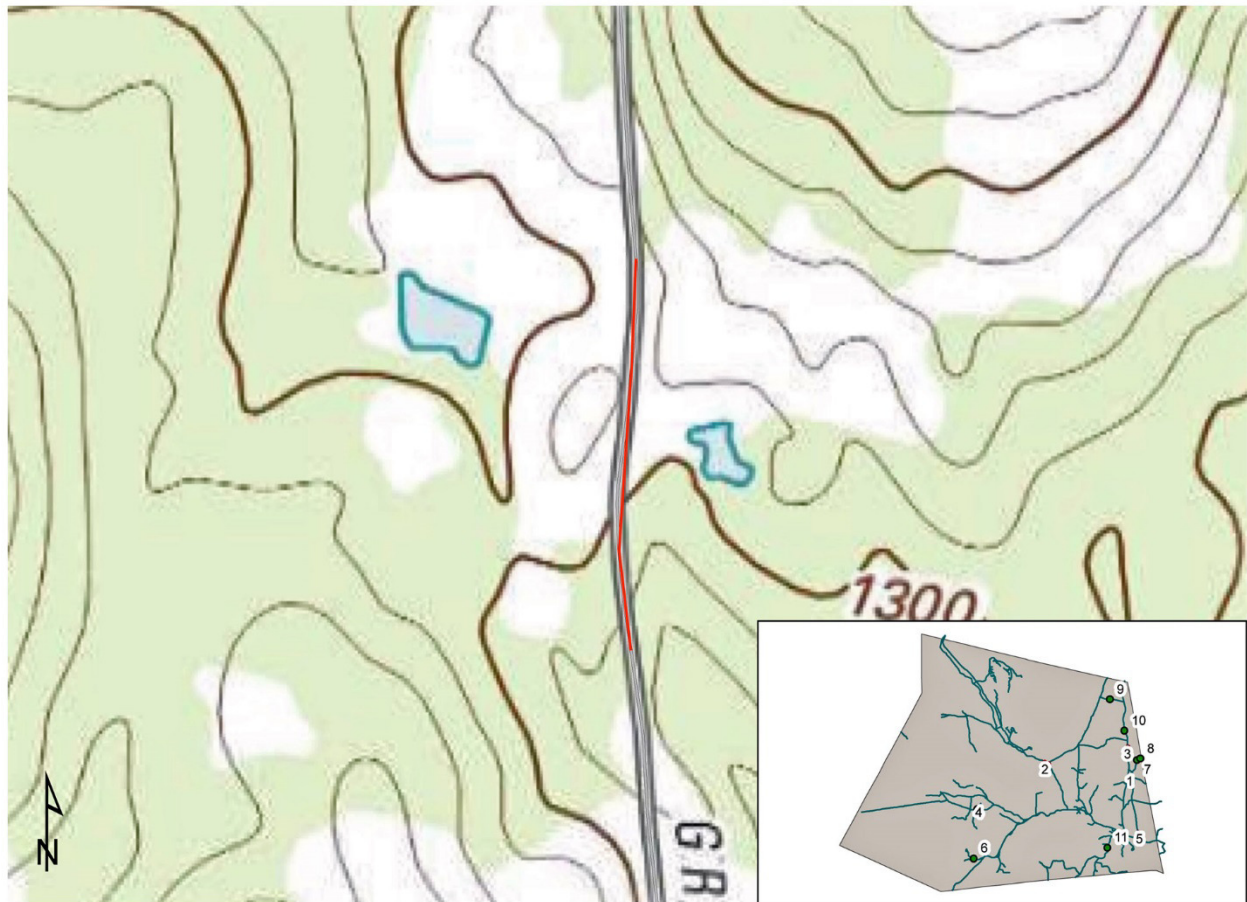
Site Location #3 Great Rd

The problem- This section of Great Road is a steep with inadequate road drainage systems in place causing significant sediment to enter this tributary to the North Branch.

The proposed treatment- Install 900 LF of stone-lined ditching on both the east and west sides of the road and two stone-lined turnouts. *There is buried wire at this site- Use Caution*

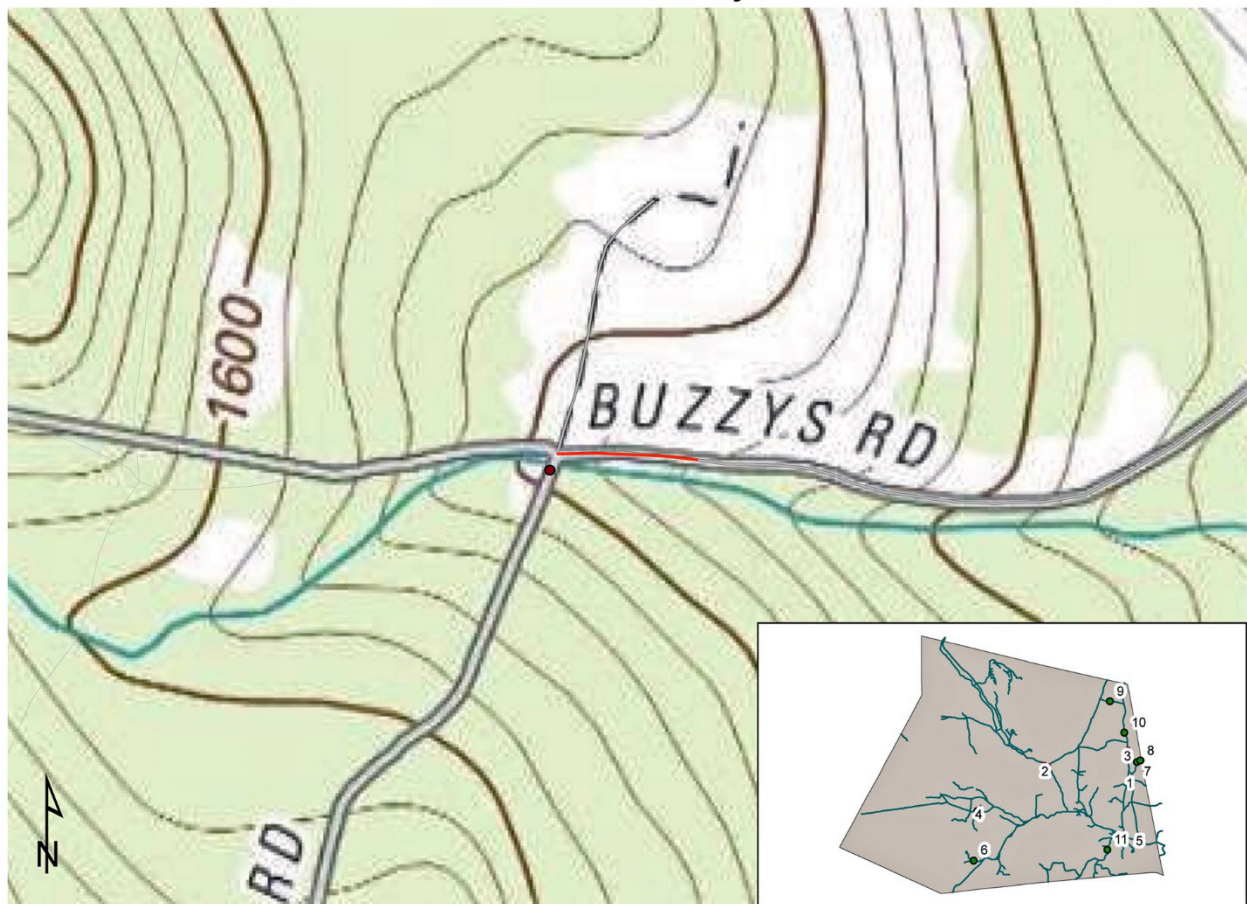
Site Location #4 Buzzy Rd

The problem- The road embankment is encroaching on the stream floodplain causing road shoulder erosion. One of the existing turnouts is outletting sediment directly to the stream. The road drainage system needs to be upgraded.

The proposed treatment- armor 25 LF of the road shoulder with riprap, install 300 LF of stone-lined ditch, re-locate turnout so that it does not directly outlet to the stream.

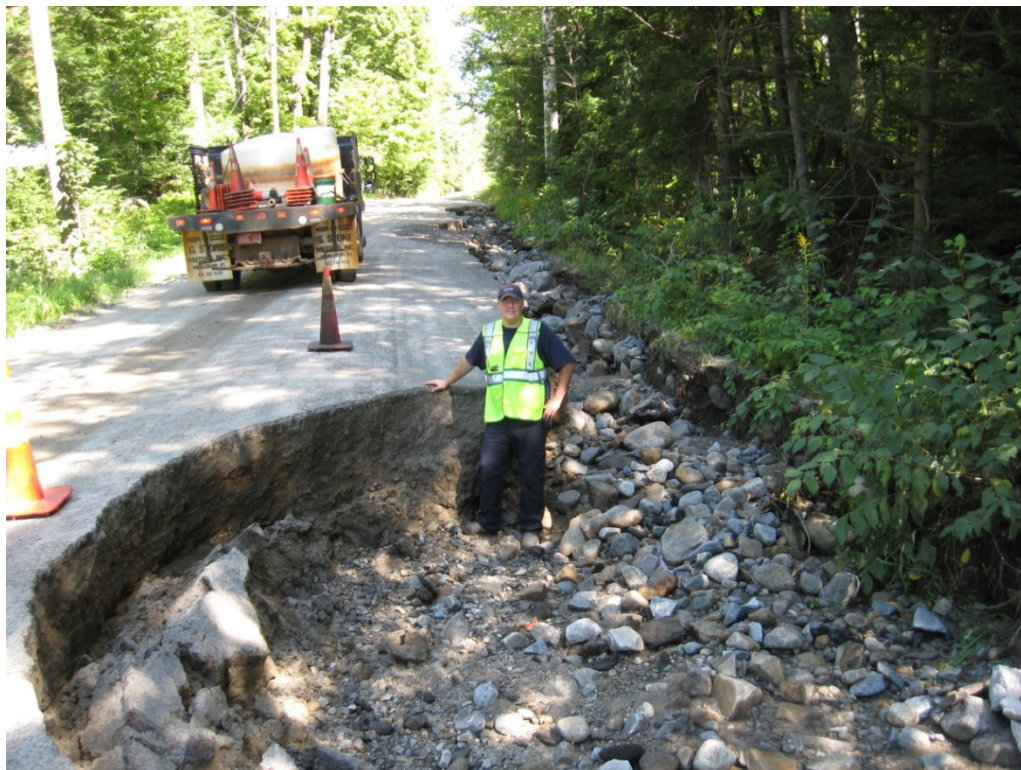
Site Location #5 Glover Rd

The problem- the Glover Road is acting as a significant floodplain encroachment and reducing the brook's access to its active floodplain. This river-road conflict has caused re-occurring road embankment failures and sedimentation to the waterway. Additionally, inadequate road drainage systems are causing road shoulder erosion.

The proposed treatment- Install 75 LF of road embankment riprap, install 50 LF of retaining wall, re-locate 150 LF of road as indicated to restore active stream floodplain area, re-grade and lower road shoulder on east side of road, install 625 LF of stone-lined ditch, and install 3 new driveway/road drainage culverts. (*Buried cable at site- Use Caution*)

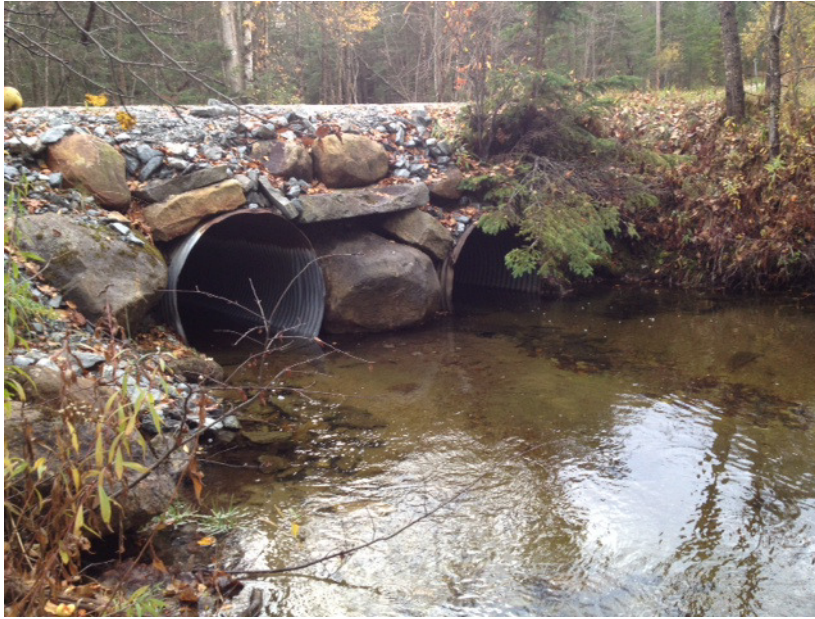
Site Location #6 Heath Brook Rd

The problem- The bankfull measured on site is 12'. The existing two 4' round culverts are not large enough to handle flow, sediment and stream debris resulting in road erosion and failure. Heath Brook is joined by another unnamed tributary immediately upstream of this structure. Heath Road is a Class 3 gravel road. Top fill was measured at 7'. Drainage Area (DA) calculated at 1.69 sm.

The proposed treatment- includes the removal of double culverts and the installation of a 12' pipe arch 34' in length. The actual pipe arch size will be 12'-4" by 7'-9" buried approximately 2' to accommodate aquatic passage. The pipe will be covered by a minimum of 2' of fill. Riprap header should be installed.

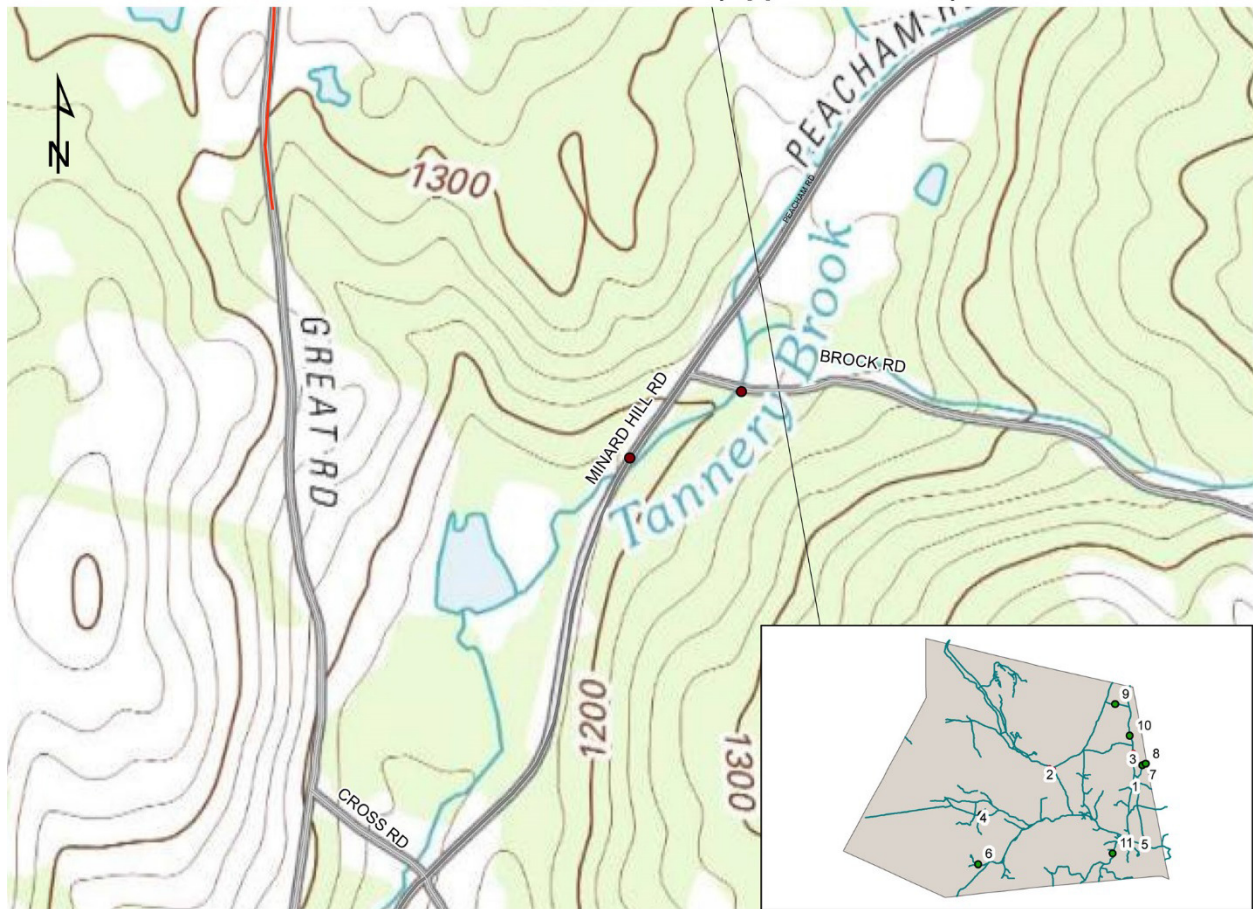
Site Location #7 Minard Hill Rd (Upper Structure)

The problem- Bankfull was measured at 8' in the field on this reach of Tannery Brook. The existing structure is a 5' round culvert. This is a Class 2 paved highway. The culvert has been overtopped, eroding the paved surfaces. The current structure is poorly aligned, causing additional downstream bank and channel erosion. The existing structure does not provide aquatic passage. Top fill was measured at 7'. DA calculated at 0.91 sm.

The proposed treatment- includes the removal of the existing structure and replacement with an 8'x8' concrete box structure. The structure would be buried 2' to accommodate aquatic organism passage. Due to the steepness of slope, it would be difficult to realign the new structure and achieve aquatic organism passage. We recommend using the existing alignment and length for the new structure.

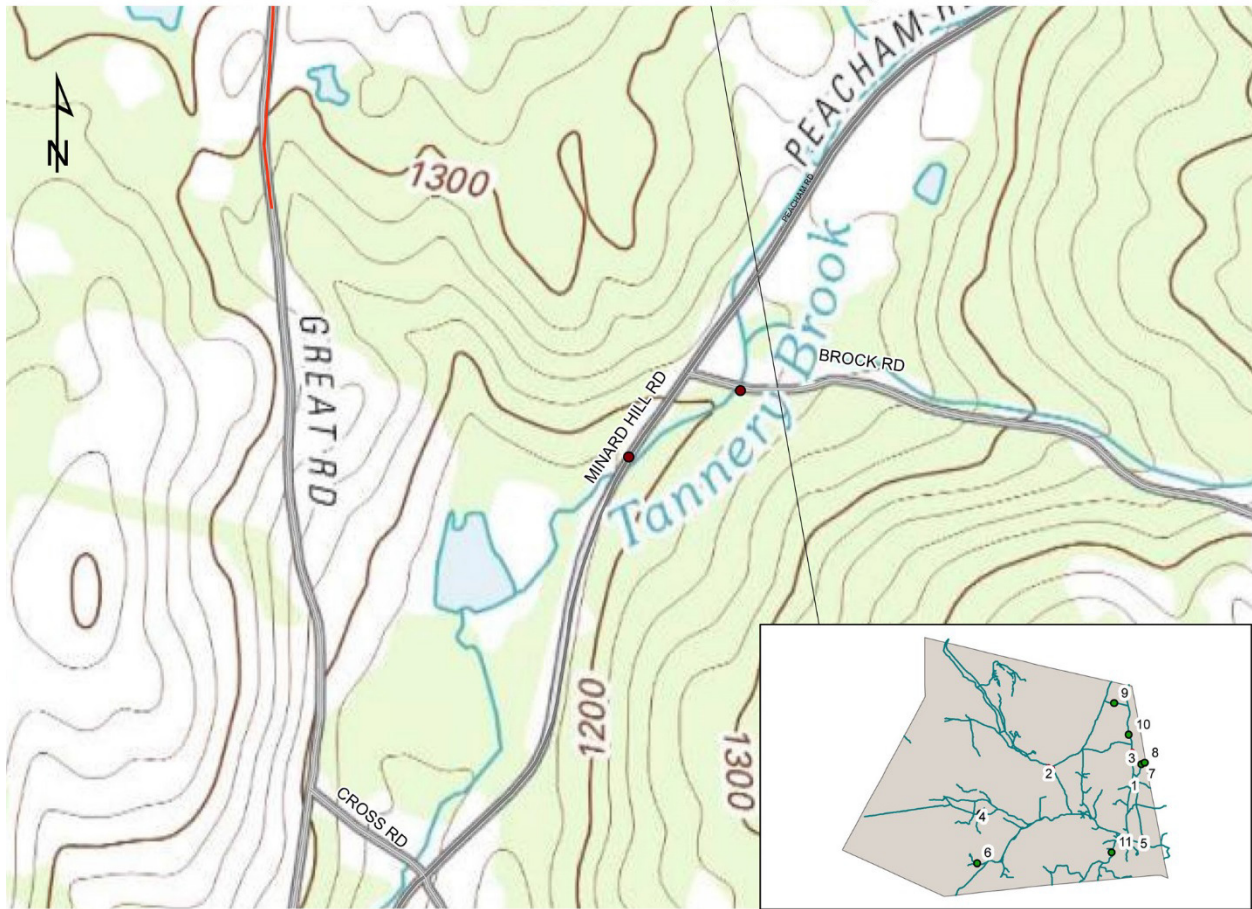
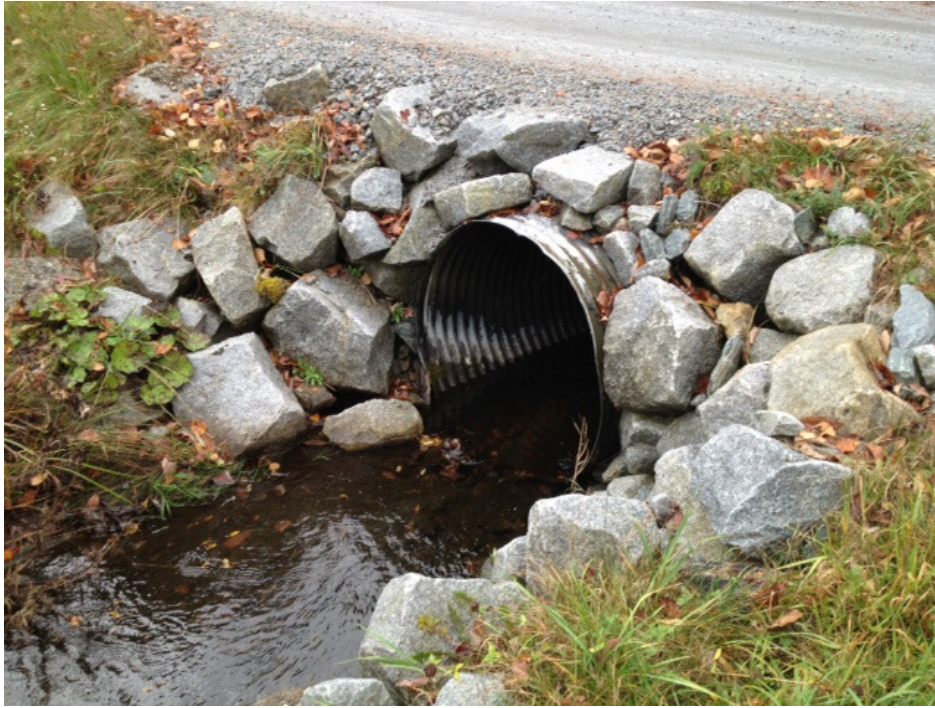
Site Location #8 Brock Rd (Structure)

The problem- bankfull was measured at 8' here in the field on Tannery Brook. The existing structure is a 4' round culvert, approximately 50% of bankfull. The culvert has been overtopped, causing road damage on several occasions. This is a Class 3 gravel road. This site is located immediately upstream of the Upper Minard Hill Road site (see above). Top fill was measured at 6' from culvert bottom to top of road. Could raise road height an additional foot to 7'*. DA calculated at 0.91 sm.

The proposed treatment- includes the removal of the existing undersized culvert and replacement with a 8'-2" x 5'-9" pipe arch buried 2' to accommodate AOP. A short term or interim treatment would be to add an additional 4' round culvert.

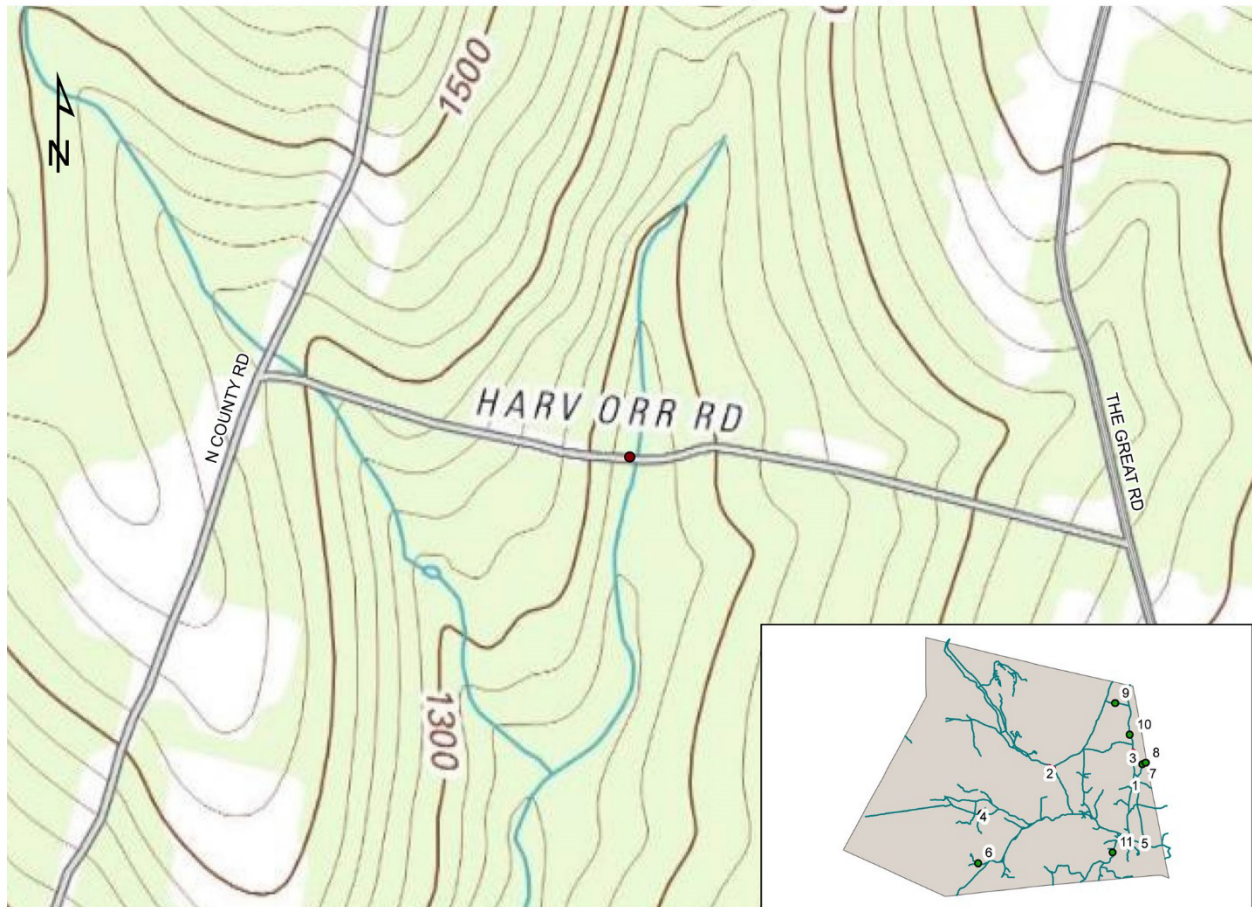
Site Location #9 Harv Orr Rd (Structure)

The problem- This section of Harv Orr Road is Class 4 gravel road and lightly traveled. The existing structure is a 3' round culvert with additional 2' culvert set at a higher elevation for flood events. Bankfull measured in the field is at 8'. Top fill was measured at 4.5'

The proposed treatment- includes the removal of the undersized structures and replacing them with a 8'-2" x 5'-9" pipe arch buried 2' to accommodate AOP. Because this is a Class 4 road, an alternative structure could include a Yard King pre-fabricated bridge set on concrete block or poured concrete abutments. A short term or interim solution could be to replace the 2' culvert with a second 4' round culvert.

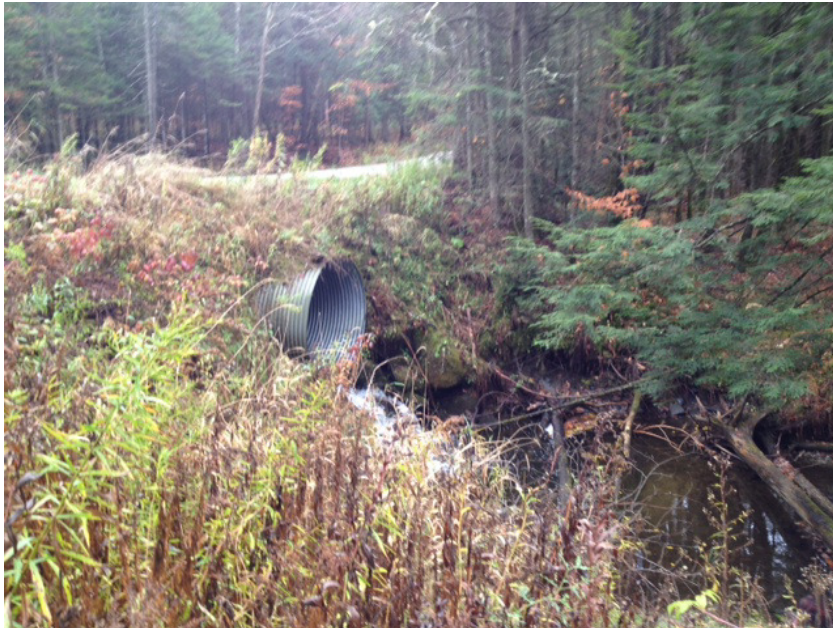
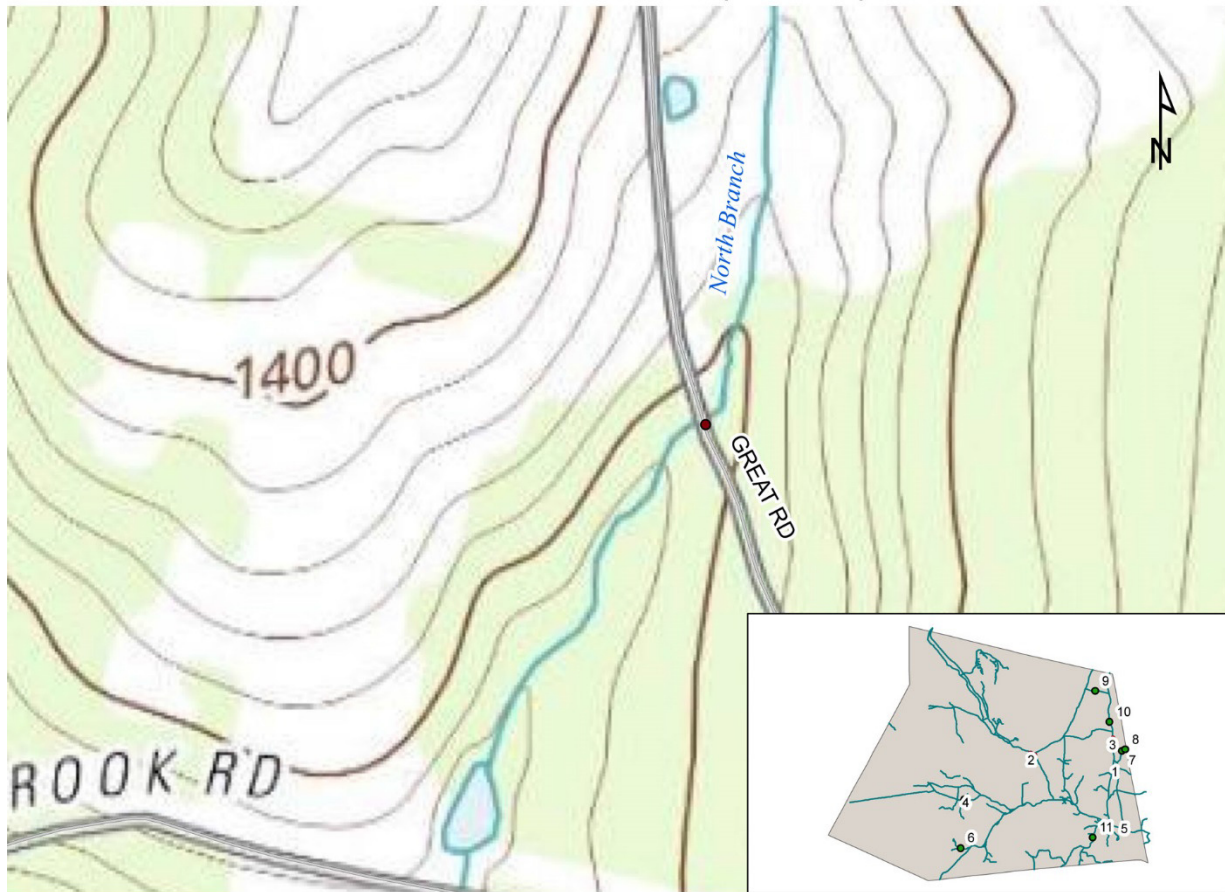
Site Location #10 Great Rd (Structure)

The problem- this structure is a significant aquatic organism passage impediment, with a 3' outlet perch. Bankfull was measured at 9' in the field. The existing structure is a 6' round culvert.

The proposed treatment- replace existing structure and replace with a pipe arch buried to accommodate AOP. The channel bed downstream may have to be raised in order to achieve AOP passage.

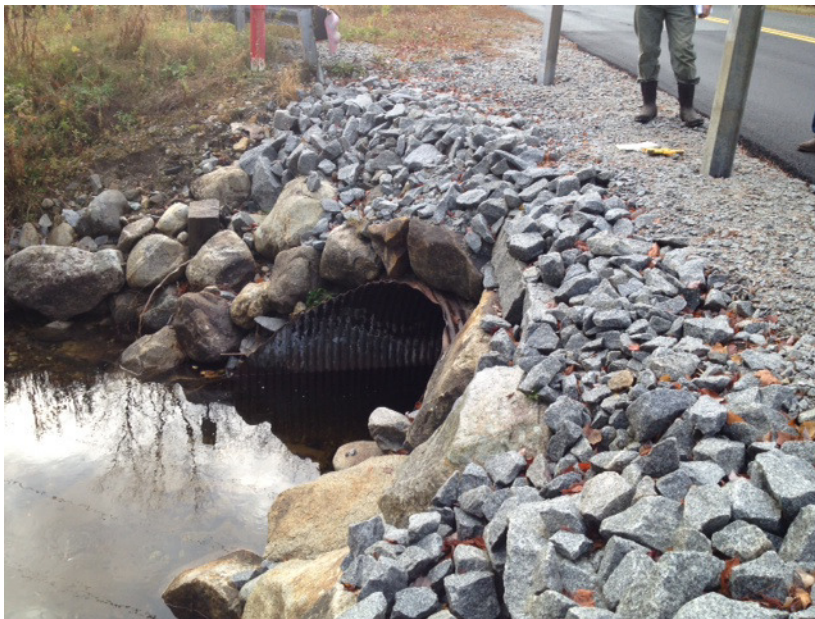
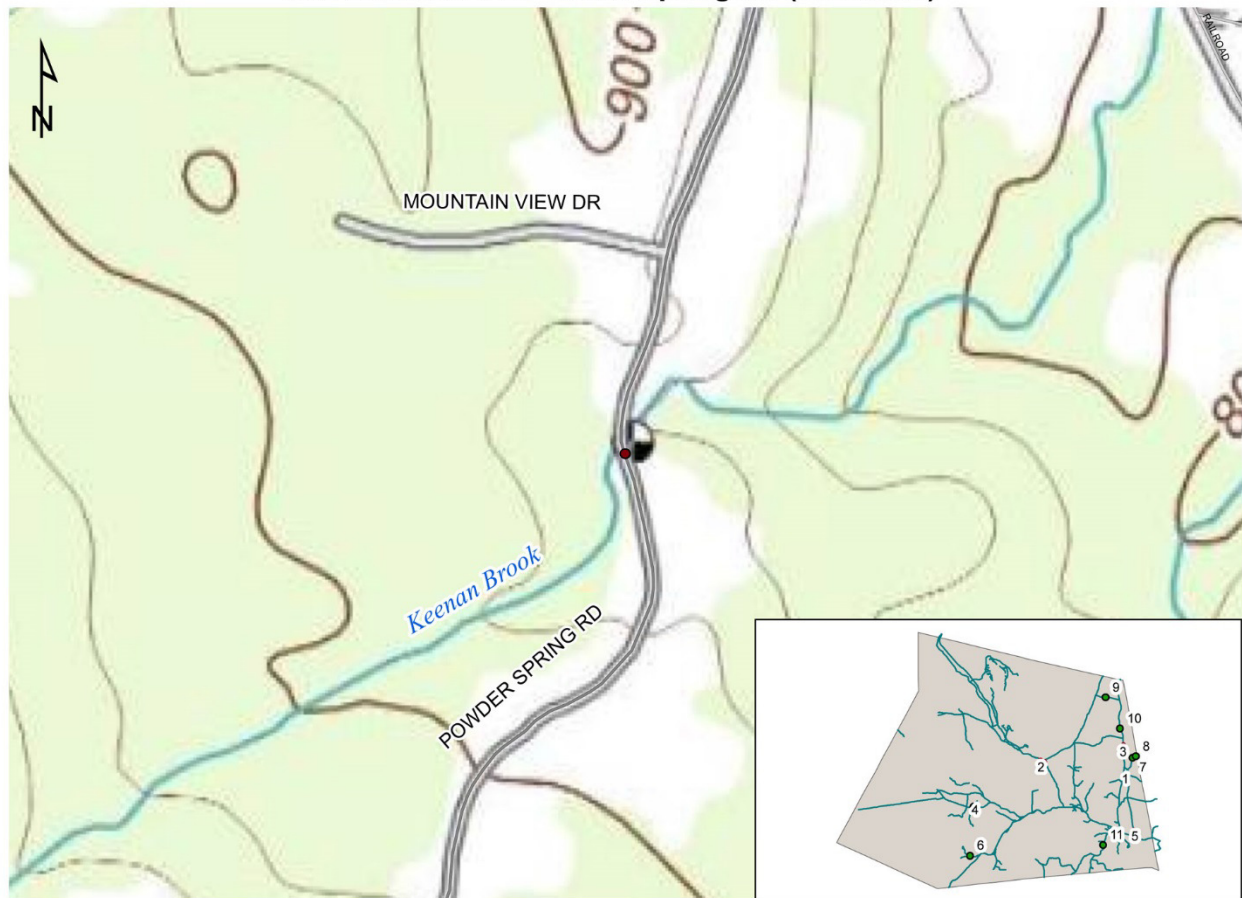
Site Location #11 Powder Spring Rd (Structure)

The problem- this structure is located along a paved section of Powder Springs Road and is also the site of a town hydrant. Bankfull was measured at 12' at this site. The existing round culvert is 6'. Additionally, AOP is limited during some flow events and to some fish species due to the placed large rock downstream of the crossing. The rock was placed to create a pool for the hydrant. The existing structure has been overtopped and caused damage to the road embankment and pavement. The existing alignment aggravates the problem. The existing structure length is 45'

The proposed treatment- replace existing structure and install a 12' buried pipe arch. The new structure should be installed to accommodate AOP and be able to impound some water downstream for the hydrant. The new structure could be slightly re-aligned towards river right. The new alignment could add 5-15' in length, compared to current structure, depending on new location. Removing and replacing pavement, would add to the project cost.

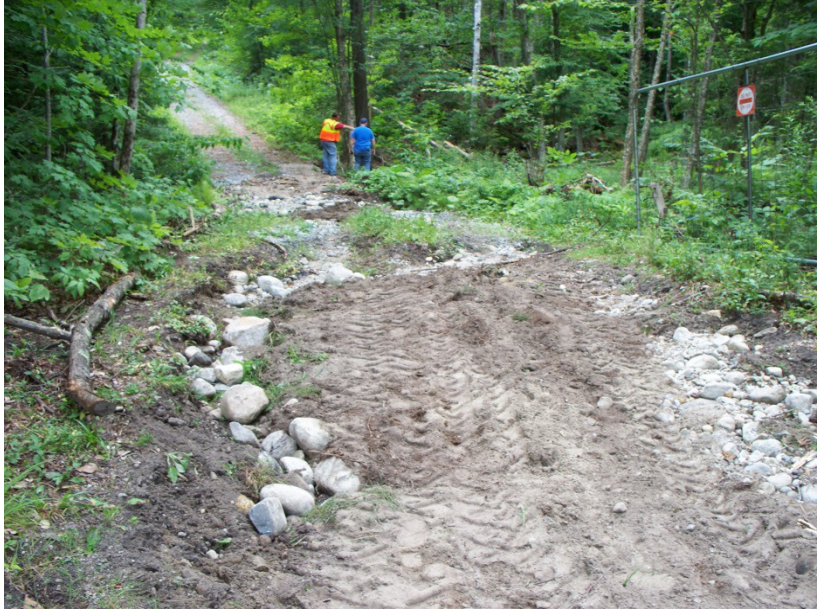
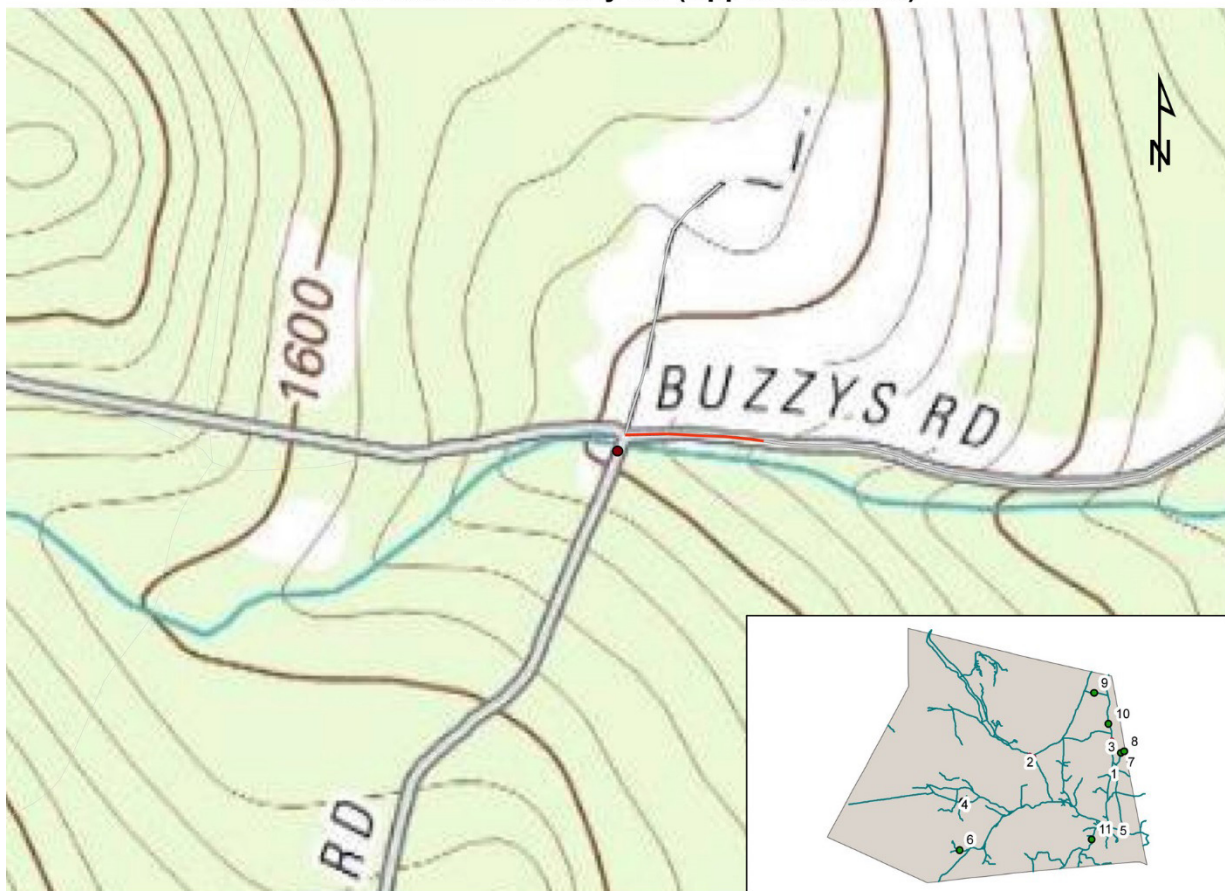
Site Location #12 Buzzy Rd (Upper/Structure)

The problem- an undersized stream crossing plugs and is outflanked by the stream taking out the road. This causes significant amounts of sediment to enter the tributary to Heath Brook

The proposed treatment- would be to replace this undersized structure with a bankfull width AOP friendly structure. In addition, a lowering of the road approach on river left would allow the brook to access its floodplain.

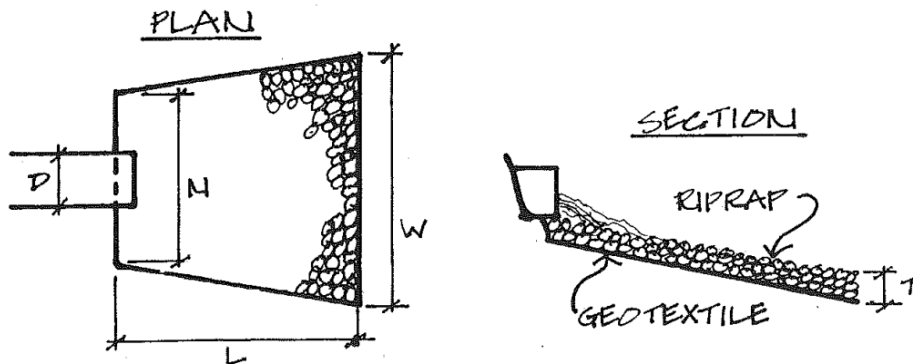
ROCK APRON

Rock Apron Specifications					
Culvert Diameter (D)	Riprap Size	T (in.)	N (ft.)	W (ft.)	L (ft.)
18 inches	(3-12 inch)	18	4.5	14.5	10.0
24 inches	(3-12 inch)	18	6.0	20.0	14.0

D= diameter of culvert
 T= depth of stone in apron
 N= width of apron near culvert
 W= width at downhill end of apron
 L= length of apron
