**Re: War Veterans Park Pool Sounding Survey and Preliminary Rehabilitation Cost**

# Appendix A – Sounding Survey Sketch

# Appendix B – Photographic Record

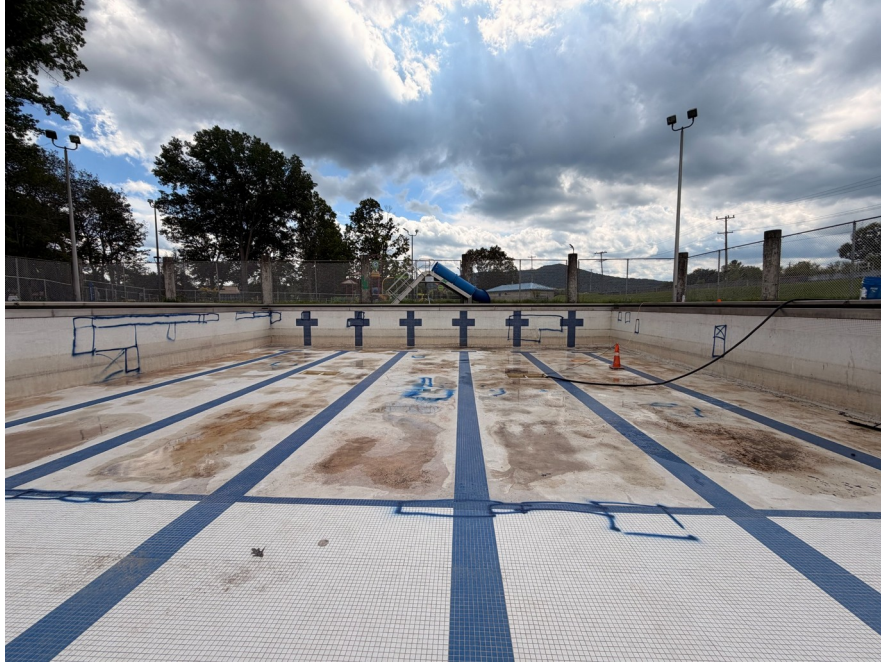
Photo 1 View toward the deeper portion of the pool. Blue-painted outlines identify areas with differing sound responses on the walls and floor.

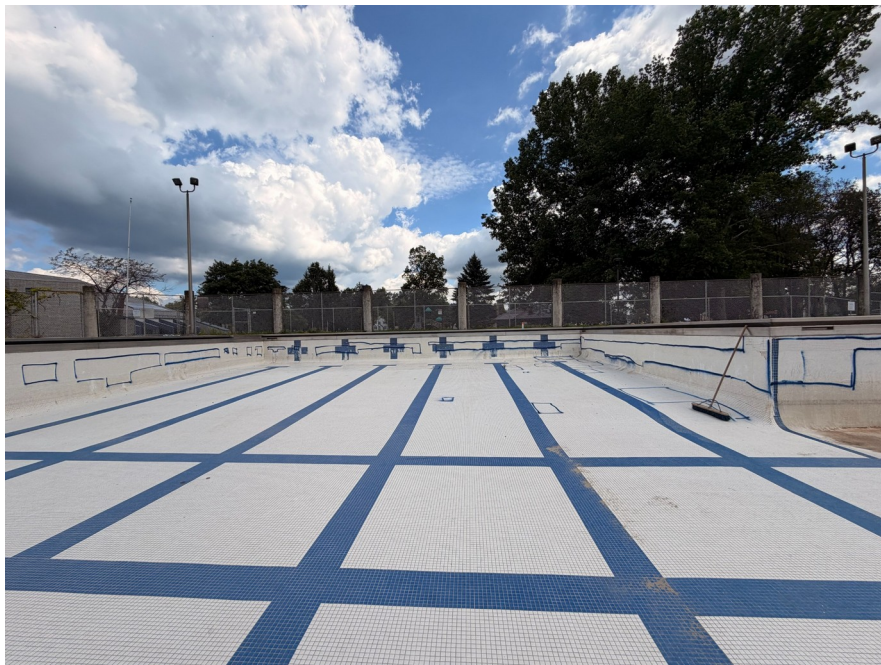
Photo 2 Opposing overview of the pool. Marked wall areas and localized floor areas are visible within the existing tiled finishes.

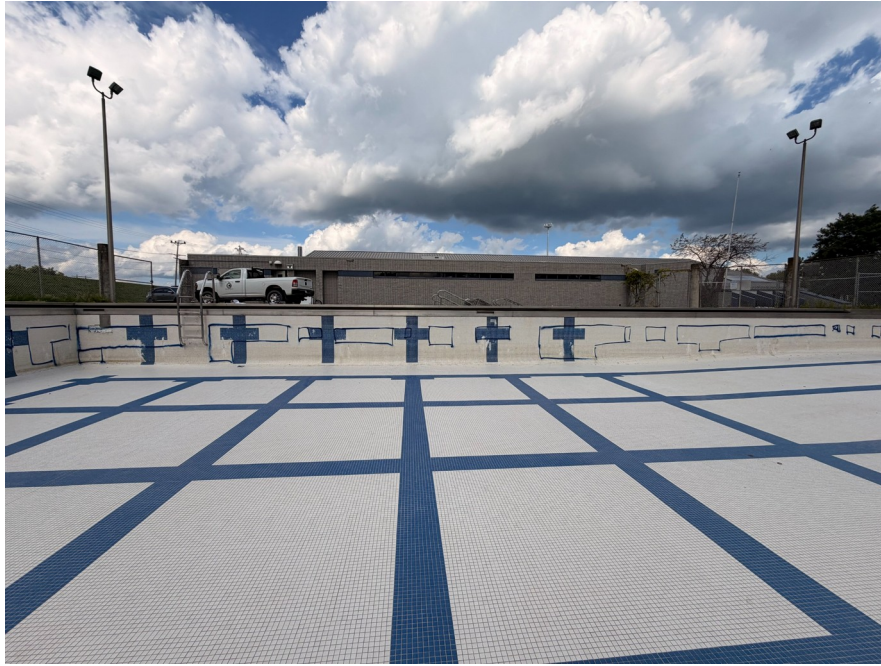
Photo 3 Wall facing the recreation center building. Blue-painted outlines document the areas identified during sounding.

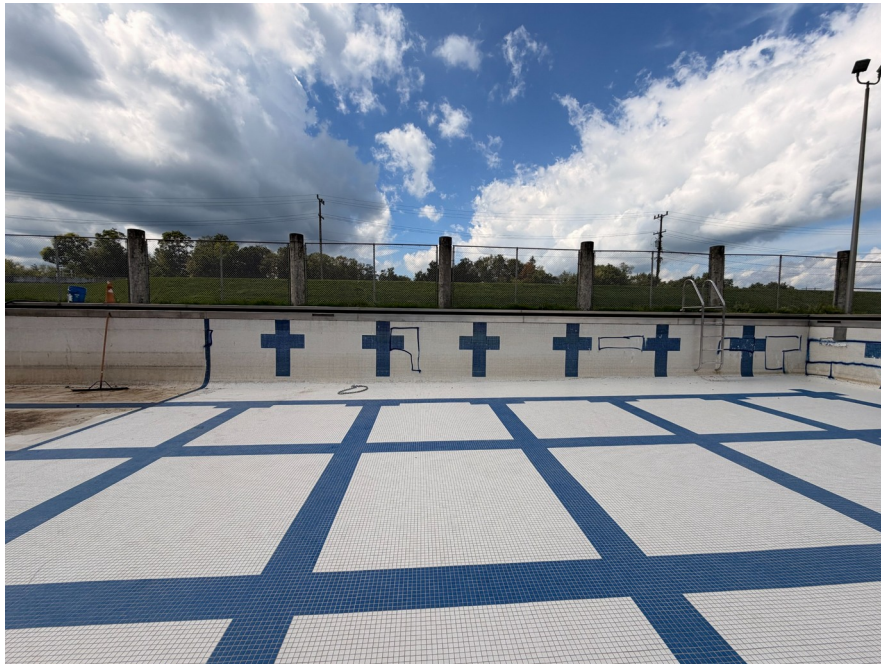
Photo 4 Opposite wall overview. Existing tile finishes, marked wall areas, and the metal chain used for sounding are visible.
