Rock River Flood Monitoring and Evaluation

Summary Presentation

February 5, 2021

Nick Hayden, PE & Rob Montgomery, PE (MARS-EOR)

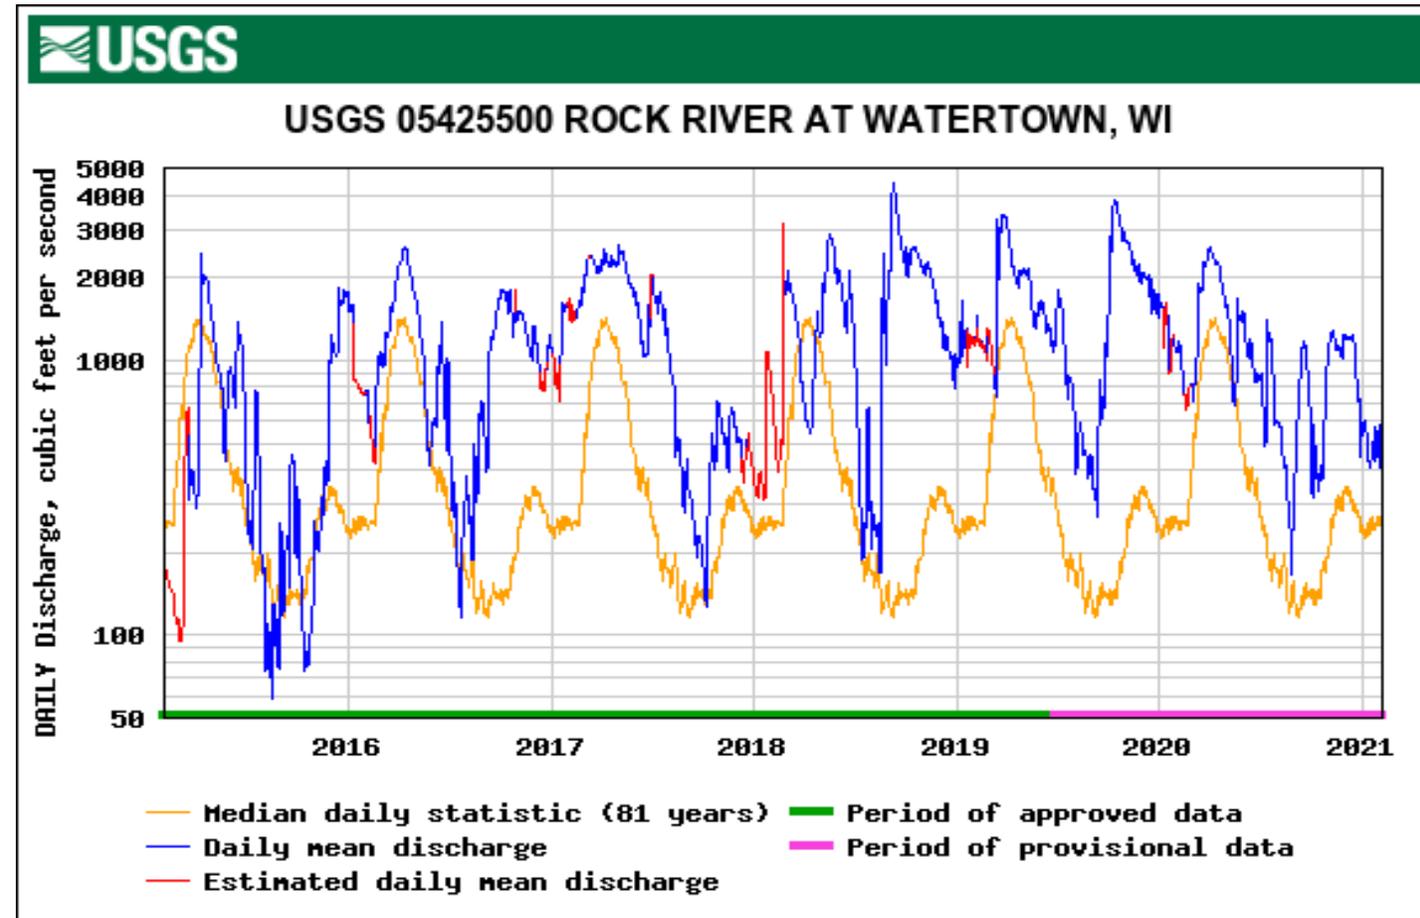
The graphics on this and the next slides quantify the extent of the flooding in this area of the Rock River that has occurred in the last several years. This graph shows the discharge of the Rock River measured at the US Geological Survey gage at Watertown over the past five years- in blue. The long-term average discharge rate is shown in orange. This graph illustrates that flooding since 2016 has had far higher flow rates and longer duration than flows that typically occurred over the past 85 years.

Note the discharge has substantially exceeded 1000 CFS for a large percentage of the year after 2016. In 2018 and 2019 flows exceeded 1000 CFS for all but a few months of the year.

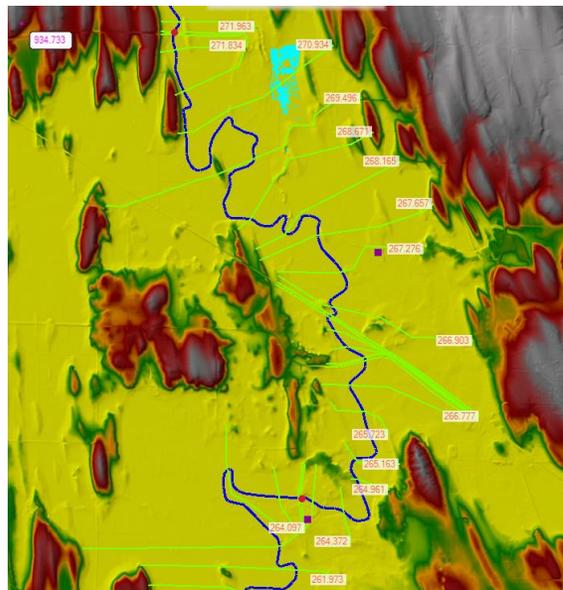
500 cfs - river between banks

The Rock River in the Town of Lebanon is very flat, with an average slope of only 0.25 ft / mile (0.005%) including sections of adverse slope (the riverbed actually rises moving downstream). This slope causes the river to drain slowly, and when there is more flow in the river than the main channel can convey water spreads out across the broad, flat floodplains and recedes very slowly. The images below, from the DNR's steady flow HEC-RAS model of the river, illustrate the extent of out-of-channel water (cyan) as flows increase.

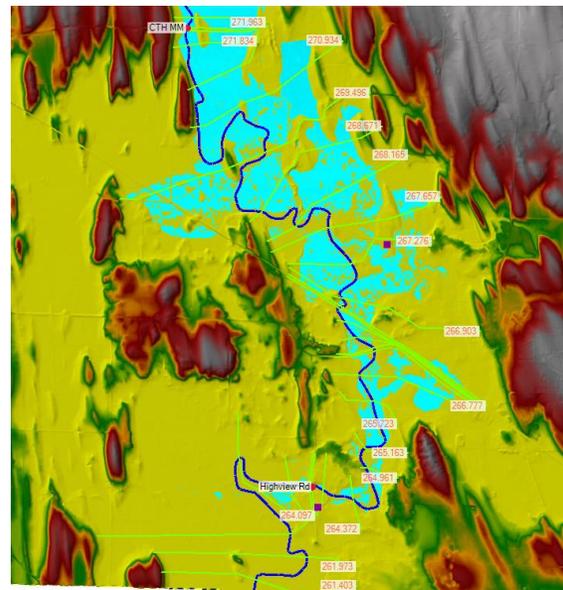
750 cfs – pockets of water in floodplain, some wider inundation

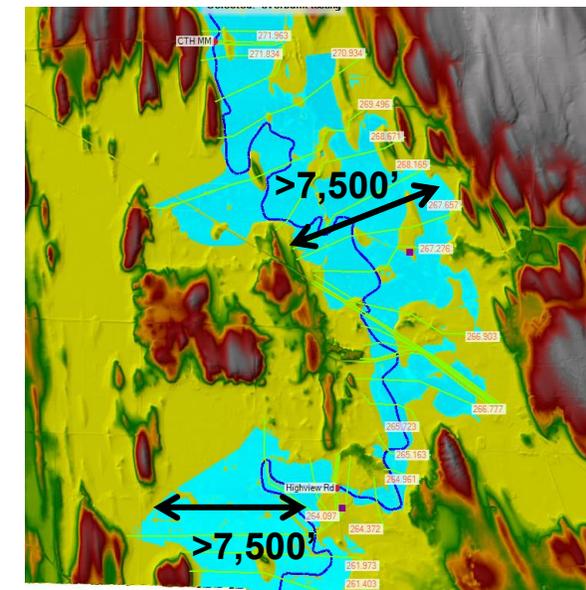
1,250 cfs – extensive water in floodplain, >1 mile wide

Using the HEC-RAS model, we determined the total out-of-channel flooded area for each flow rate. The table below shows this relationship between flow and out-of-channel flooding area from downstream of Hustisford Dam to CTH P near Ixonia.

Flow Rate	Out-of-channel wet area	Area increase (compared to 500 cfs)
500 cfs	15,500 acres	-
750 cfs	18,400 acres	+ 19%
1000 cfs	23,350 acres	+ 51%
1250 cfs	25,400 acres	+ 64 %

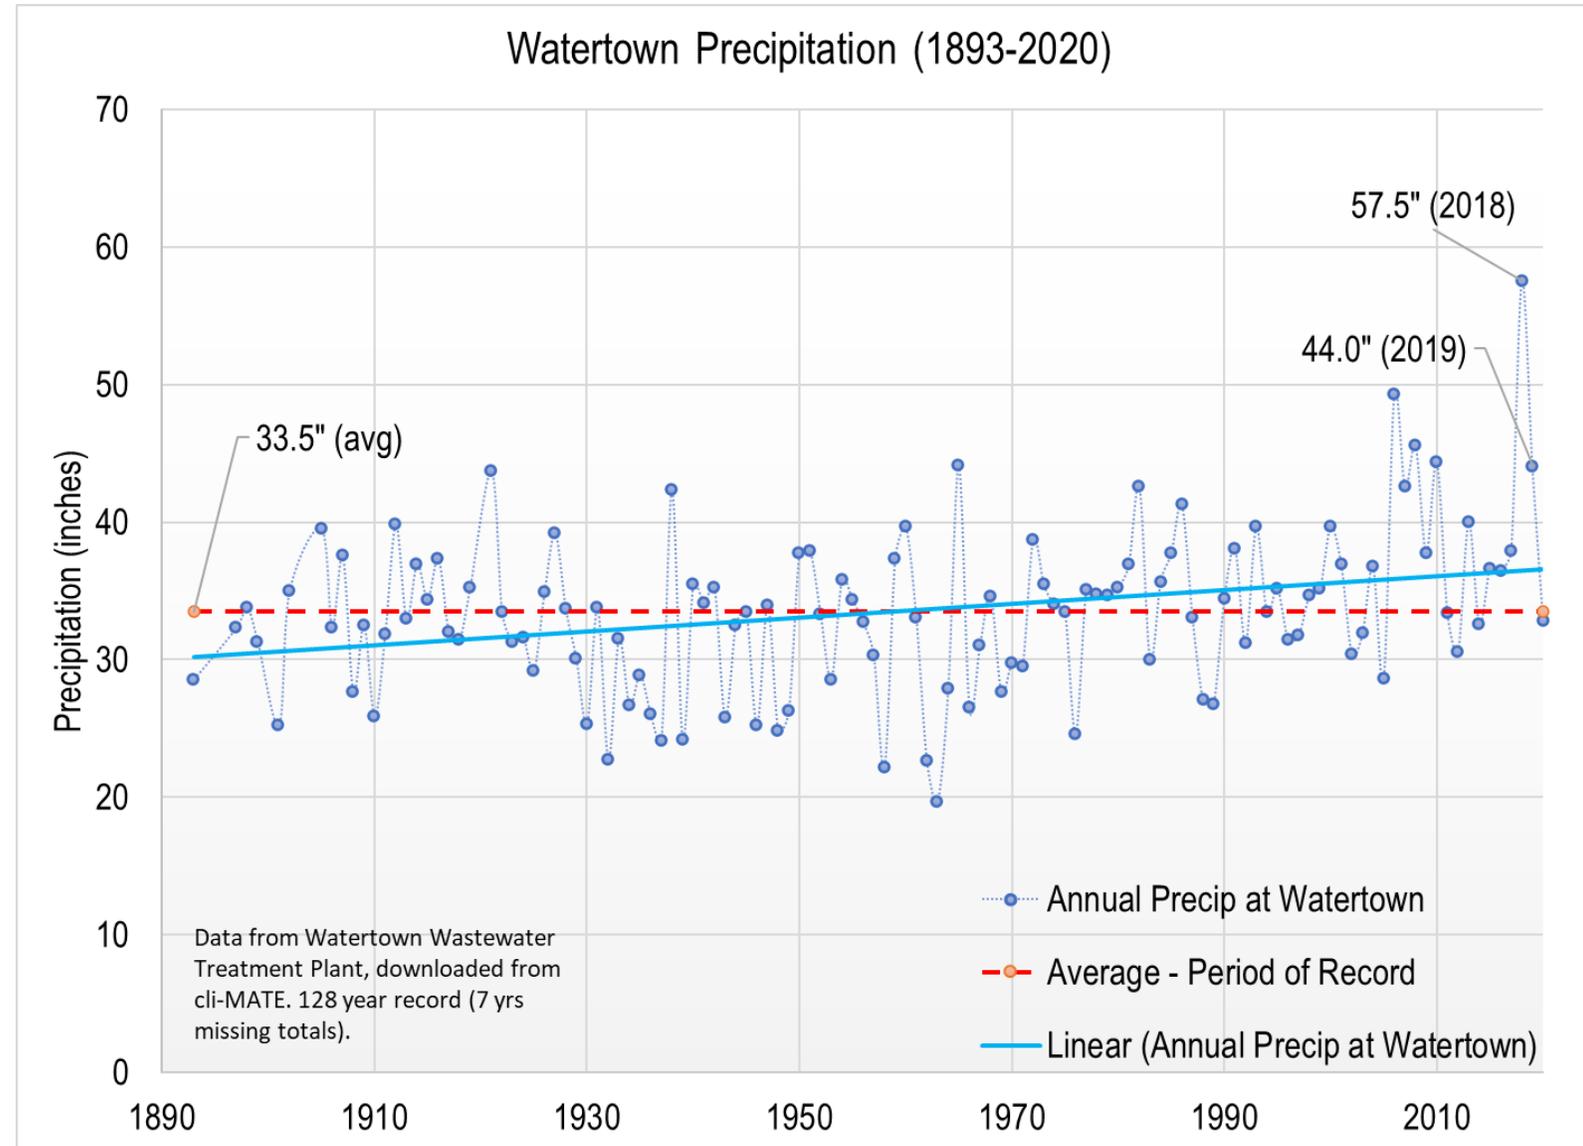
One obvious source of recent flooding is that higher rainfall amounts that have been observed across Wisconsin, and particularly during the last several years. This plot shows annual precipitation in recent years at Watertown, the nearest rain gage with the longest period of record. 2018 was by far the wettest year on record – annual precipitation was 24” above the long-term average – and was followed by a wet 2019 (10.5” above average).

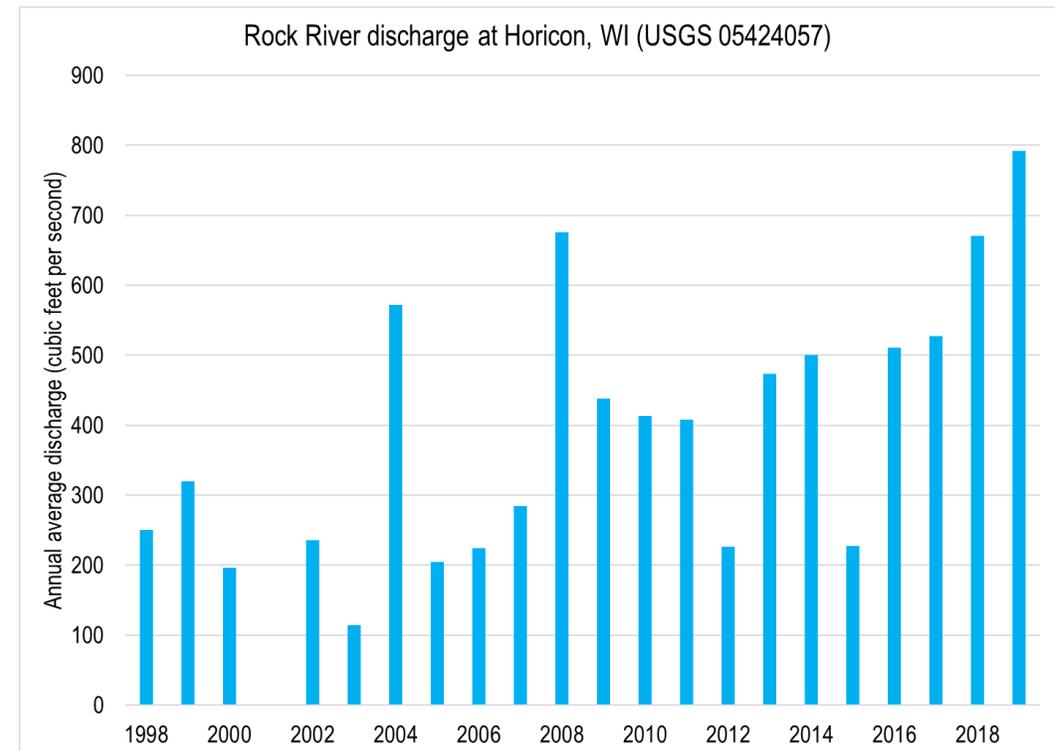
Discharge leaving Horicon Marsh shows this trend in the Rock River. Annual flows have generally increased over the gage record and have been particularly high recently, with average daily flow in 2019 exceeding that seen during the last major regional flood event (2008).

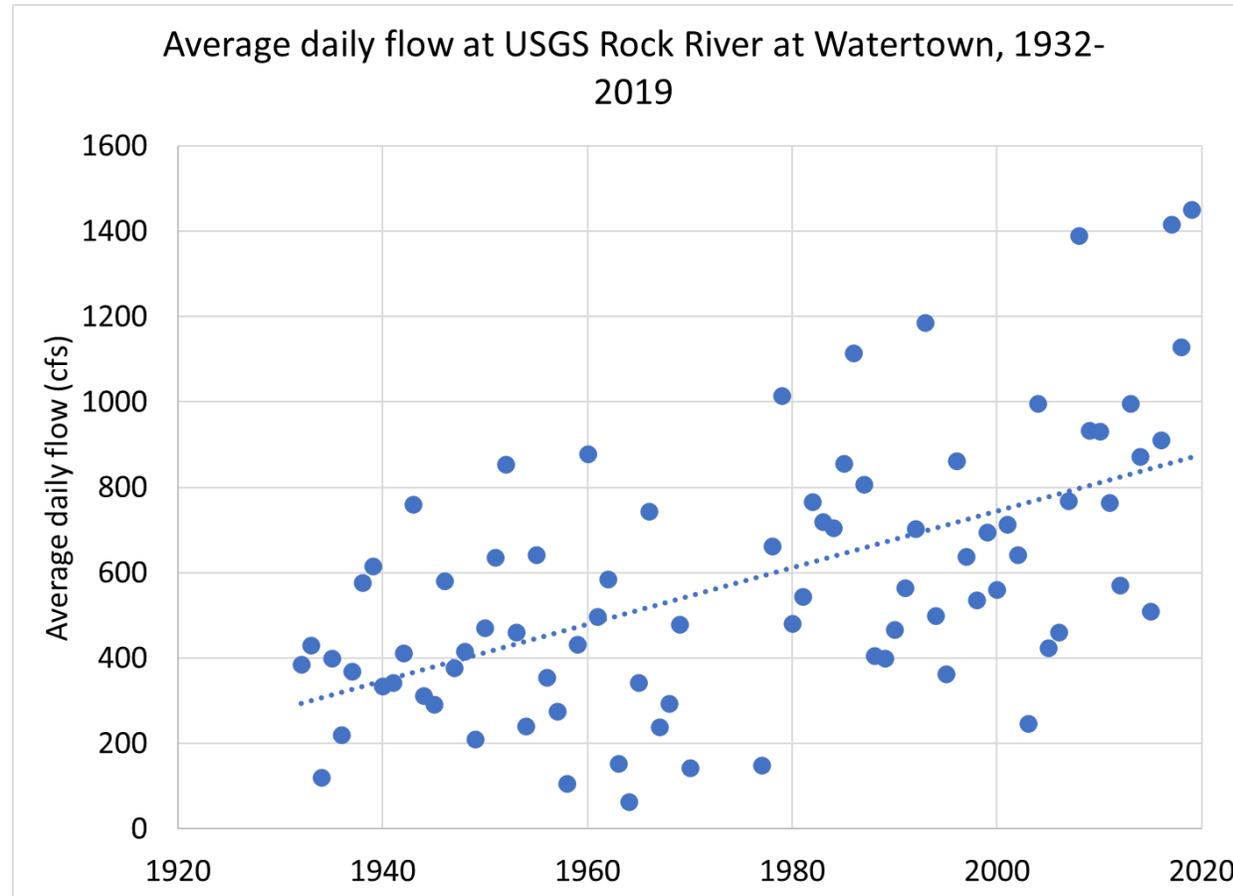
The same streamflow increase is evident at the USGS gage on the Rock River in Watertown. The flow data show a steady increase over the period of record, to nearly triple the average flow observed in the 1940s.

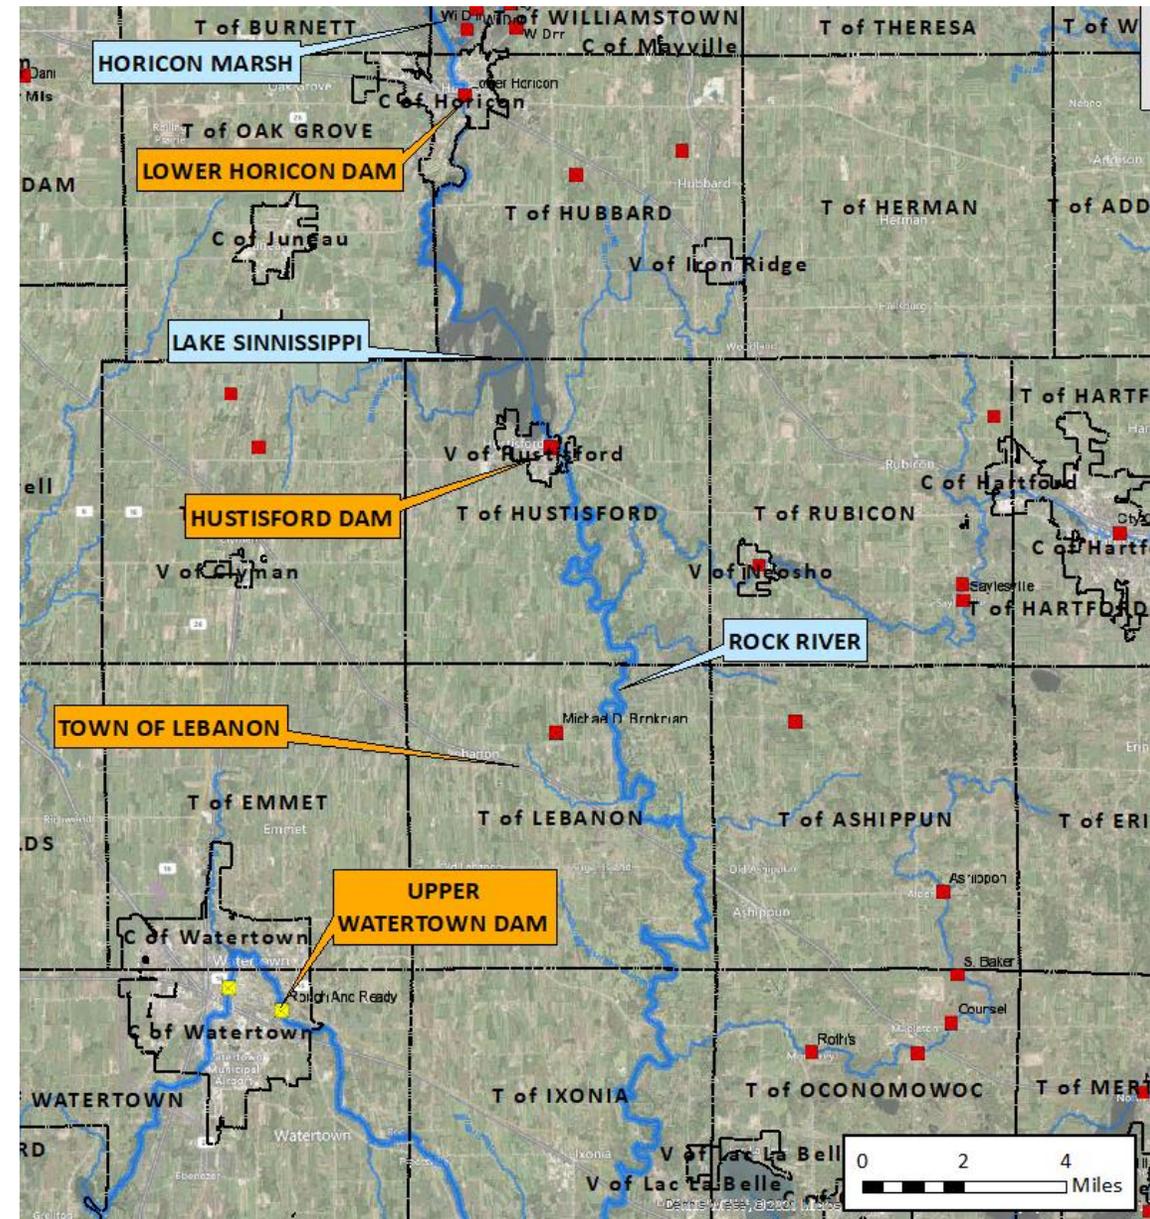
There are many dams on the Rock River upstream and downstream of the Town of Lebanon, with the nearest upstream dams being Lower Horicon and Hustisford, which are connected by Lake Sinnissippi. Upper Watertown is the next dam downstream.

Part of the objective of this study was to better understand how dam operation impacts Rock River flow and timing, and to learn if there are any management strategies that could provide relief to the many riparian landowners in this stretch. We are also evaluating if there are any physical restrictions contributing to high water levels in this area.

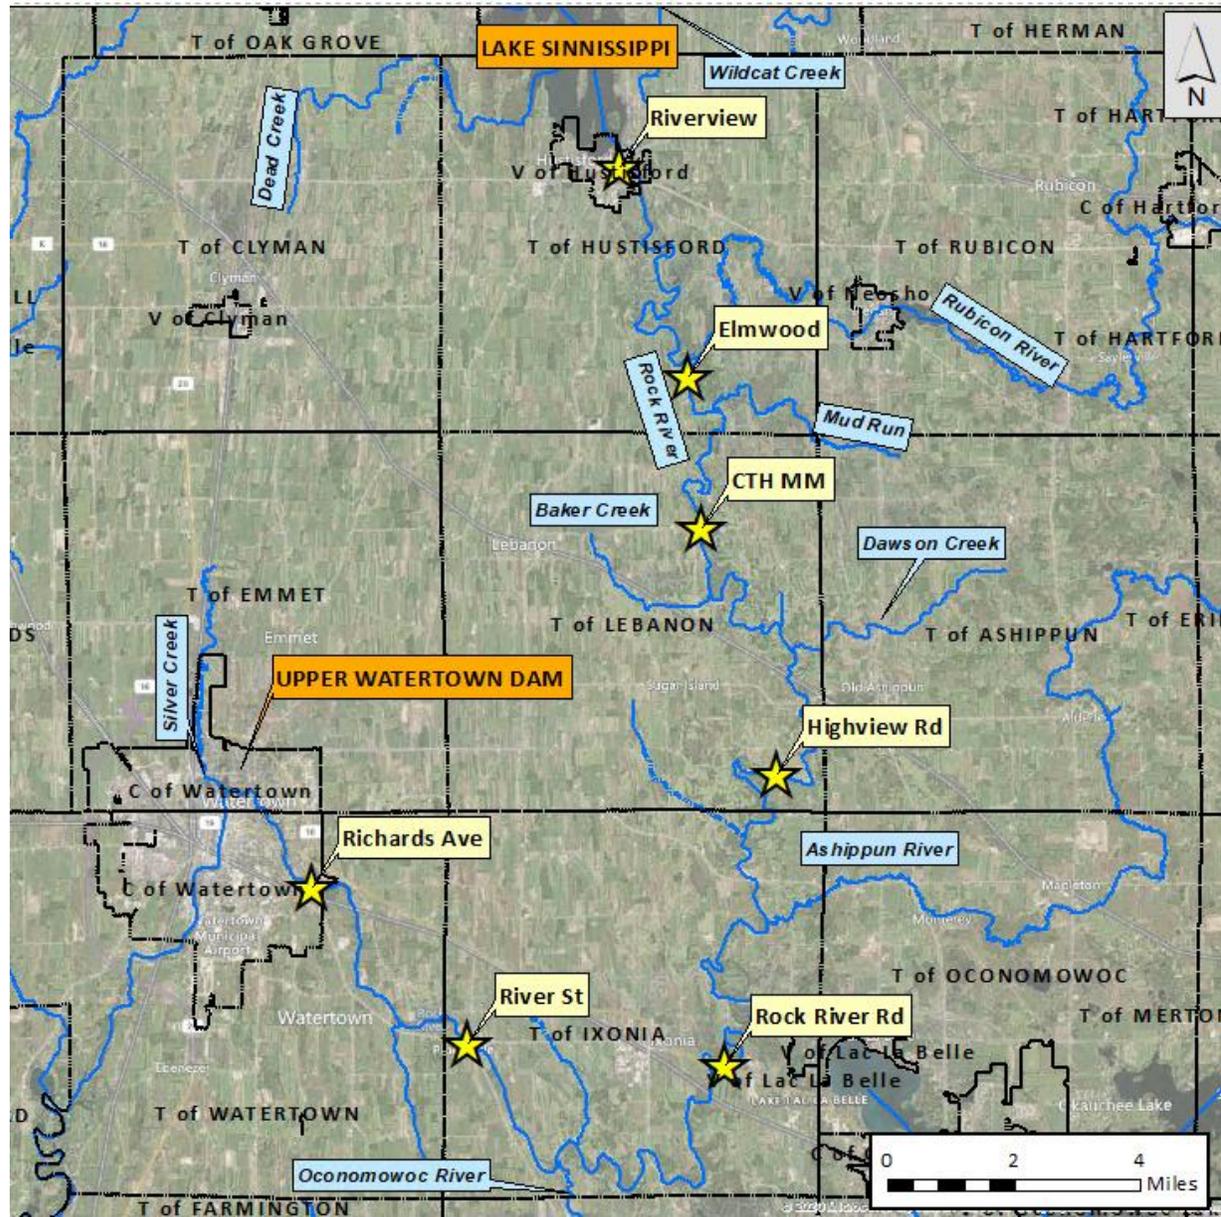
We developed a water level monitoring program, in cooperation with the dam operators at upper Watertown, Hustisford and Lower Horicon to collect data that will help understand the hydraulics of the system. We established water level monitoring locations at 7 sites along the Rock River between Hustisford and the Upper Watertown Dam. These locations were based on previous watershed and RAS model analysis and access opportunities. At 6 sites we installed edge-of-river wells using fence posts and PVC pipe, and at the “Riverview” site in Hustisford we re-established a former USGS gage site. Well locations are shown on the following slide.

7 monitoring locations (upriver to downriver):

- Riverview (old USGS Hustisford site)
- Elmwood
- CTH MM
- Highview Rd
- Rock River Rd
- River St
- Richards Ave

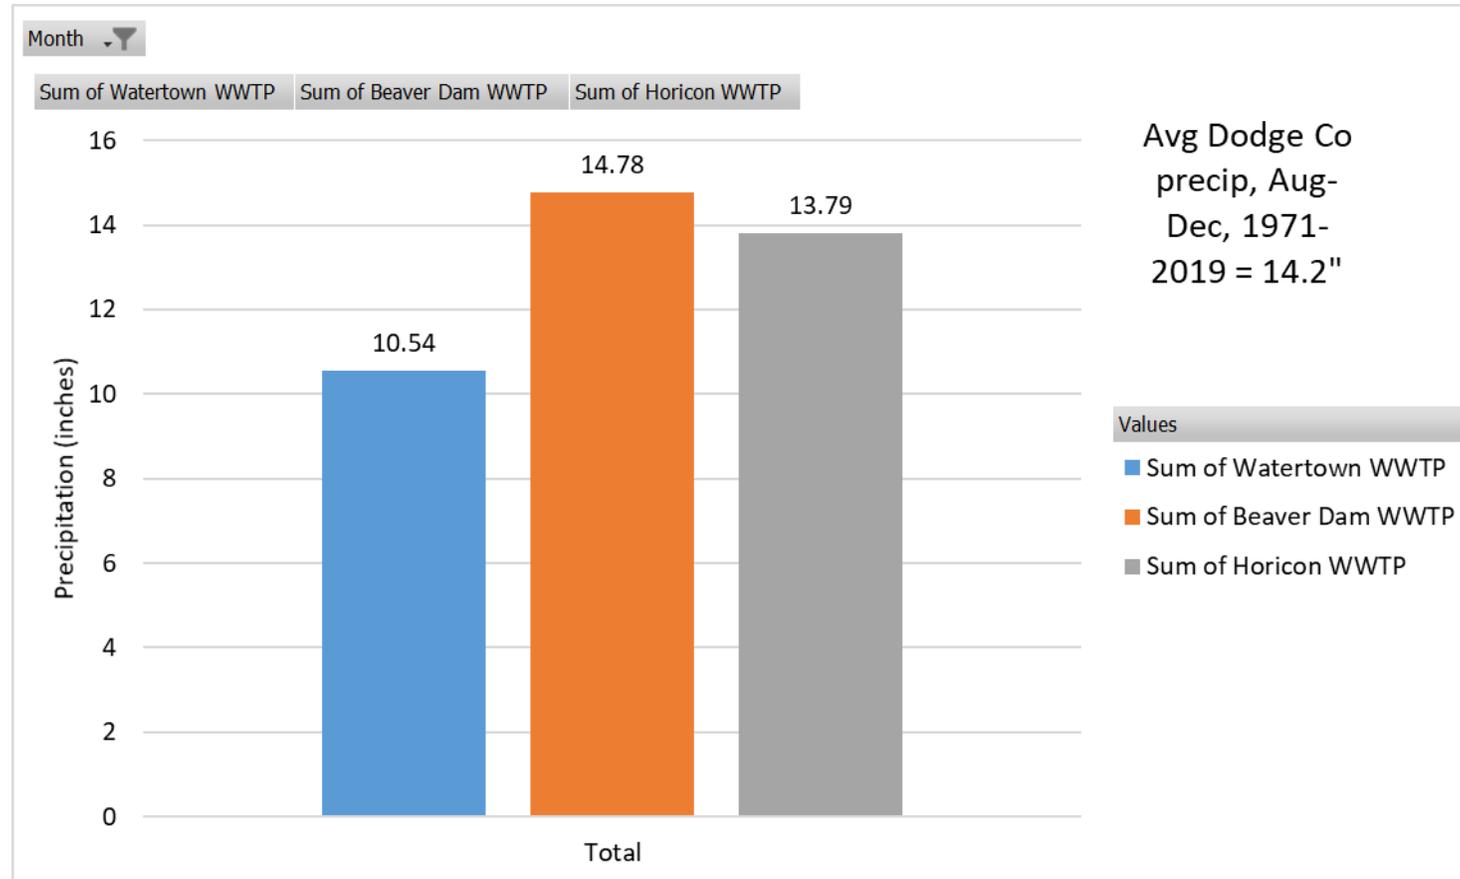
Rainfall during monitoring period

The upper watershed (Horicon and Beaver Dam stations) received ~ 14" of rain during the monitoring period, while the lower watershed (Watertown station) received ~10.5". The average August through December rainfall for Dodge County is ~14.2" based on the last 50 years of data at the Horicon wastewater treatment plant, meaning that overall watershed rainfall during our monitoring period was slightly below the long-term average.

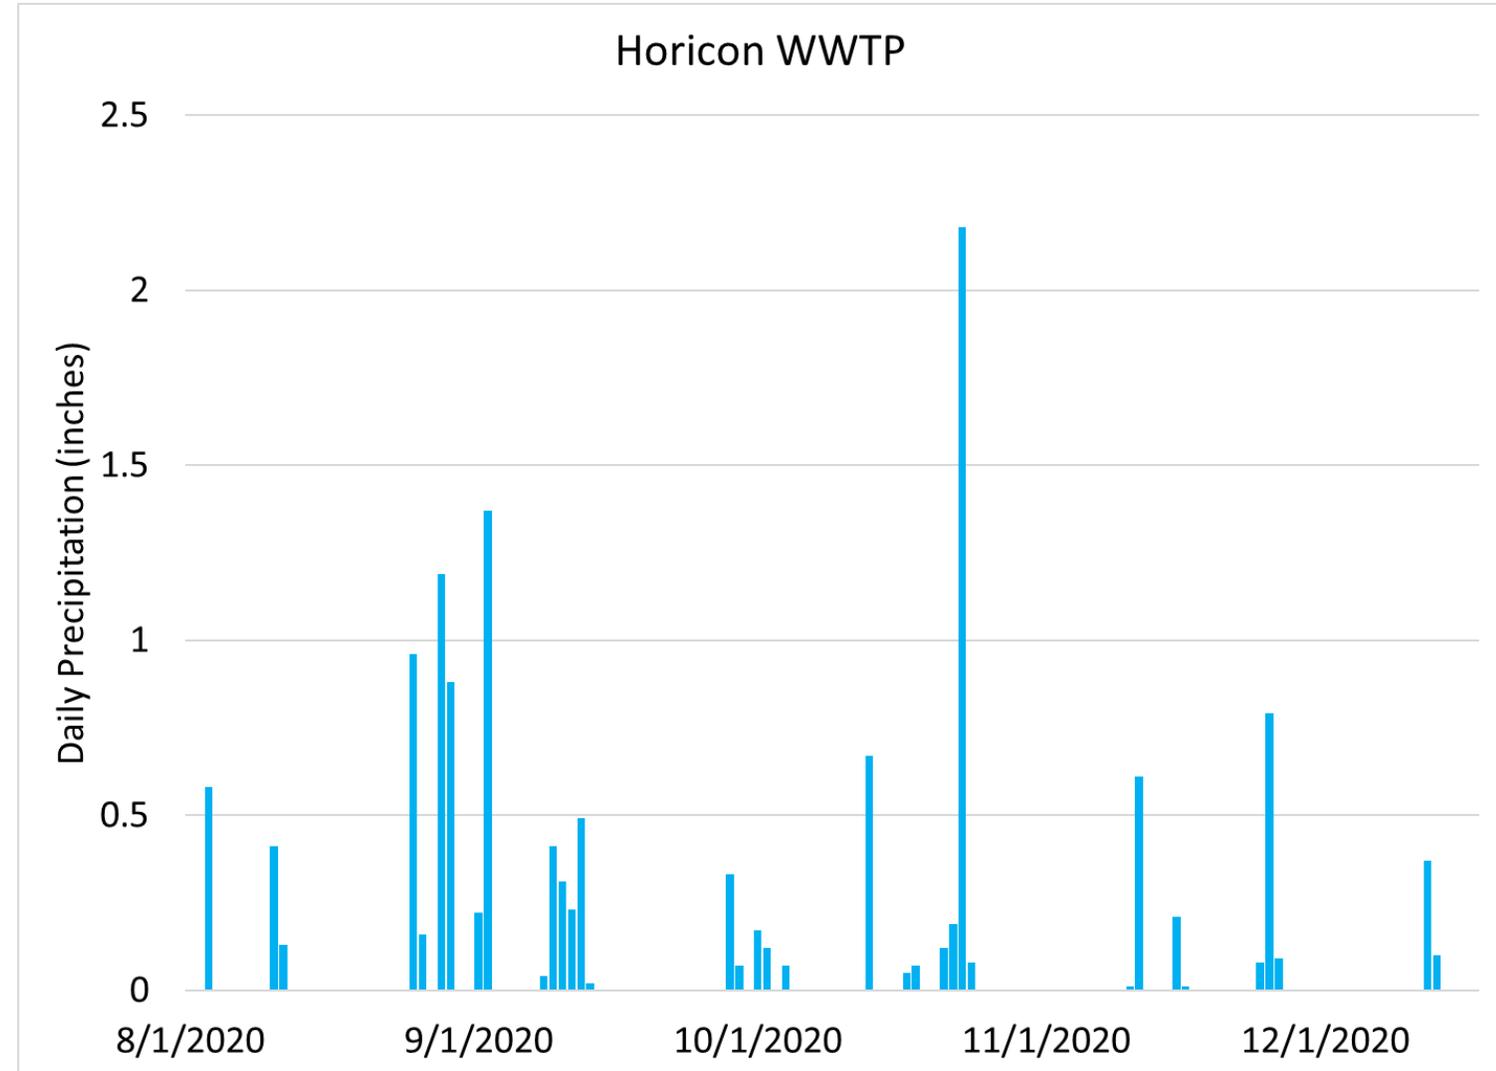
Rainfall events during monitoring period

- The period leading up to the test through late August was relatively dry
- Horicon measured 4.8" of rain from August 25 – Sep 2, with an additional 1.5" from Sep 8 – Sep 13. The 10-day, 2-yr rainfall for Horicon is 4.8".
- The other significant runoff producing event was the 2.2" of rain in a single day on October 23. The NOAA Atlas 14 24-hour, 1-yr rainfall for Horicon is 2.3".
- The southern part of the watershed received less rain on Oct 23 (1.33" in Watertown)

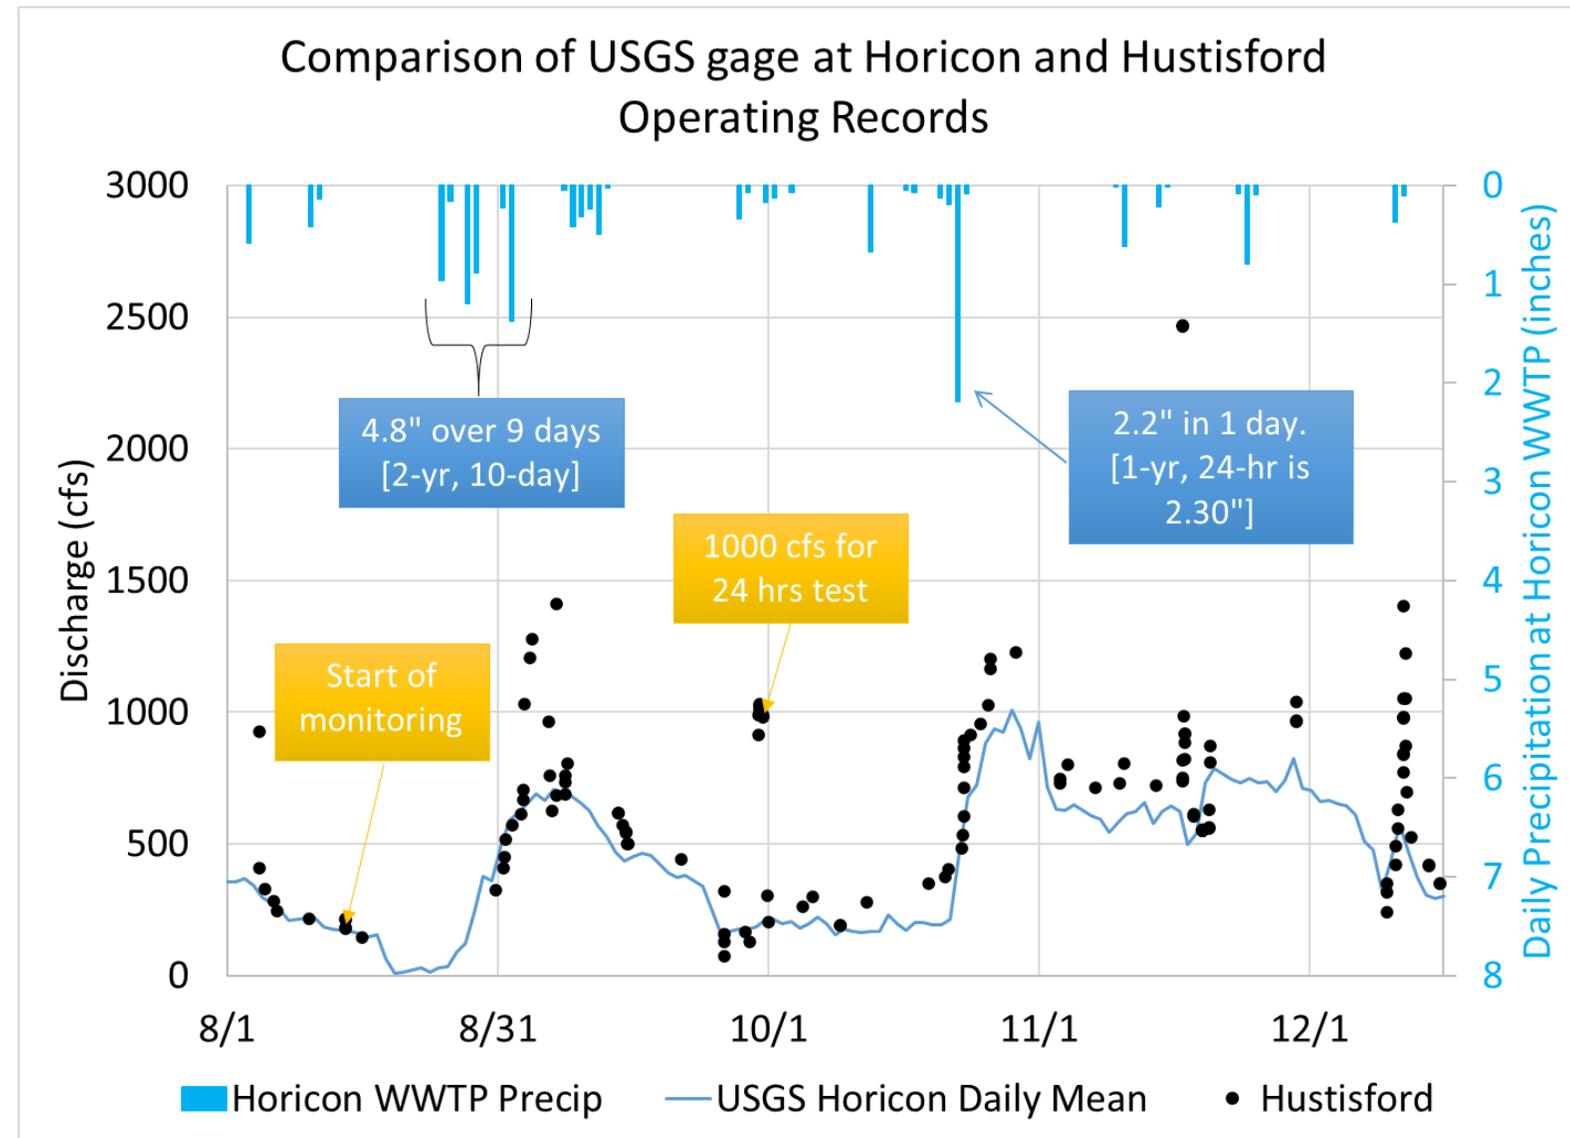
River flow during monitoring period – Horicon vs. Hustisford

- At the start of monitoring the lower Horicon dam was closed to try and raise their water levels
- The multi-day rainfall in late Aug – early Sep increased flows up to 750 cfs, and flows stayed high for several weeks
- Note that the rainfalls were not unusually large – the largest series of storms at the end of August had a return period of approximately 2-years
- We coordinated a 1-day test of 1,000 cfs release from Hustisford on Sep 30 – Oct 1
- The heavy rains on Oct 23 raised flows from 200 cfs to 1,000 cfs, and these high flows persisted for nearly six weeks up to the very end of our monitoring period

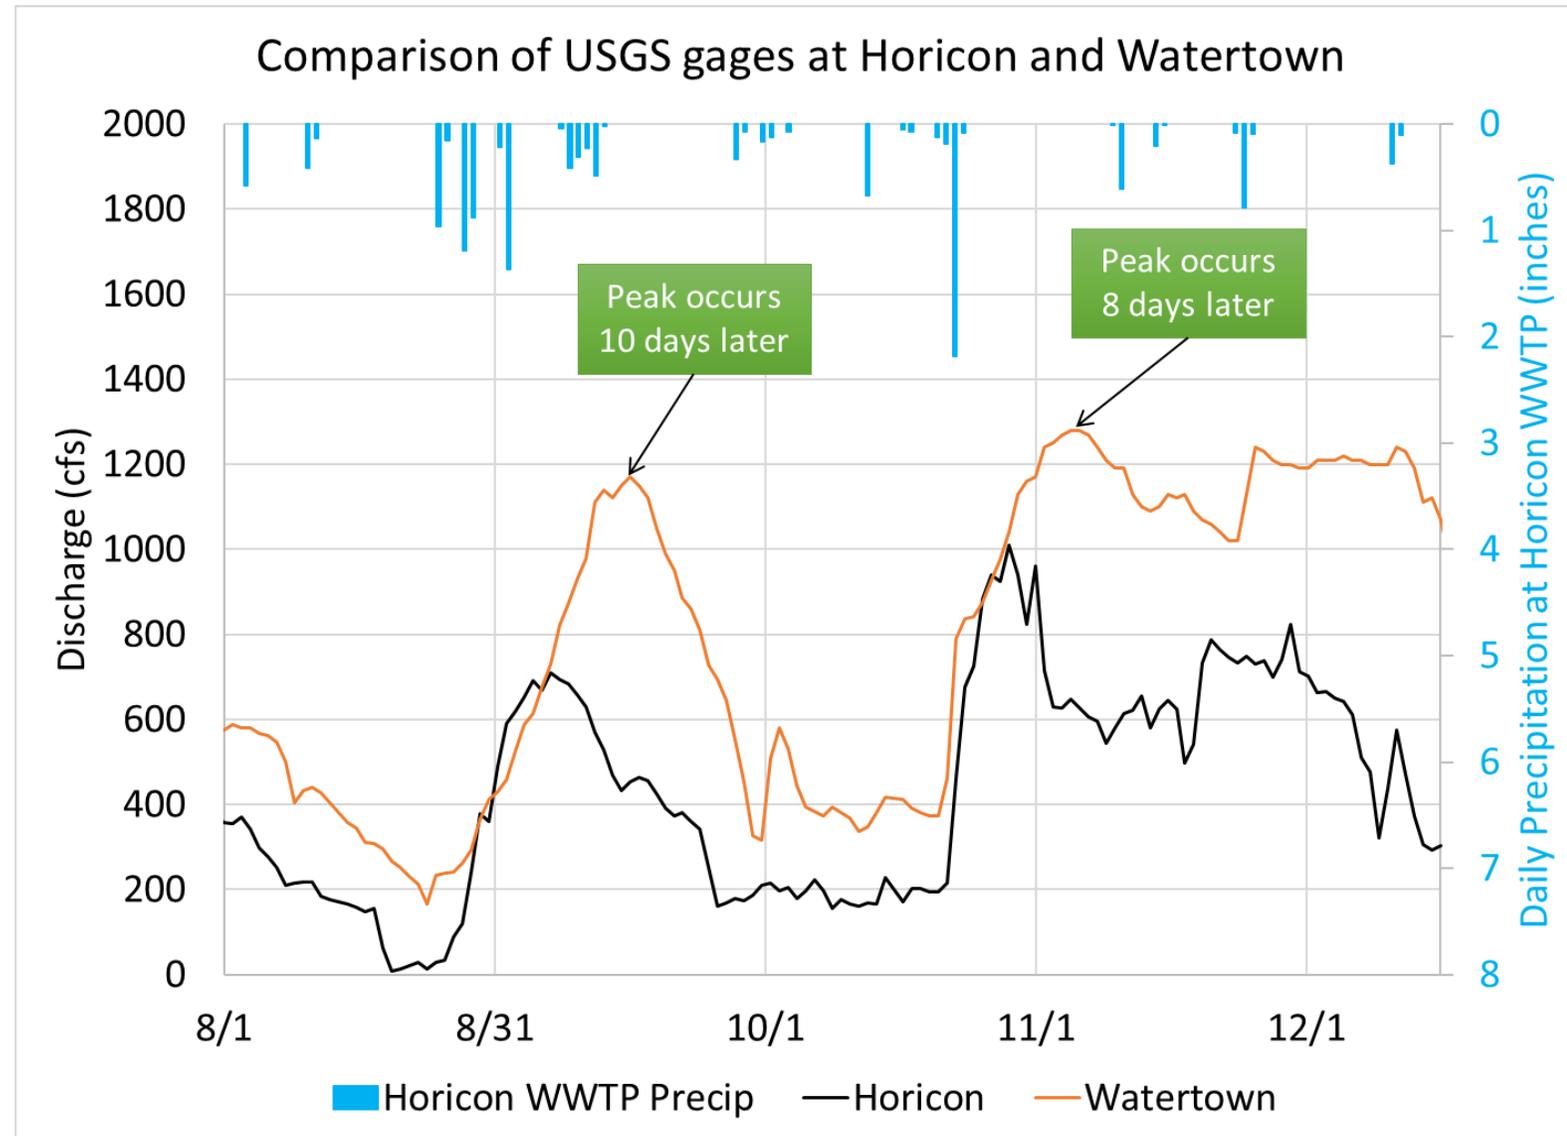
River flow during monitoring period – Horicon vs. Watertown

- The downstream peaks occur over a week later than at Horicon.
- Discharge at Watertown is typically 50-100% higher than at Horicon.
- This increased discharge is consistent with the increasing watershed area from 456 square miles at Horicon to 969 square miles at Watertown, meaning that the river is gaining both storm runoff flow and groundwater baseflow between these locations.

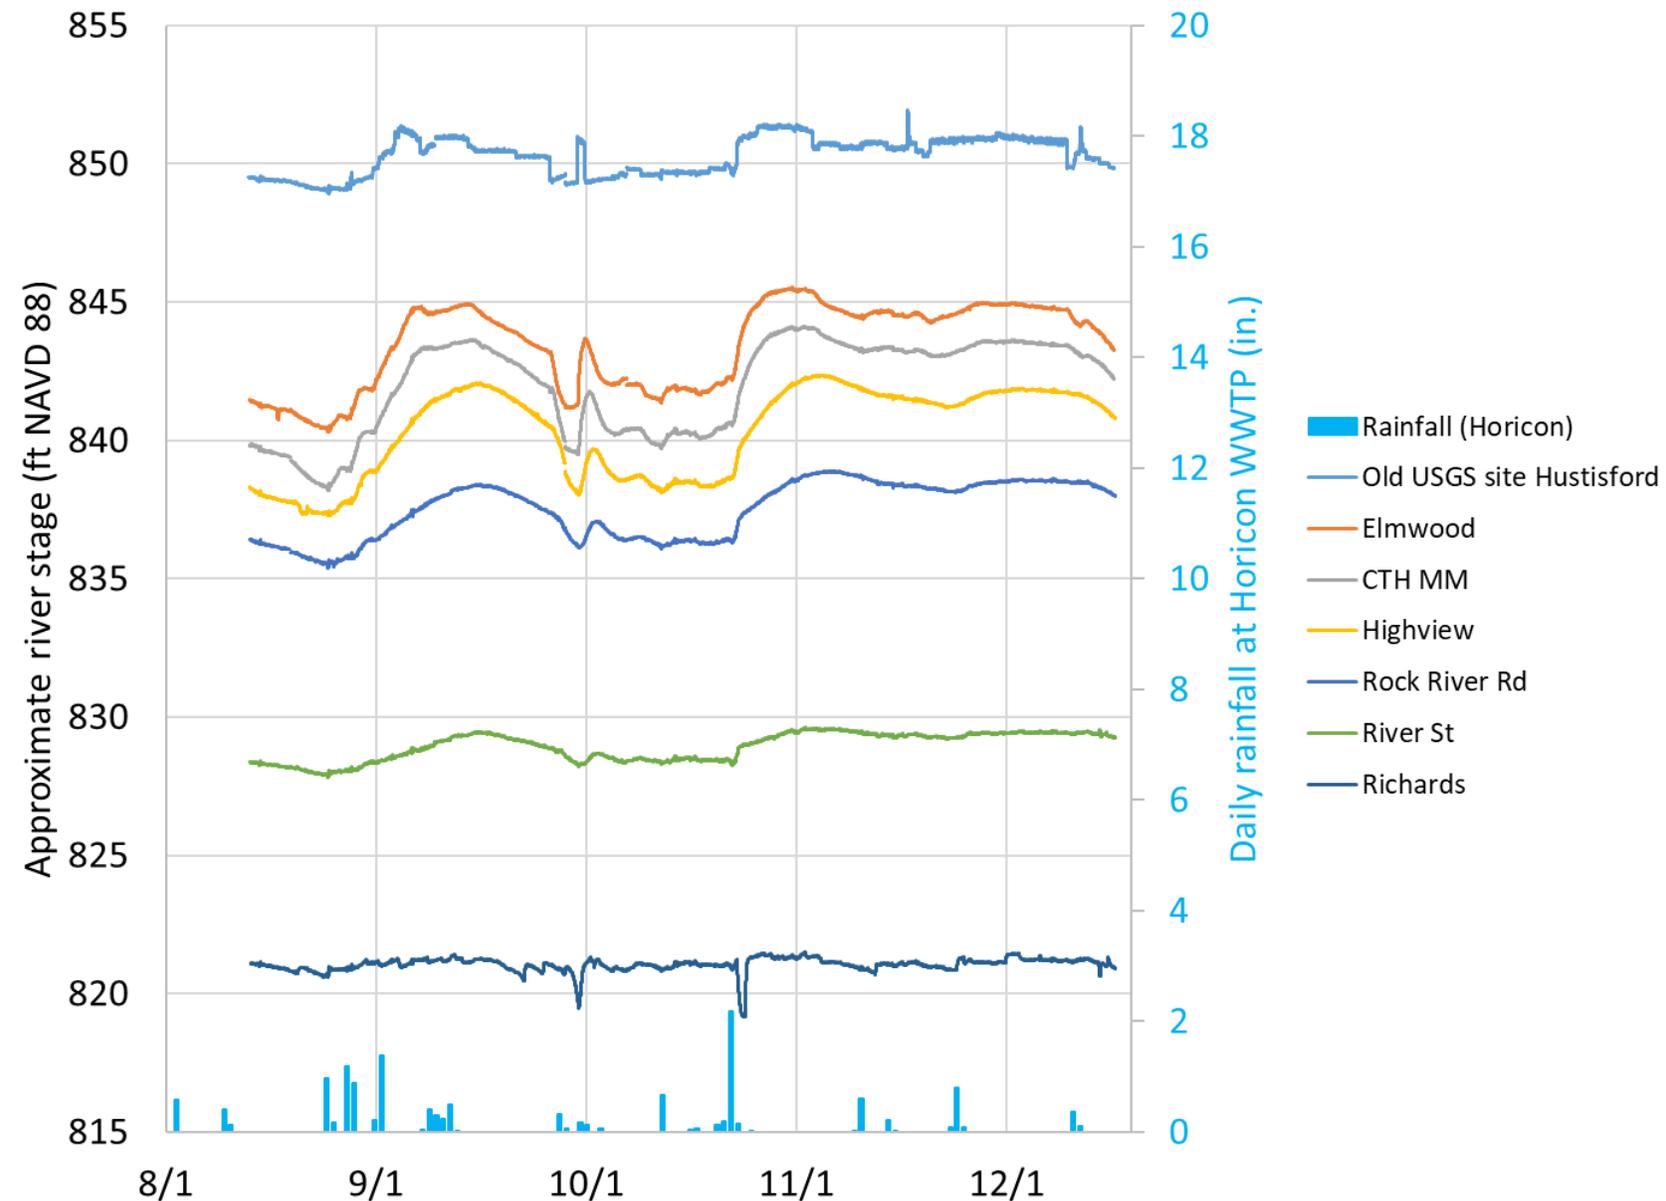
River stages during monitoring period

- The Riverview (old USGS site) location reflects flow from Hustisford Dam and changes abruptly based on gate operations. The levels don't change too much because the river channel is steep.
- The 4 middle loggers (Elmwood, CTH MM, Highview and Rock River Rd.) are in the very flat portion of the Rock River which includes the Town of Lebanon. These gages will be referred to as the "Town of Lebanon gages".
- The 2 downstream loggers are at locations with lower riverbed elevations and are closer to Watertown. The Richards logger is in the pool behind the Upper Watertown dam.

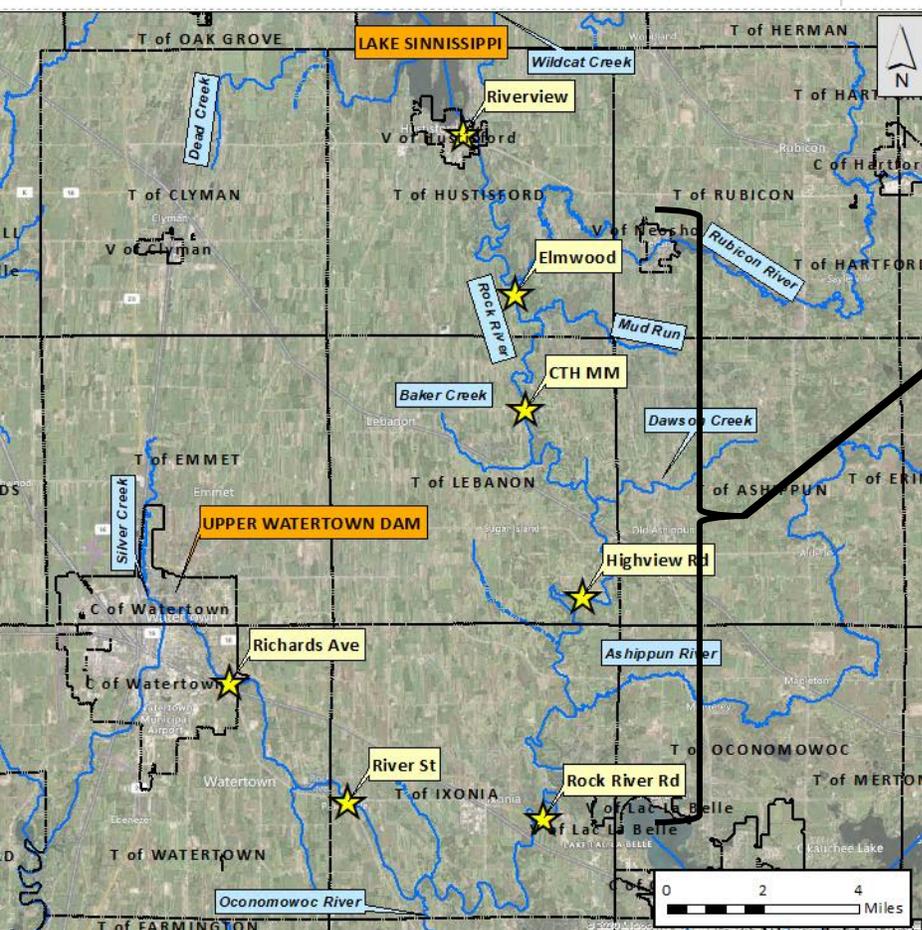
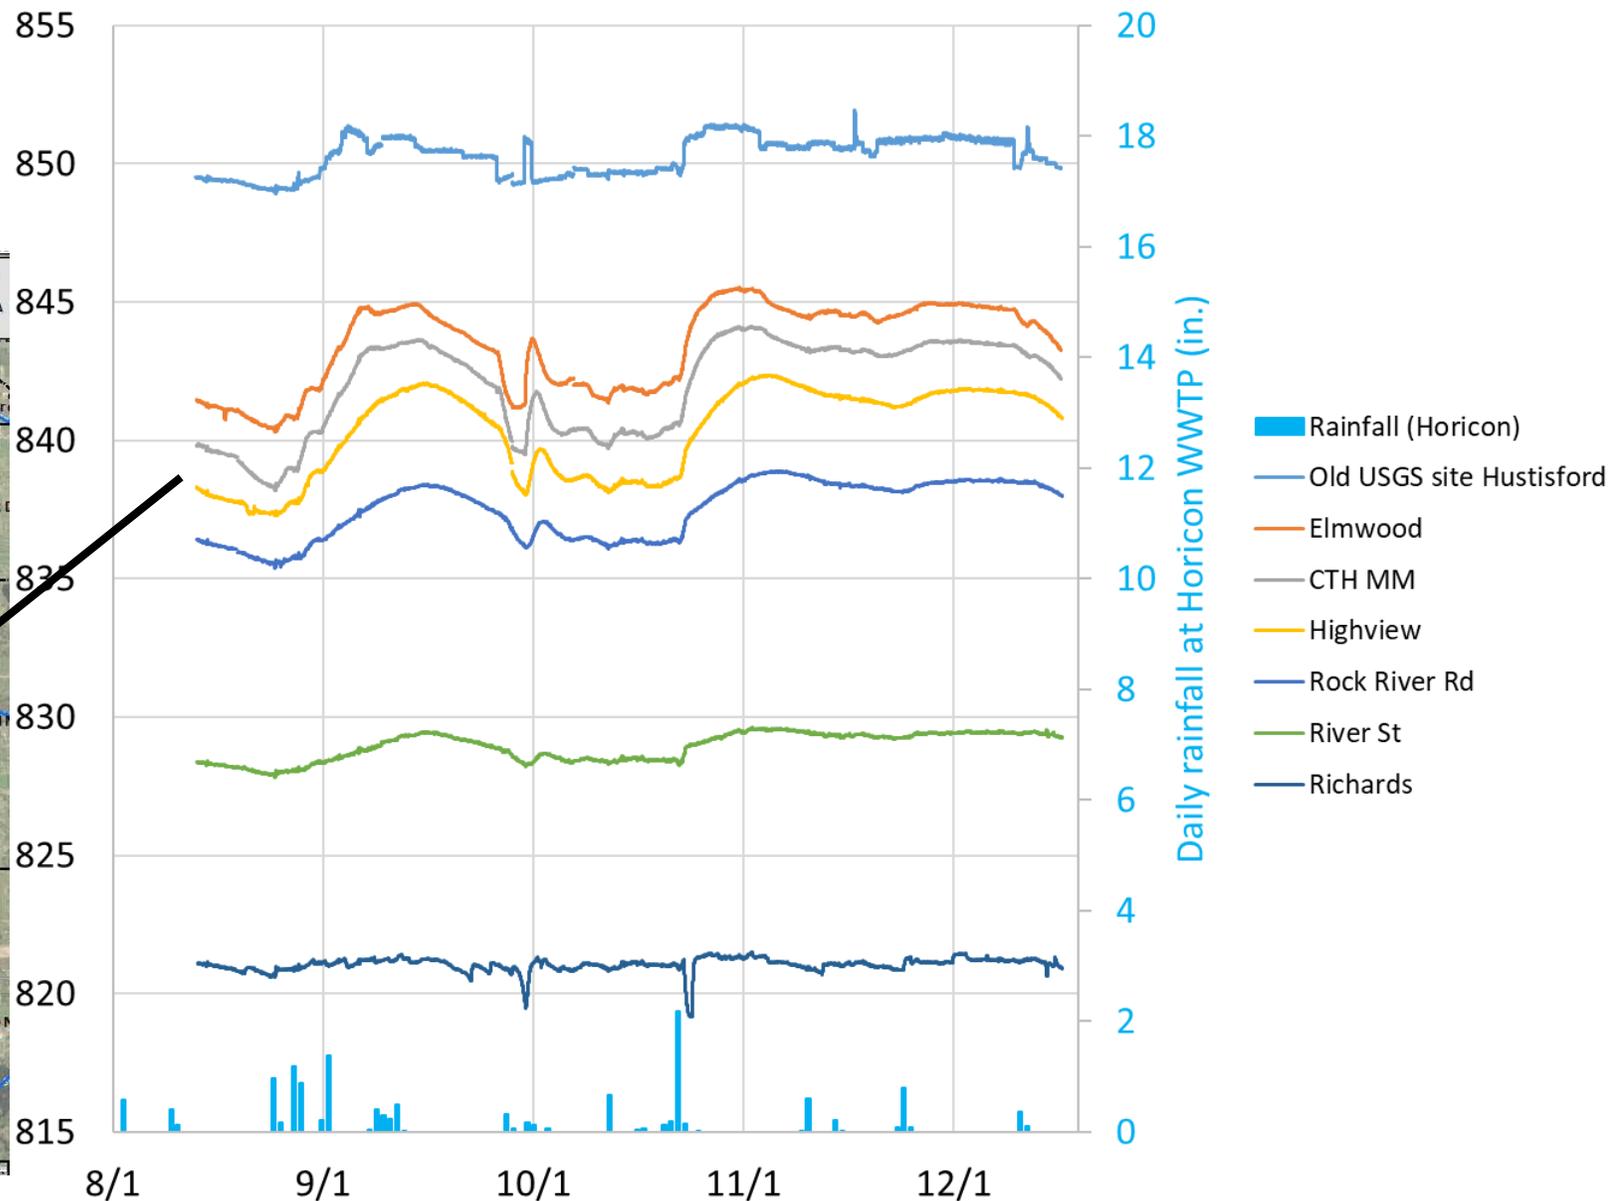
River stages during monitoring period

With the map again for reference.
Very little elevation drop over 35
river miles in middle section.
