Rock River Flood Monitoring and Evaluation

Summary Presentation

February 5, 2021

Nick Hayden, PE & Rob Montgomery, PE (MARS-EOR)

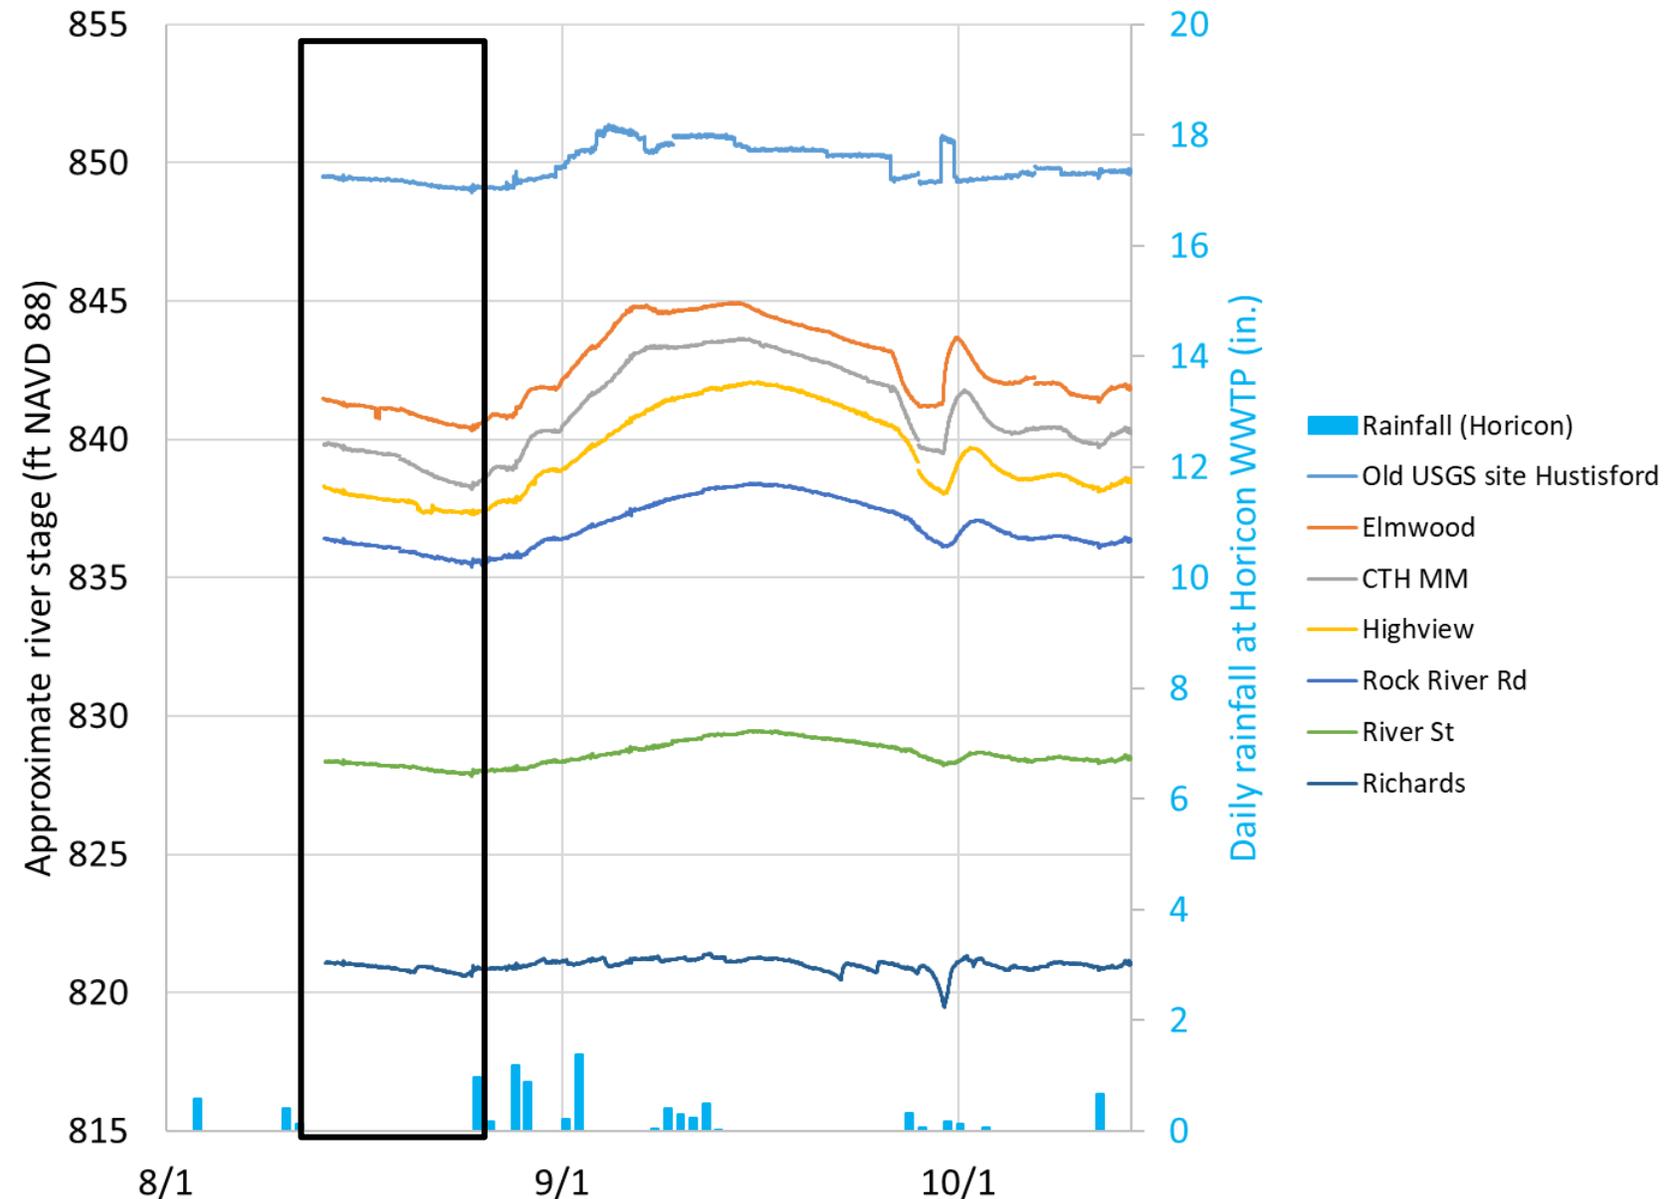
Early portion of monitoring period

There was no rainfall in the first two weeks of monitoring and lower Horicon dam was mostly closed to raise the pool to their target level.

Downstream water levels in the Town of Lebanon fell approximately 1 foot during this dry period when flows leaving the Horicon gage were below 200 cfs.

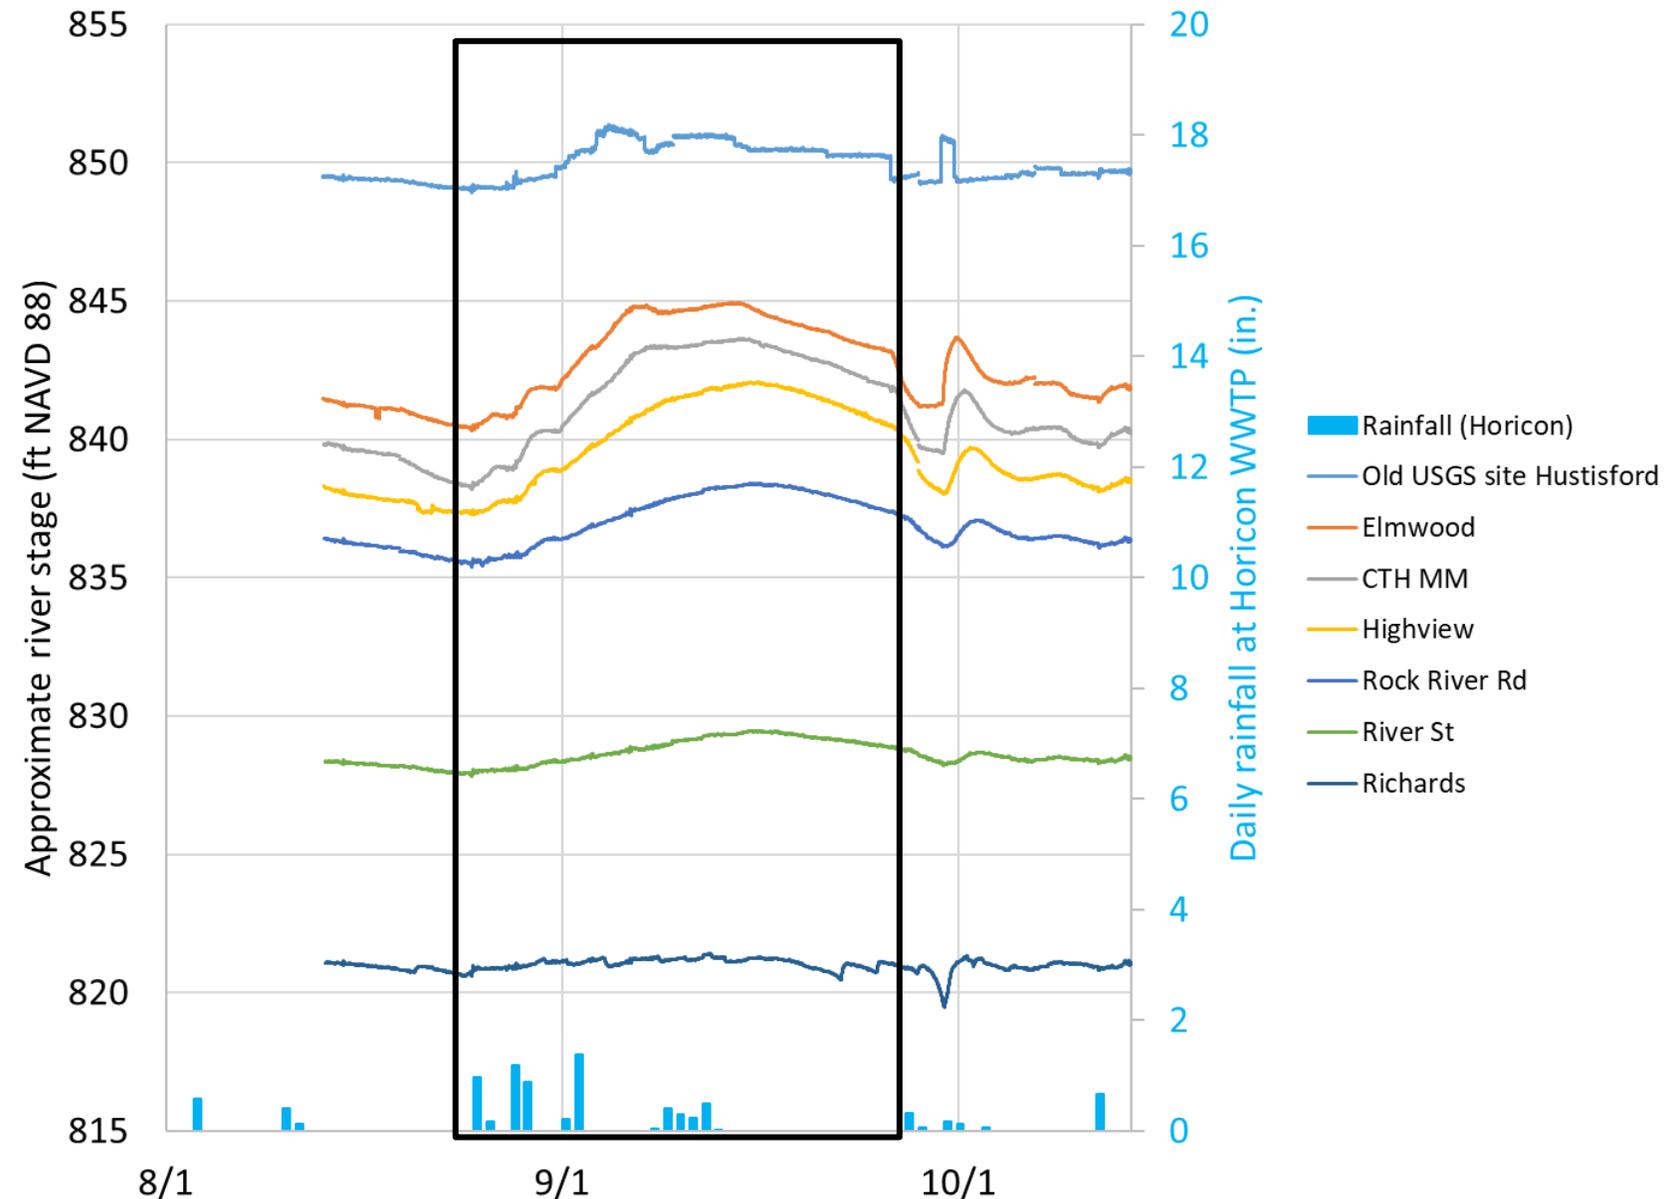
Large, extended rainfall late Aug – early Sep

Lower Horicon and Hustisford increased discharge following the 4.8” of rain over 9 days (Aug 25 – Sep 2).

Following the rains, the water level in lower Horicon marsh stabilized near the target of ~7.2’ on September 6th.

River levels in the Town of Lebanon rose upwards of 5 feet and remained high for over a month (until our test Sep 30).

The downstream gages showed a much smaller water level change. The Upper Watertown pool was very steady during this time.

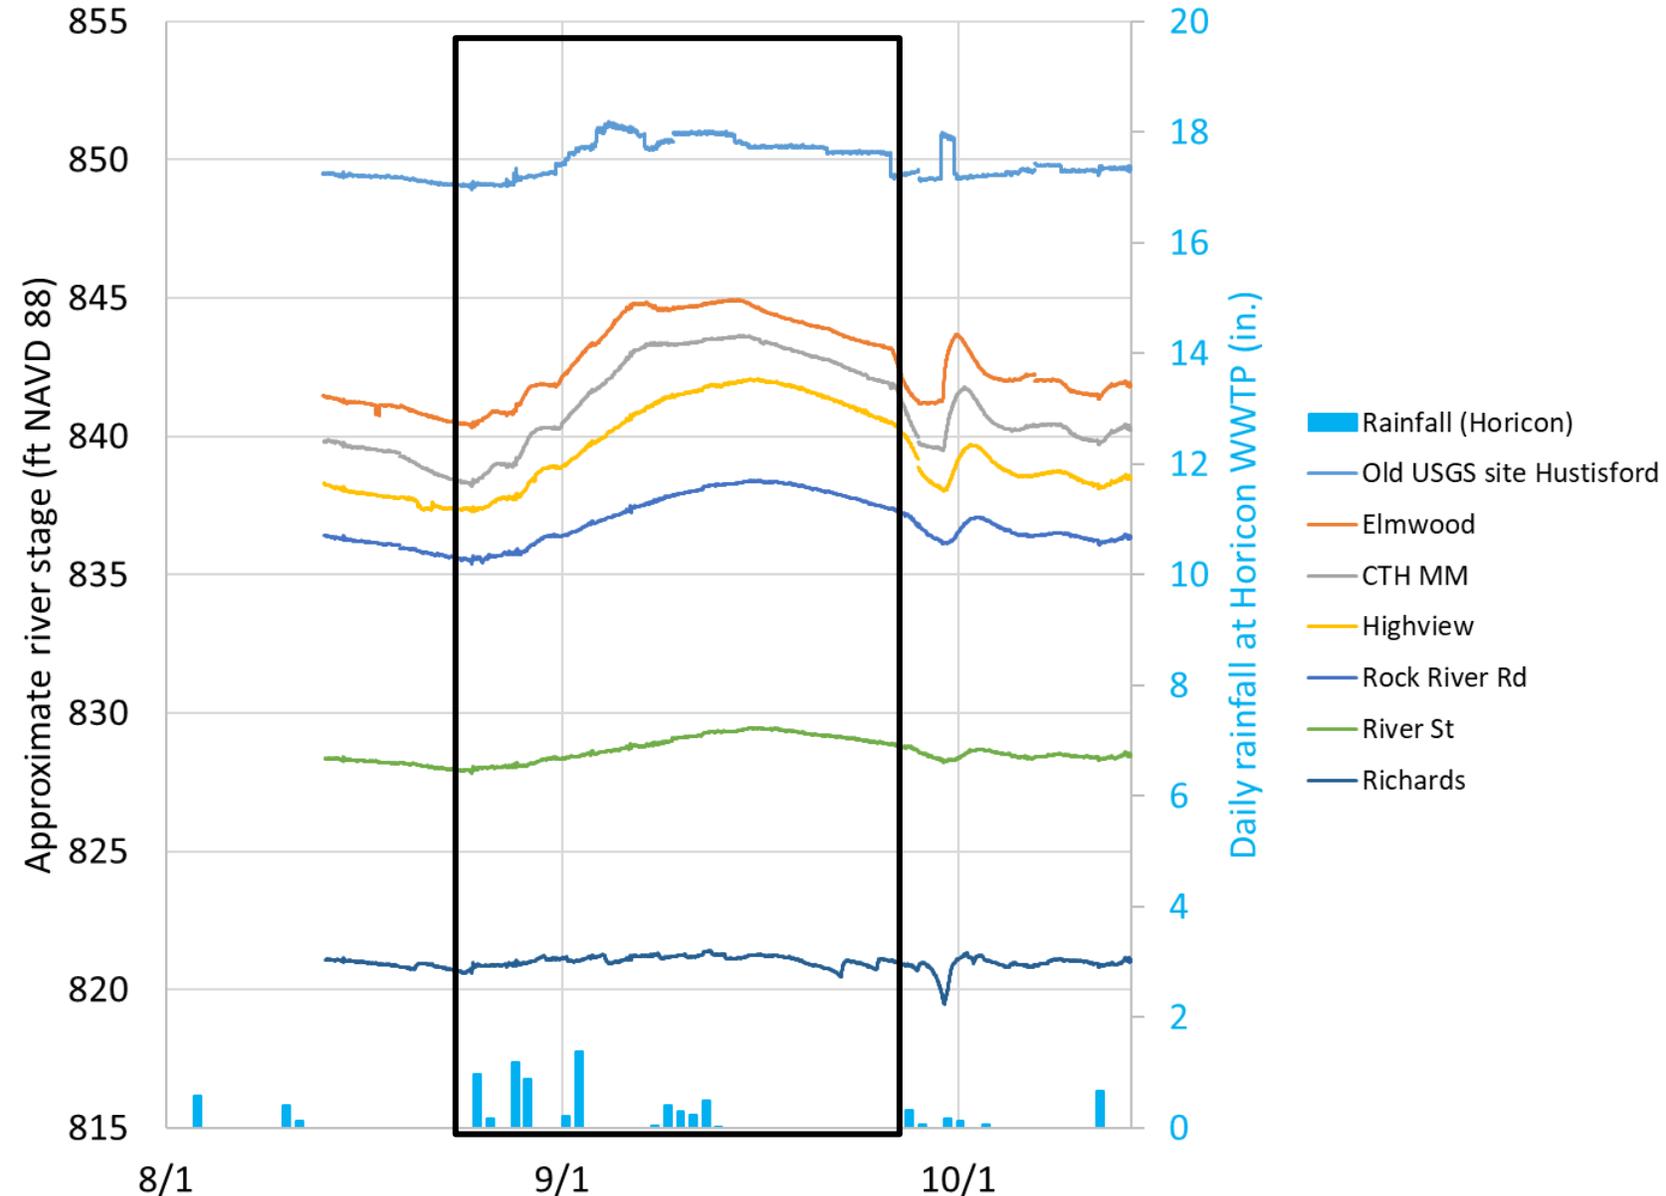
Large, extended rainfall late Aug – early Sep (cont.)

- The downstream peak at River St occurred ~ 10 days after the peak at Elmwood.
- The magnitude of change was MUCH greater in the Town of Lebanon than elsewhere. This reach is very sensitive to higher flows and very slow to drain. Some of these higher flows are due to tributary watersheds downstream of Hustisford.
- Levels at the Upper Watertown dam remained steady, and the water surface is 15-20 ft lower at the dam than in the Town of Lebanon.

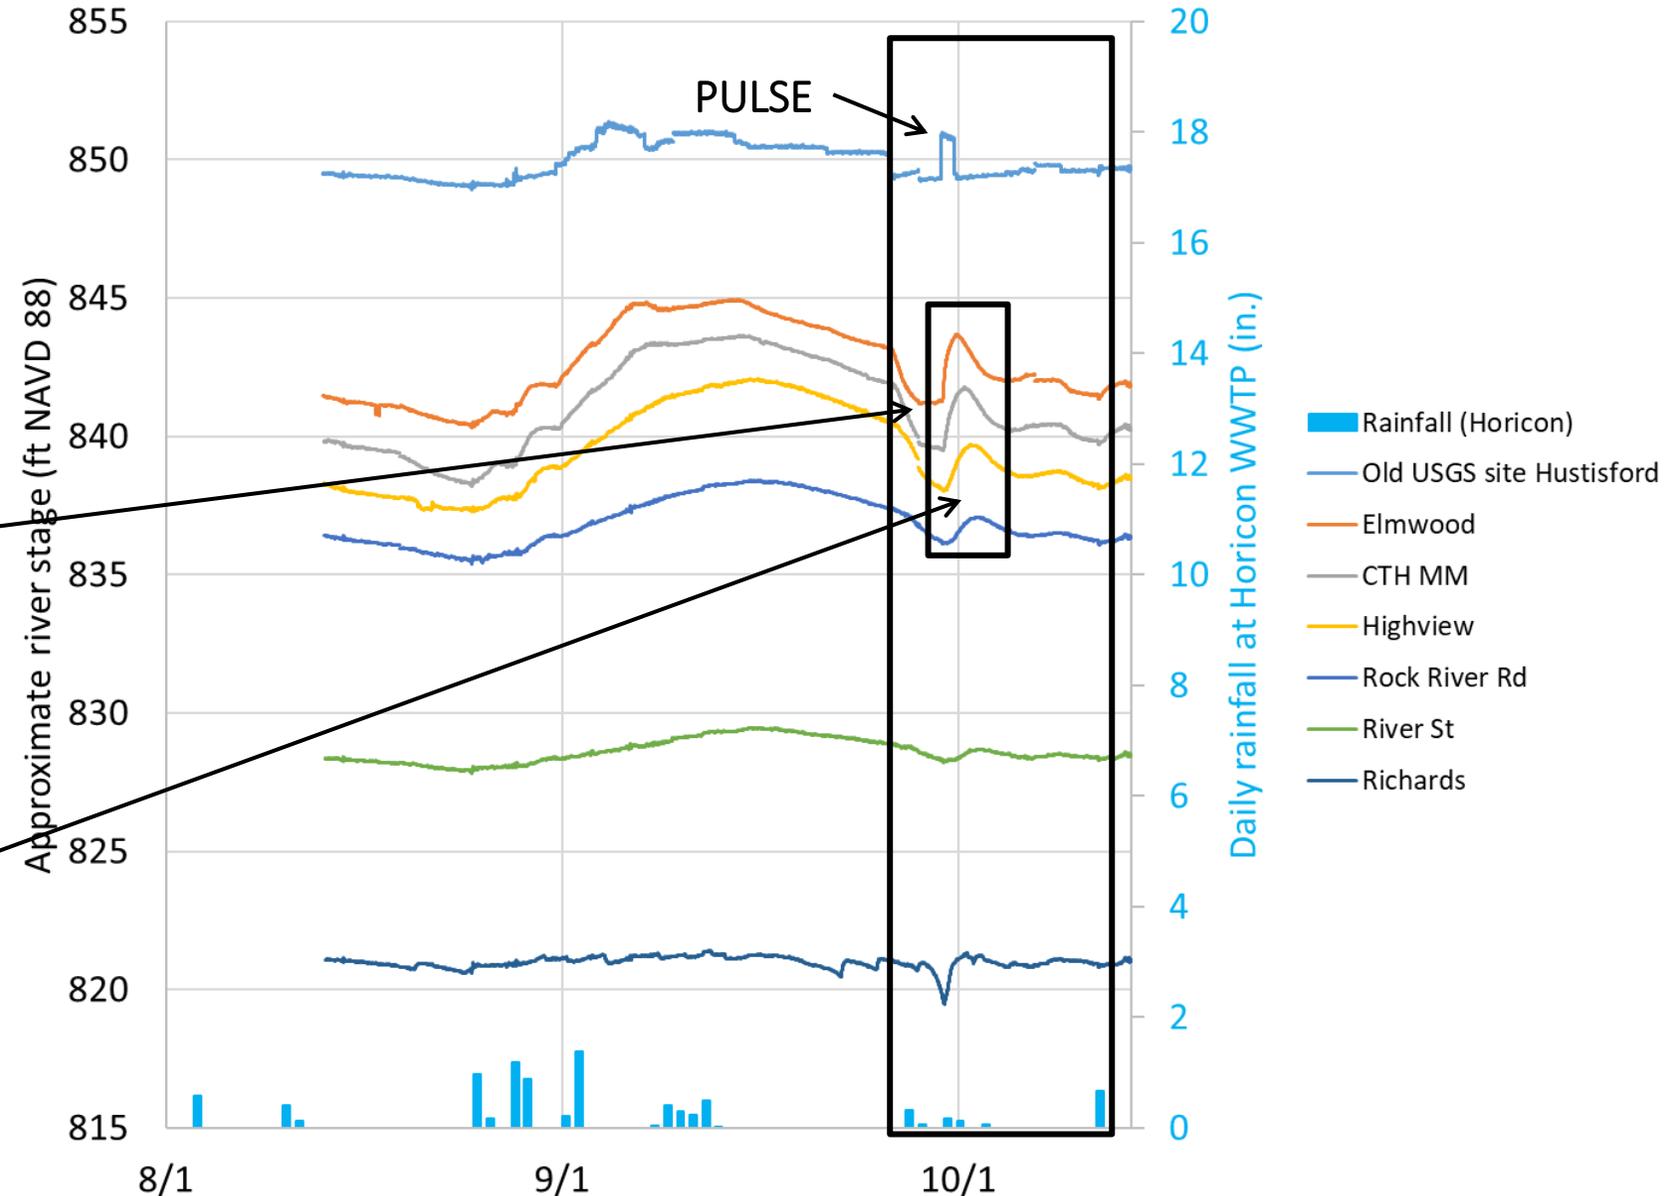
Hustisford 1000 cfs pulse test

We coordinated a 24-hour, 1,000 cfs pulse from Hustisford to study river behavior at the flow rate downstream, including the timing and magnitude of river level changes.

Leading up to the test Hustisford closed their gates, and water levels fell downstream ~ 1.5 ft over 3 days.

The test raised levels at Elmwood over 2 feet but had less impact downstream, and levels subsided fairly quickly - within a few days - after the 1-day test.

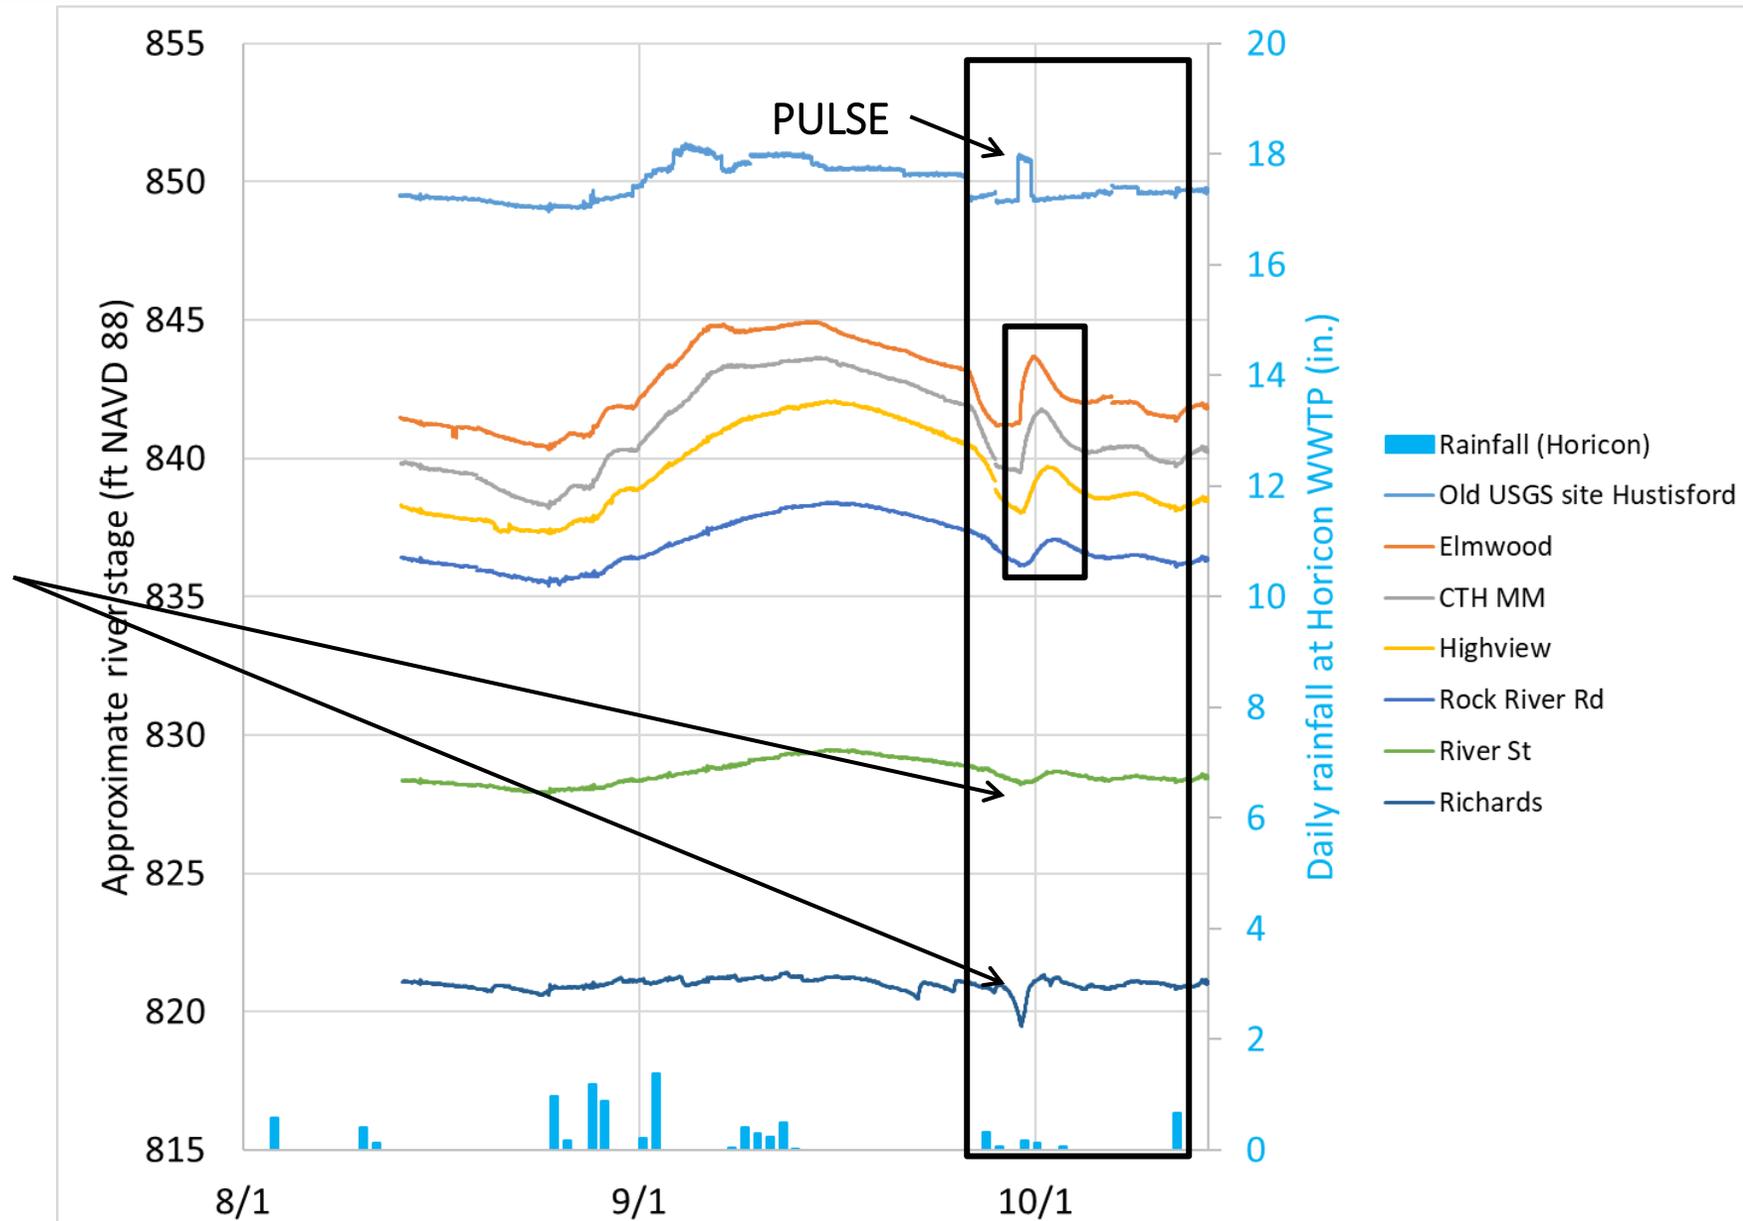
Hustisford 1000 cfs pulse test (cont.)

During this same time, the Upper Watertown dam gates were briefly opened, as seen in the Richards logger. The River Street logger, 4 miles upstream from Richards, doesn't show any impact from this opening. This brief lowering of the Upper Watertown pool provided useful data on the hydraulics of the steeper downstream portion of the study reach – discussed further below.

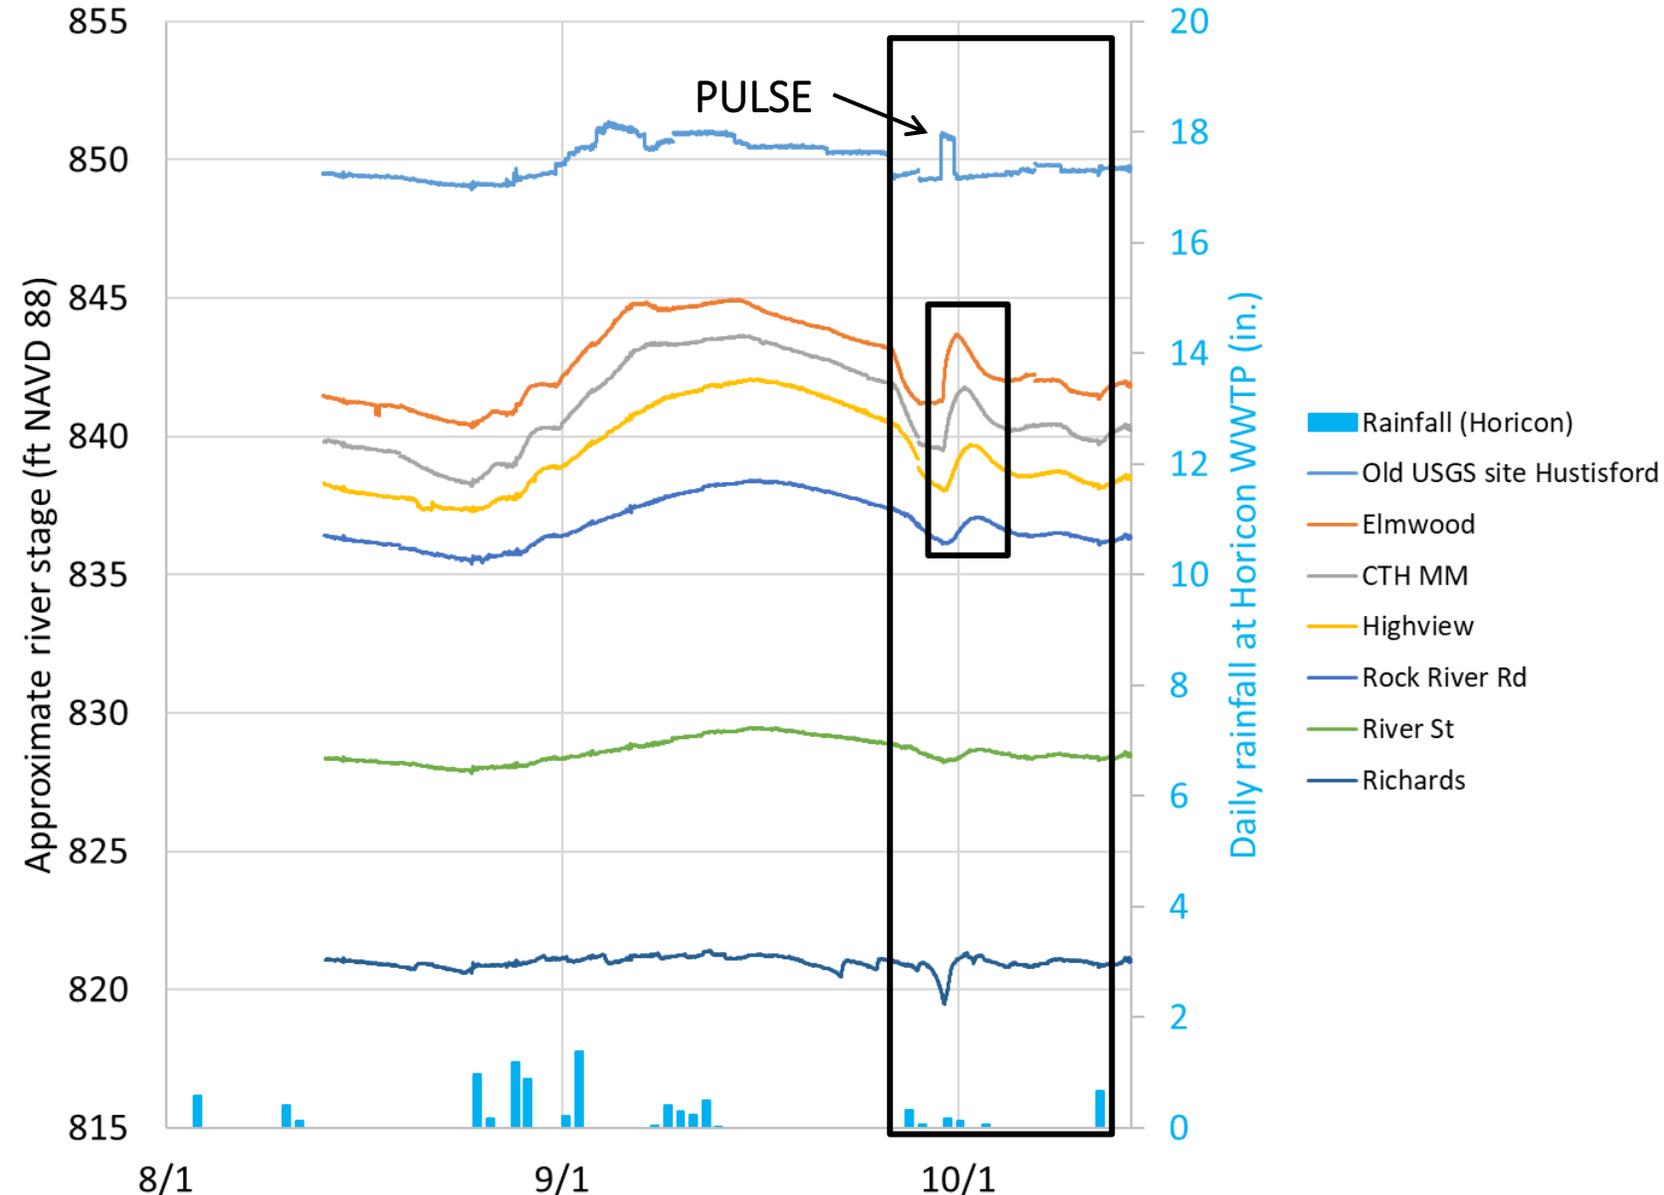
Hustisford 1000 cfs pulse test (cont.)

- Despite the slow timing of flood flow peaks moving downriver, the Town of Lebanon gages were fairly quick to respond to decreases in flow coming from Horicon and Hustisford.
- When the river isn't already high, there seems to be enough storage in this section of river to handle this higher flow (1,000 cfs) for a limited duration.

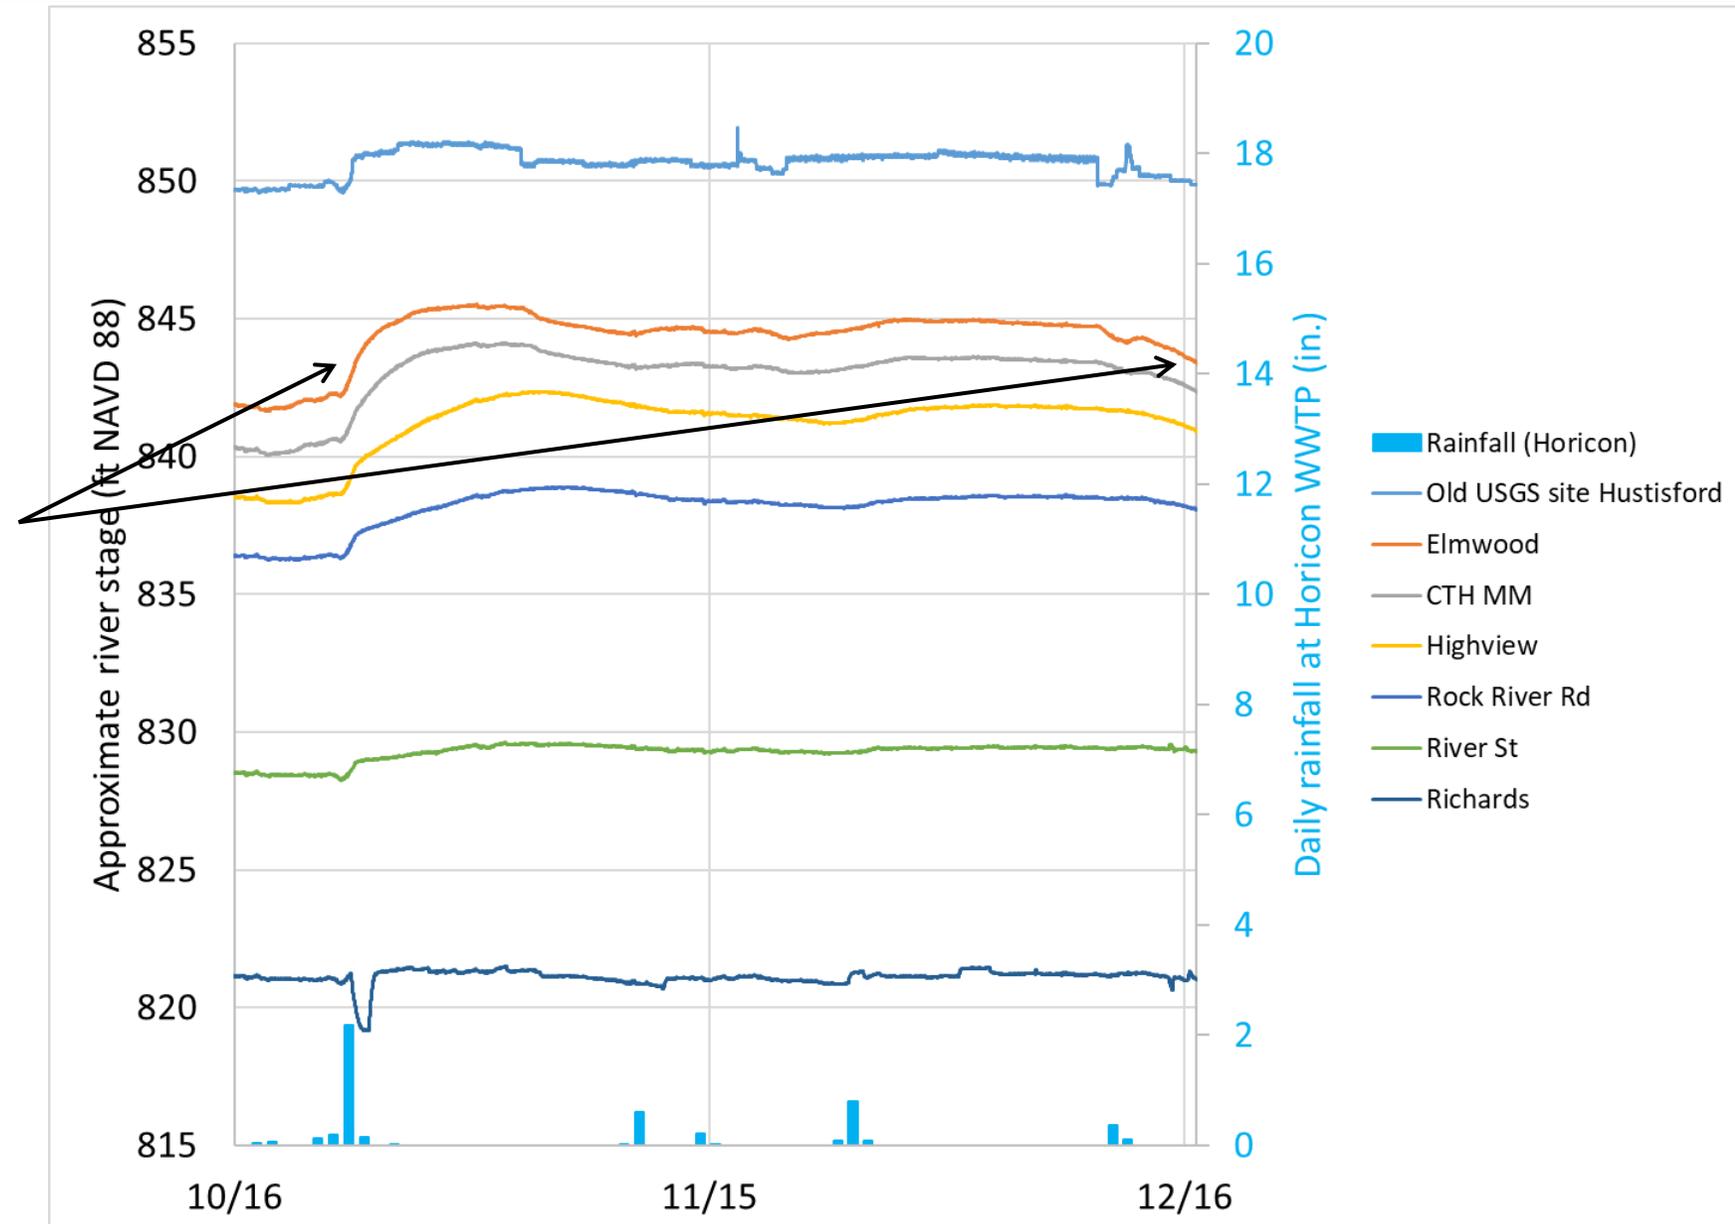
Heavy rain and long duration high water

The 2.2" of rain (an approximately 1-year storm) measured at Horicon on October 23 (possibly more in the upper watershed) had a significant impact on water levels for the remainder of the monitoring period.

Water levels increased by ~3 feet at Elmwood and remained high until the very end of the monitoring period when Horicon outflow dropped from 600-800 cfs down to ~200 cfs and the river dropped quickly. We recorded ~1.5 feet of drop before pulling loggers due to ice, but our clients reported the river continued to drop down to about 3 ft lower than it had been.

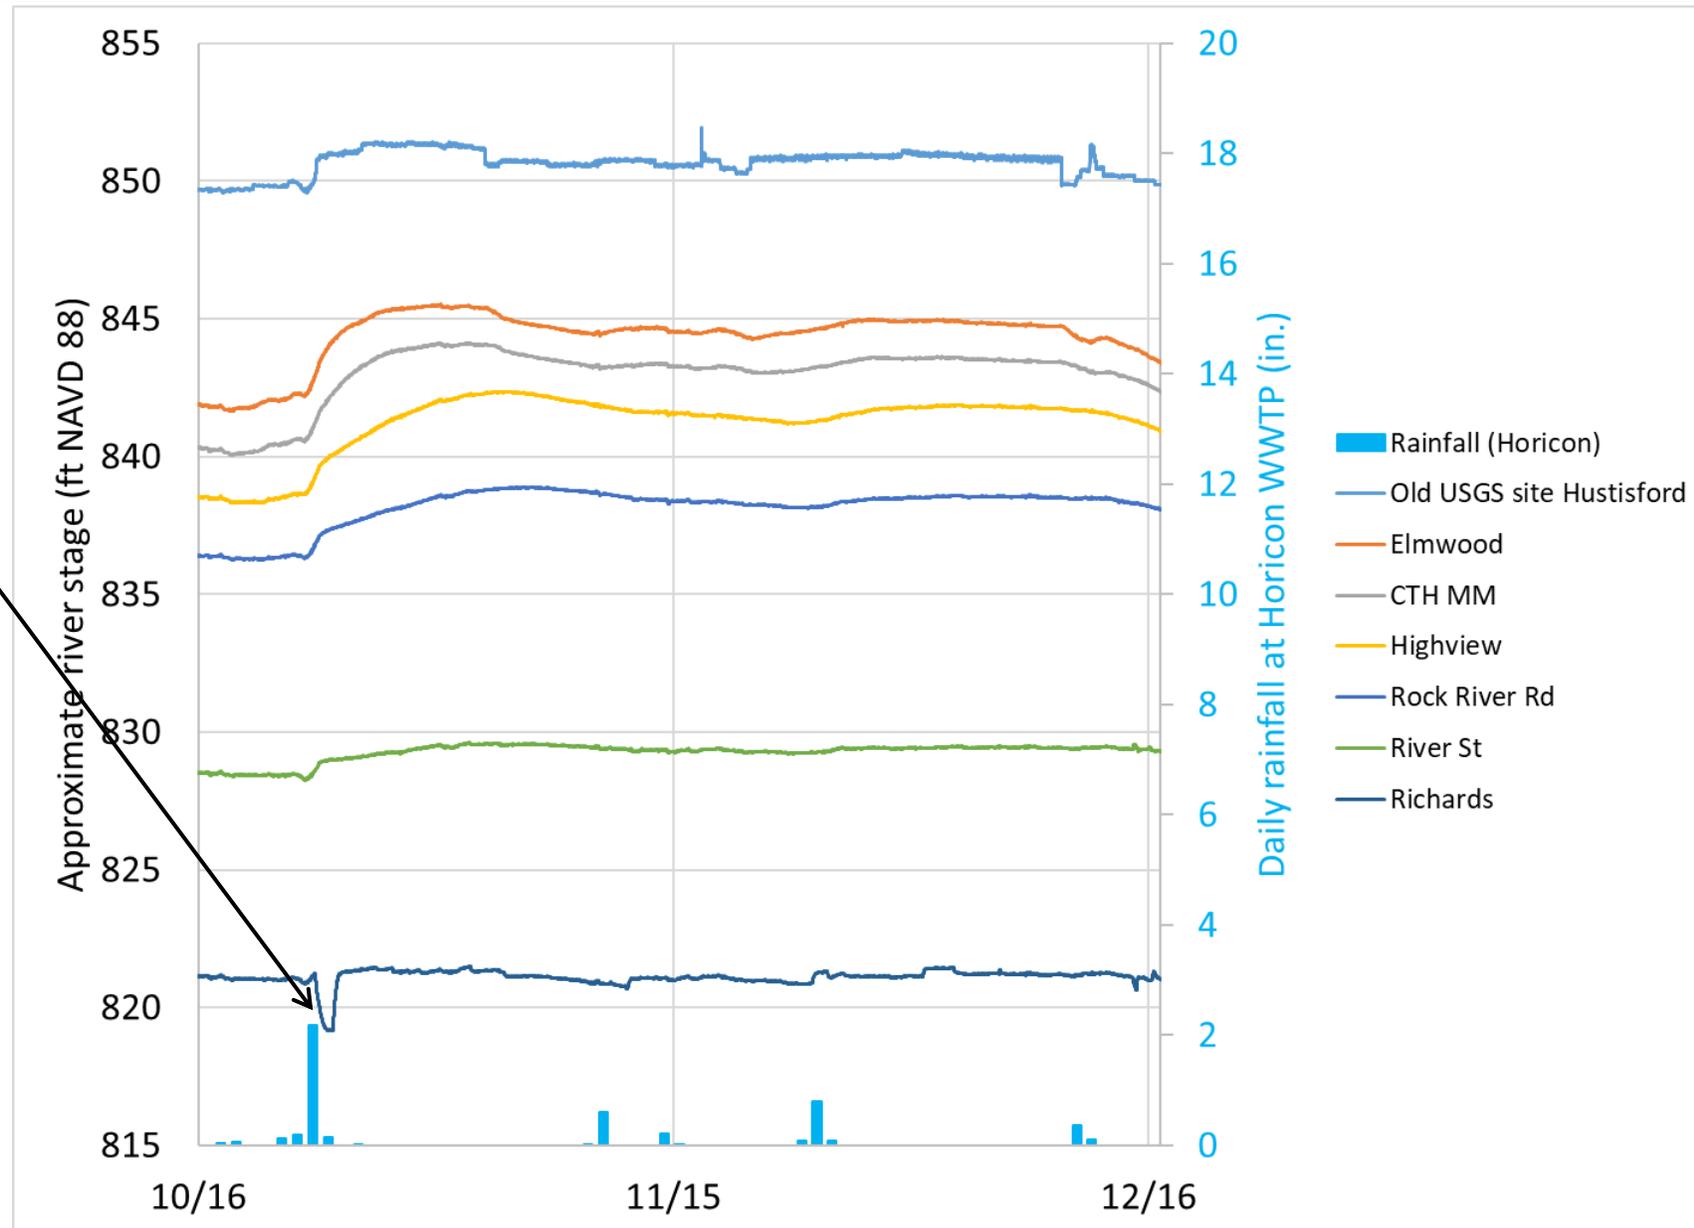
Heavy rain and long duration high water (cont.)

On the day of heavy rain (Oct 23), Upper Watertown opened gates based on locally high runoff. Instead, the river upstream of the dam dropped enough to expose mud flats and the pool fell almost 2 feet below the minimum elevation. The operator received many complaints from the City during this event regarding low water levels upstream, and promptly closed the gates to restore water levels.

Despite this sudden lowering, no water level change is seen upstream at River St – instead levels there continue to slowly rise, similar to upstream.

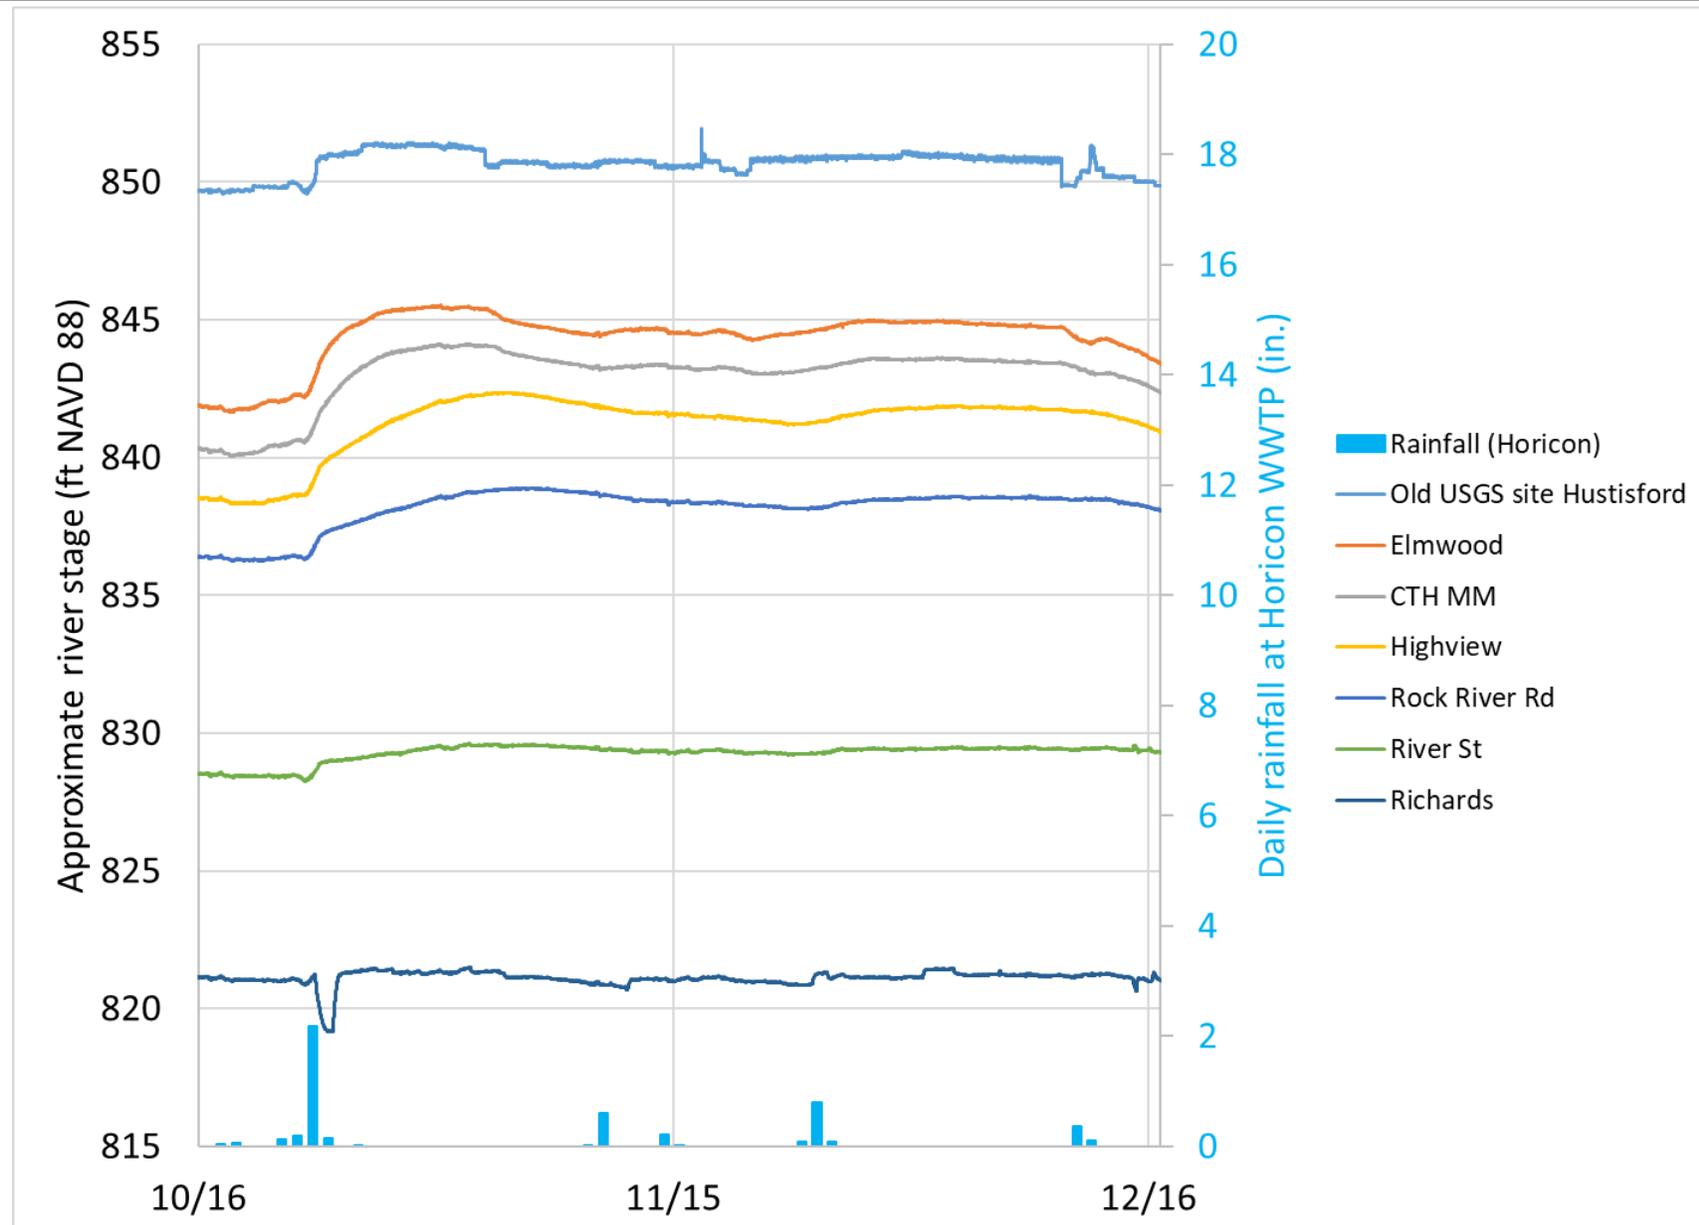
Heavy rain and long duration high water (cont.)

- The sustained flow of 600-800 cfs was too high to allow flood waters to recede in the Town of Lebanon. Once the river is out-of-bank, it seems that inflow needs to be ~400 cfs or lower to allow water to drain from the floodplain and for the water levels to drop.
- The Upper Watertown dam does not impact river levels very far upstream of its pool. Opening gates doesn't provide storage for upstream flow or drop water levels in the Town of Lebanon.

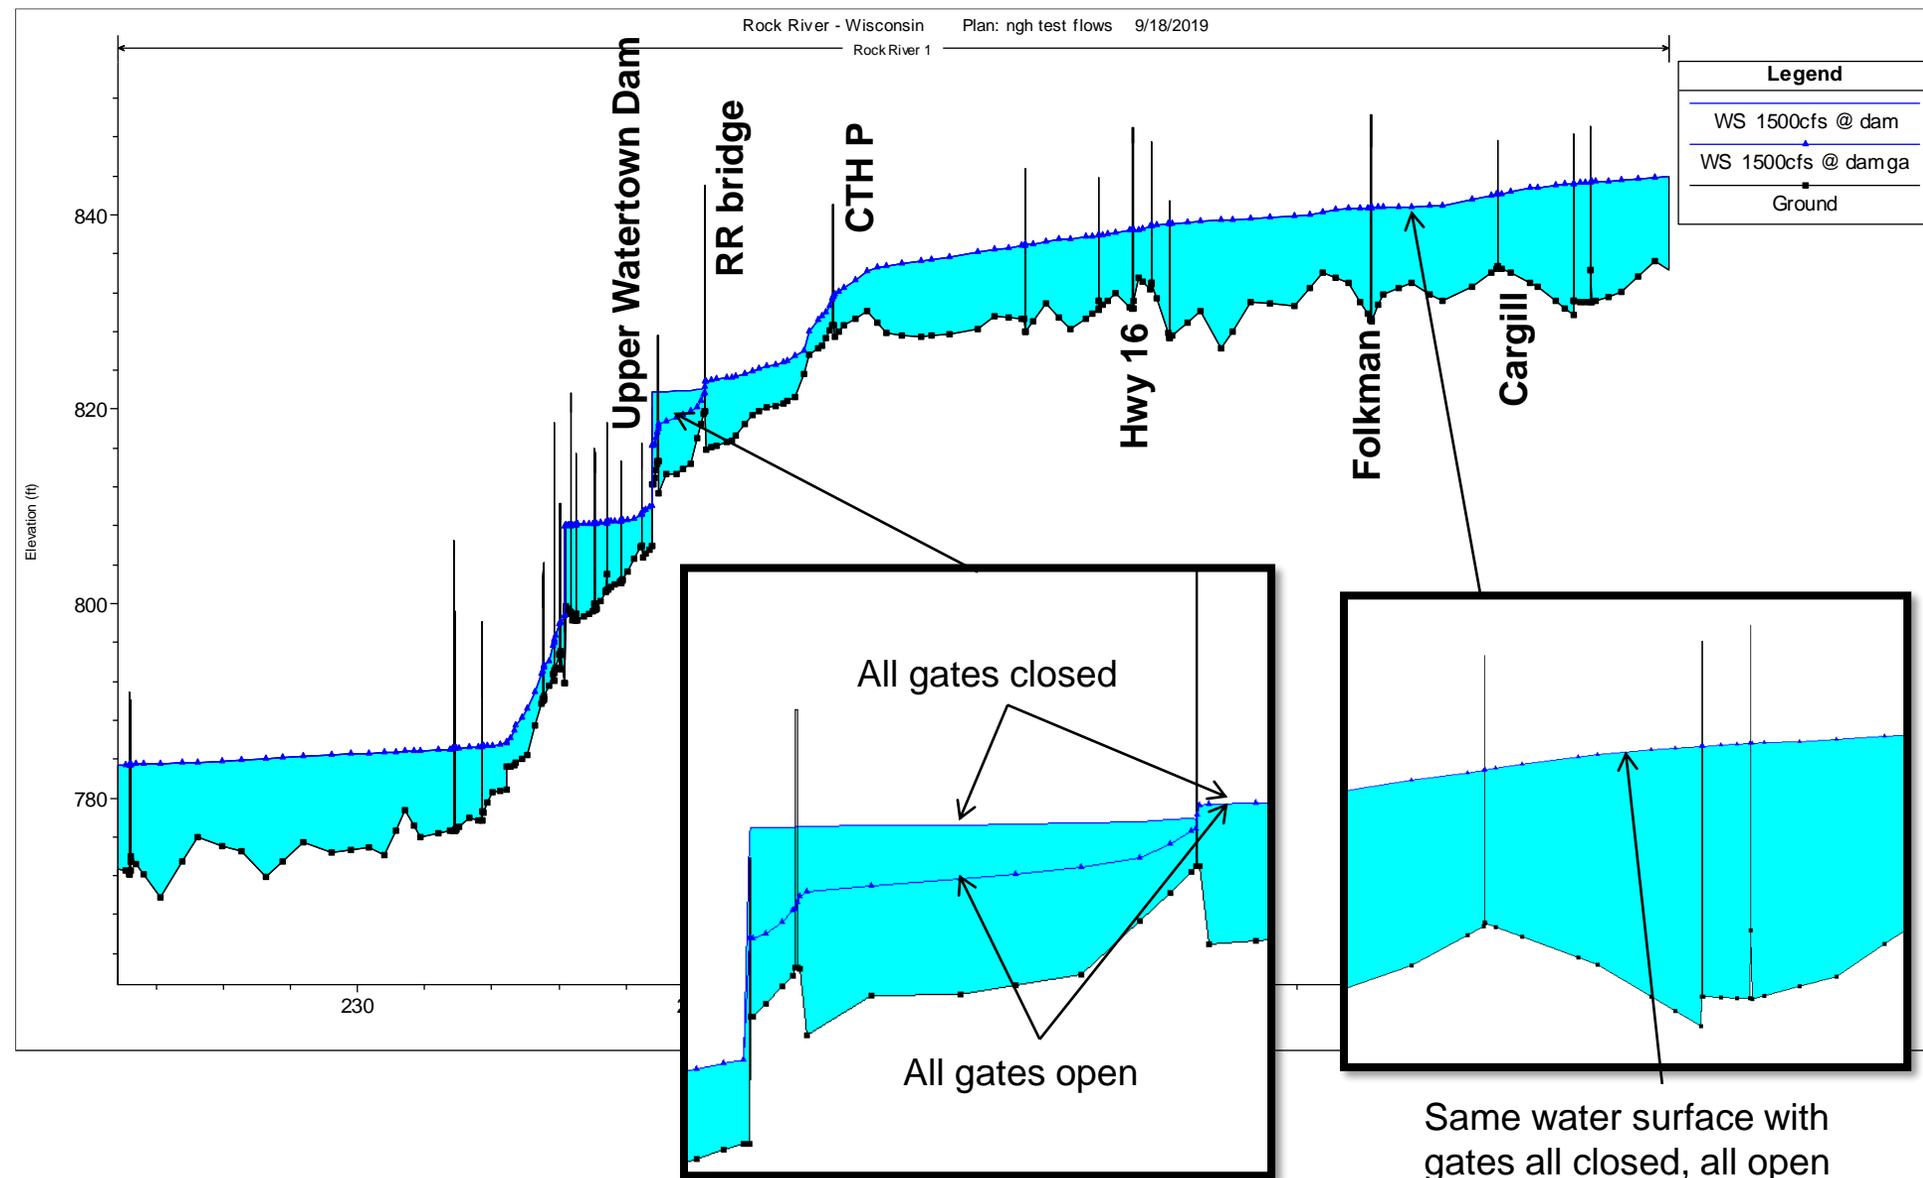
Upper Watertown dam impacts - modeled

With a steady flow set at 1,500 cfs, drastically changing the gate operations at Upper Watertown to be wide open lowers the upstream pool drastically but impacts dissipate above the railroad bridge and are imperceptible above CTH P.

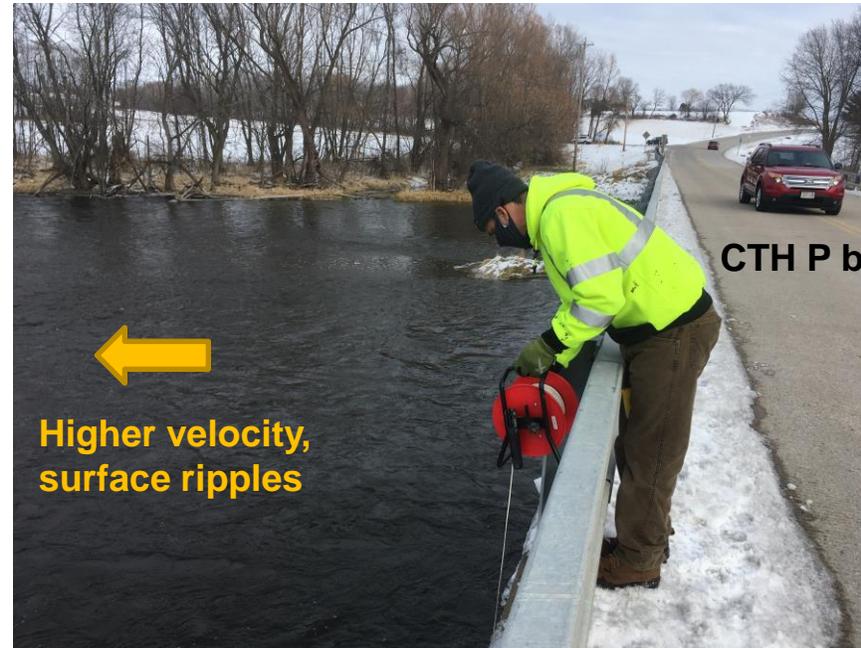
Higher velocity,
surface ripples

The steeper downstream river slope and separation between downstream (Upper Watertown dam) and upstream (above CTH P) hydraulics can be observed in-person at CTH P, the RR bridge, and near the River St logger. The velocity in those locations is much higher here than upstream of the CTH P bridge and throughout the Town of Lebanon.
