Rock River Flood Monitoring and Evaluation

Summary Presentation

February 5, 2021

Nick Hayden, PE & Rob Montgomery, PE (MARS-EOR)

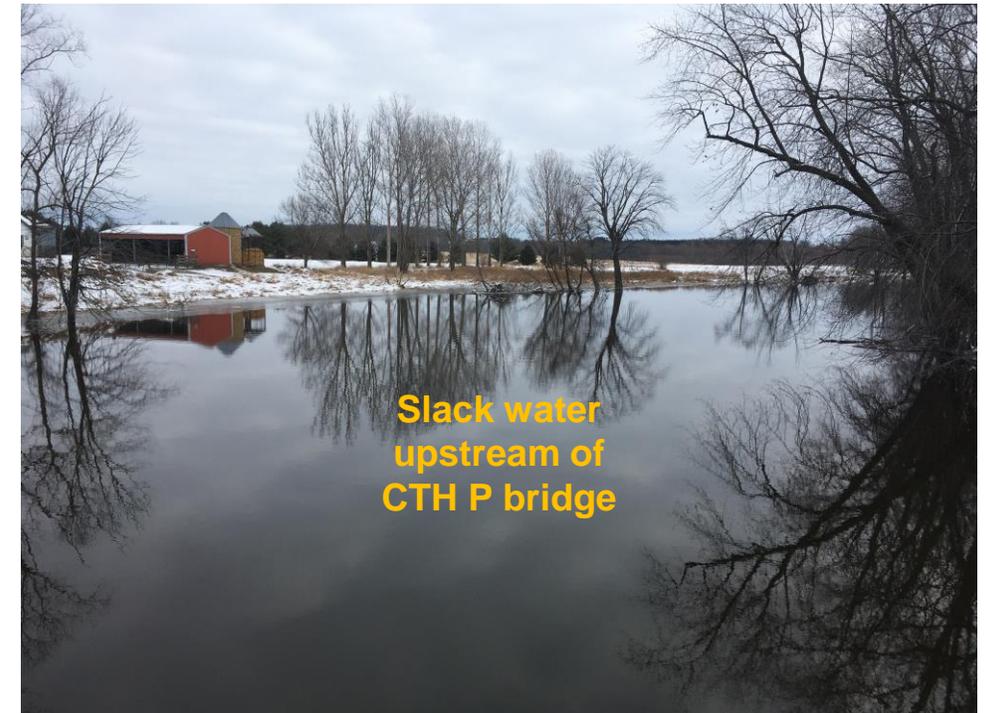
Slack water
upstream of
CTH P bridge

The steeper downstream river slope and separation between downstream (Upper Watertown dam) and upstream (above CTH P) hydraulics can be observed in-person at CTH P, the RR bridge, and near the River St logger. The velocity in those locations is much higher here than upstream of the CTH P bridge and throughout the Town of Lebanon.

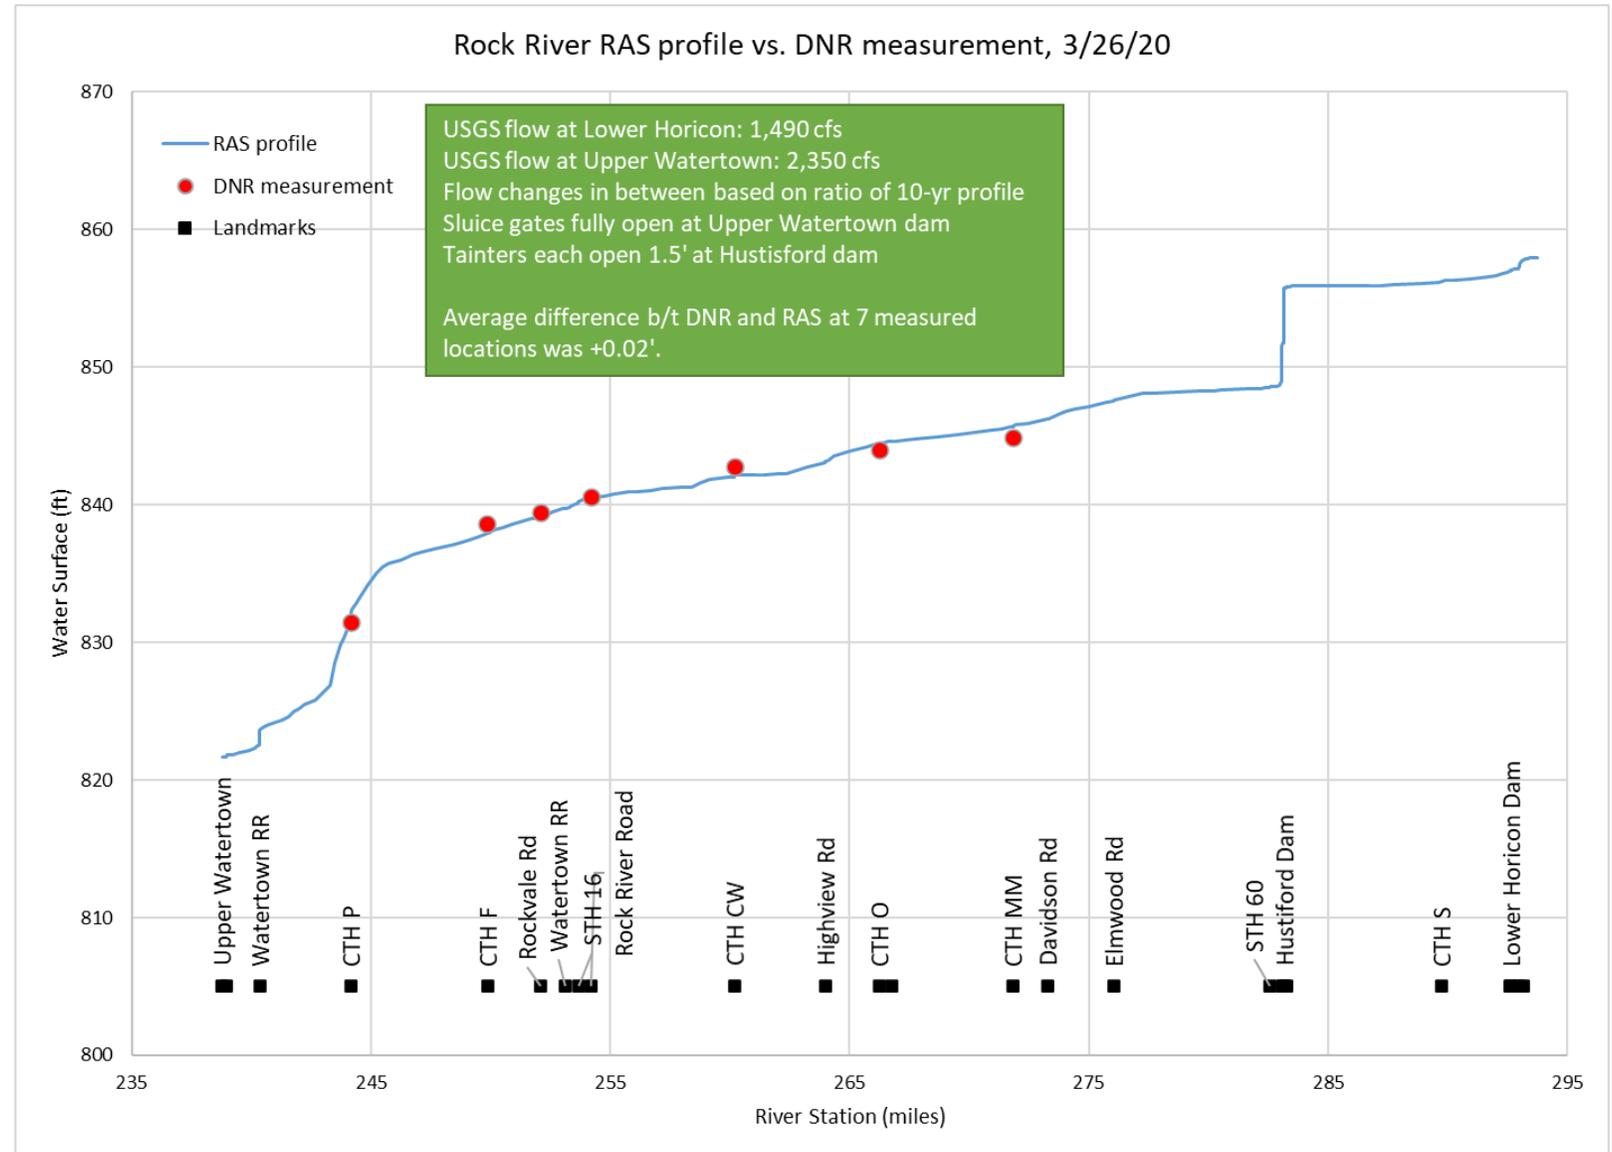
The DNR provided water surface measurements from 2 separate dates in spring 2020. We ran the estimated flows on those days in the model and compared the water surface elevations predicted to those measured. The difference between model and measurements were generally well under 1 foot and weren't consistently biased.

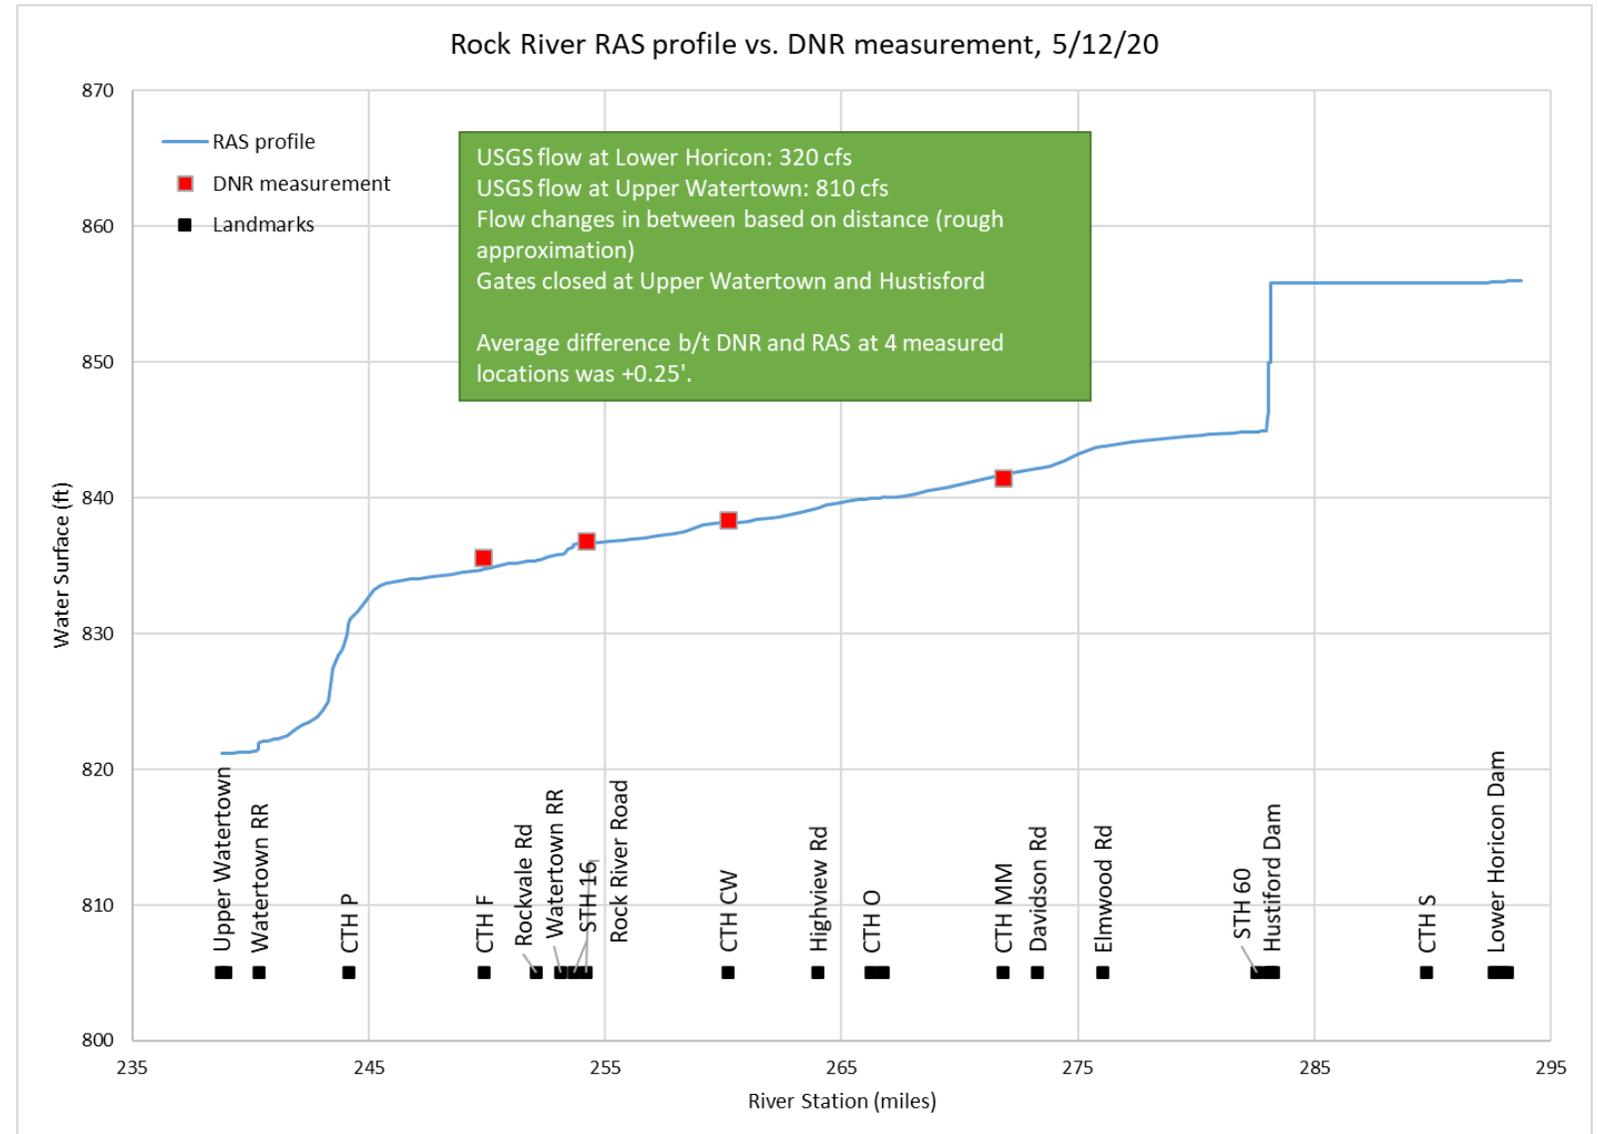
Model validation (cont.)

The HEC-RAS seemed to represent water surface levels well and this confirmed its utility as an analysis tool.

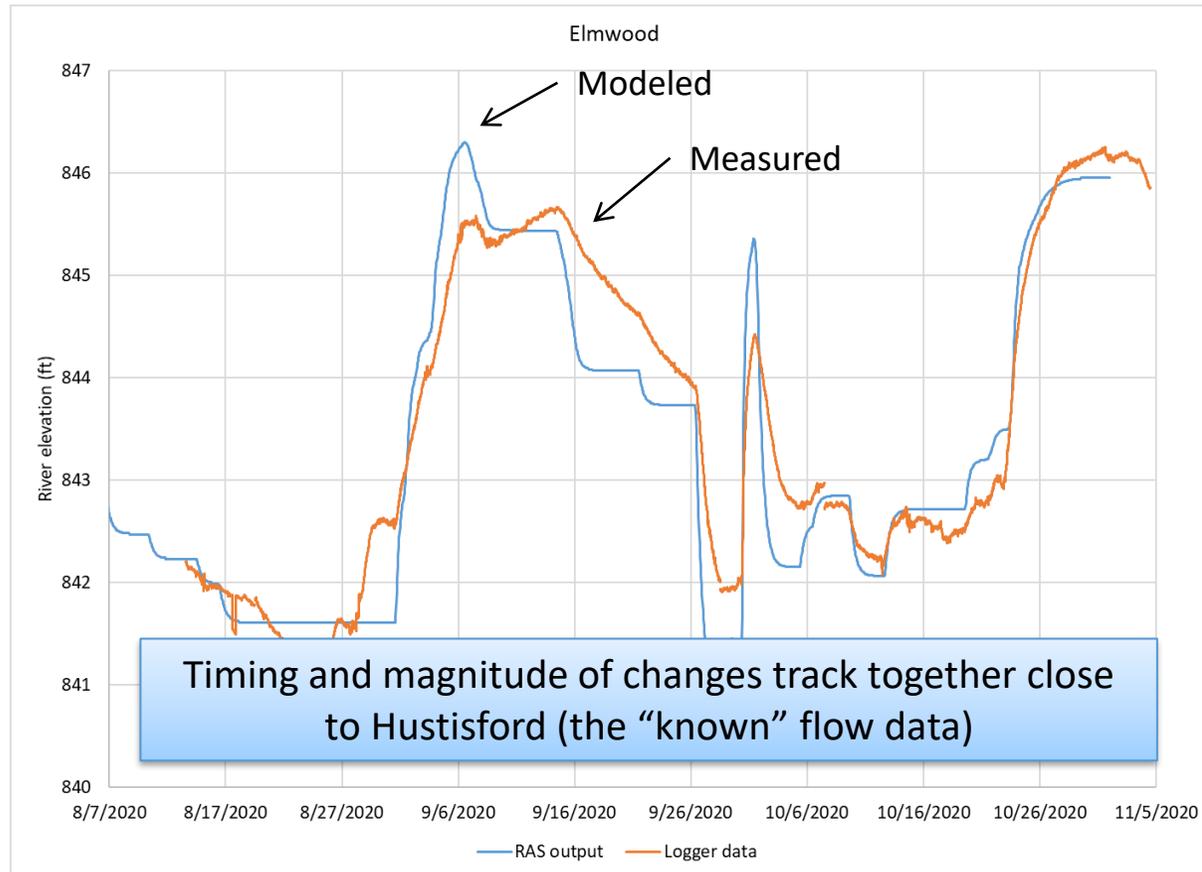
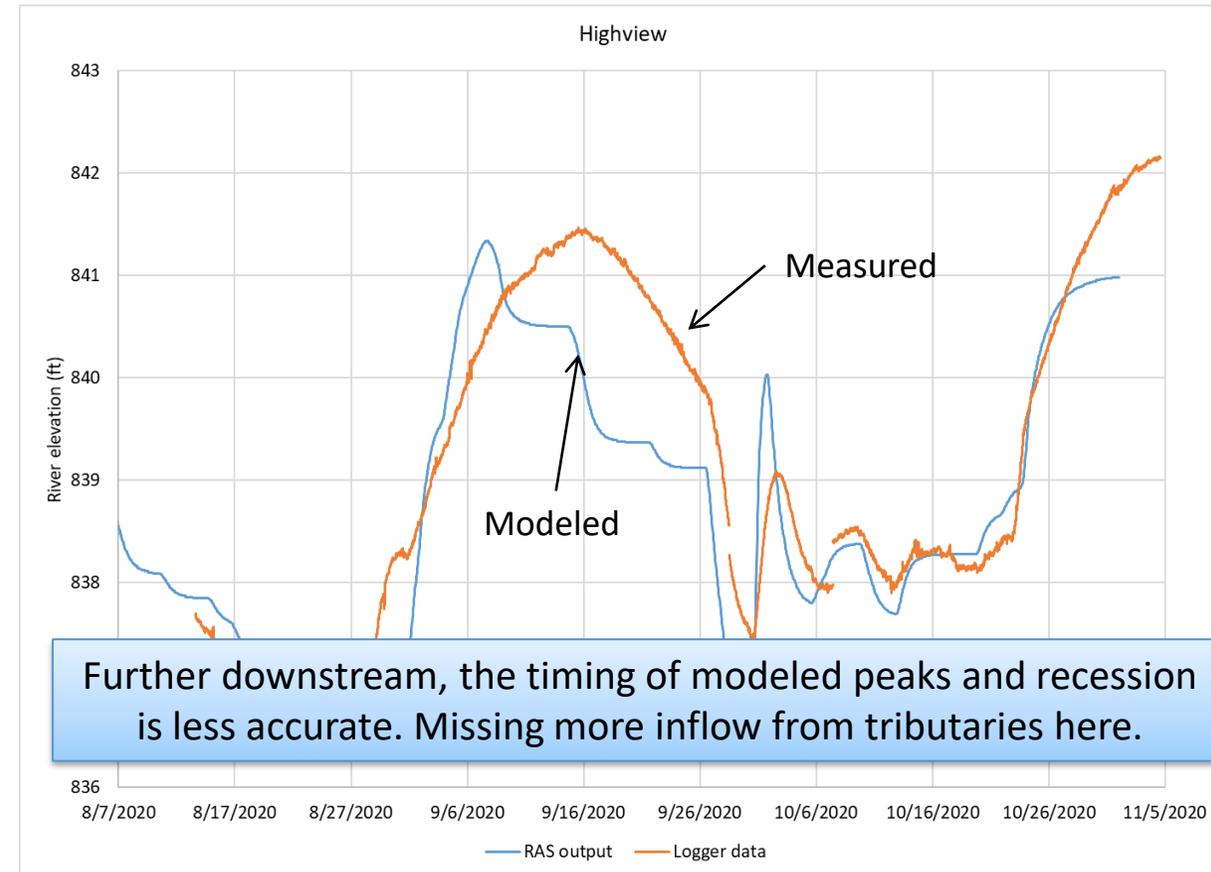
Model validation (conclusion)

We also ran the model in unsteady mode with some of the monitoring data. Unsteady flow requires more assumptions about dam operations and tributary inflow. We compared observed and modeled river stage at Elmwood and Highview in the Town of Lebanon. The model results indicate that the model reasonably replicates observed data and will be useful in evaluating management alternatives.

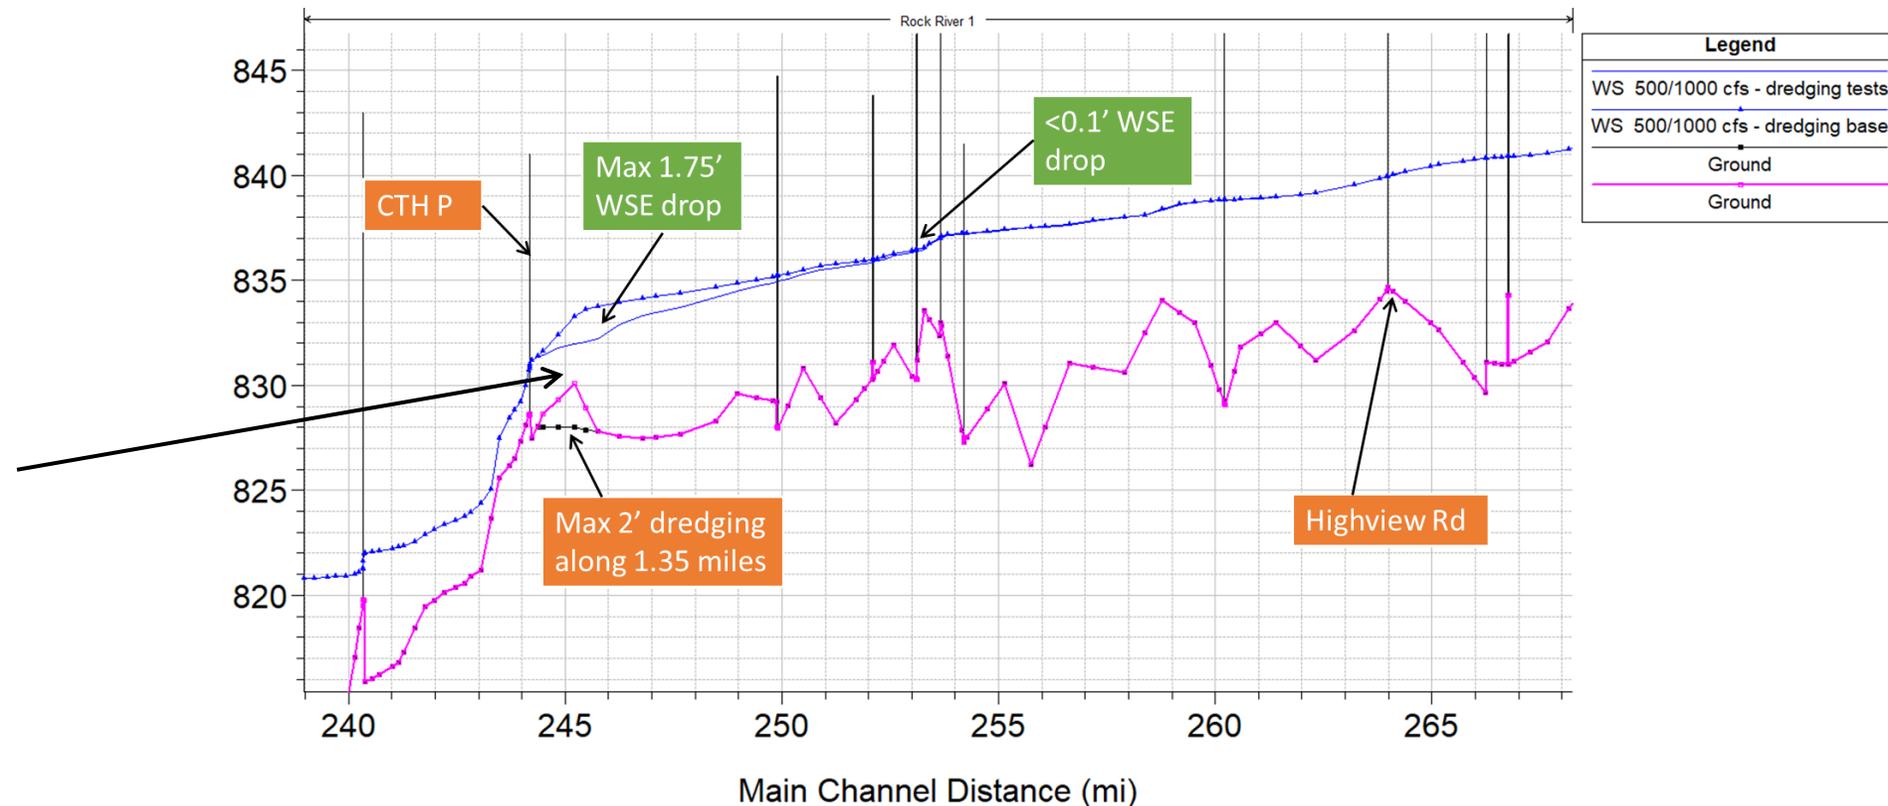
Initial Evaluation on POSSIBLE actions: Downstream channel obstruction removal

There is an island of sediment and logs upstream of CTH P that appears to be blocking flow through the bridge. There are also many “high points” seen in the model’s channel profile along the river sections within the Town of Lebanon that likely slow flow and raise water levels. We briefly analyzed the potential for improving drainage by removing obstructions or otherwise enhancing channel capacity. The purpose of this analysis is not necessarily to say these are feasible or permanent solutions – it is to assess if increasing channel capacity by some means (dredging, bridge widening, blasting rock ledges, etc.) would have an impact, and how far upstream the impact would extend.

Removing the high point upstream of CTH P dropped local upstream water levels considerably (1.75 ft), but the impacts tapered off upstream

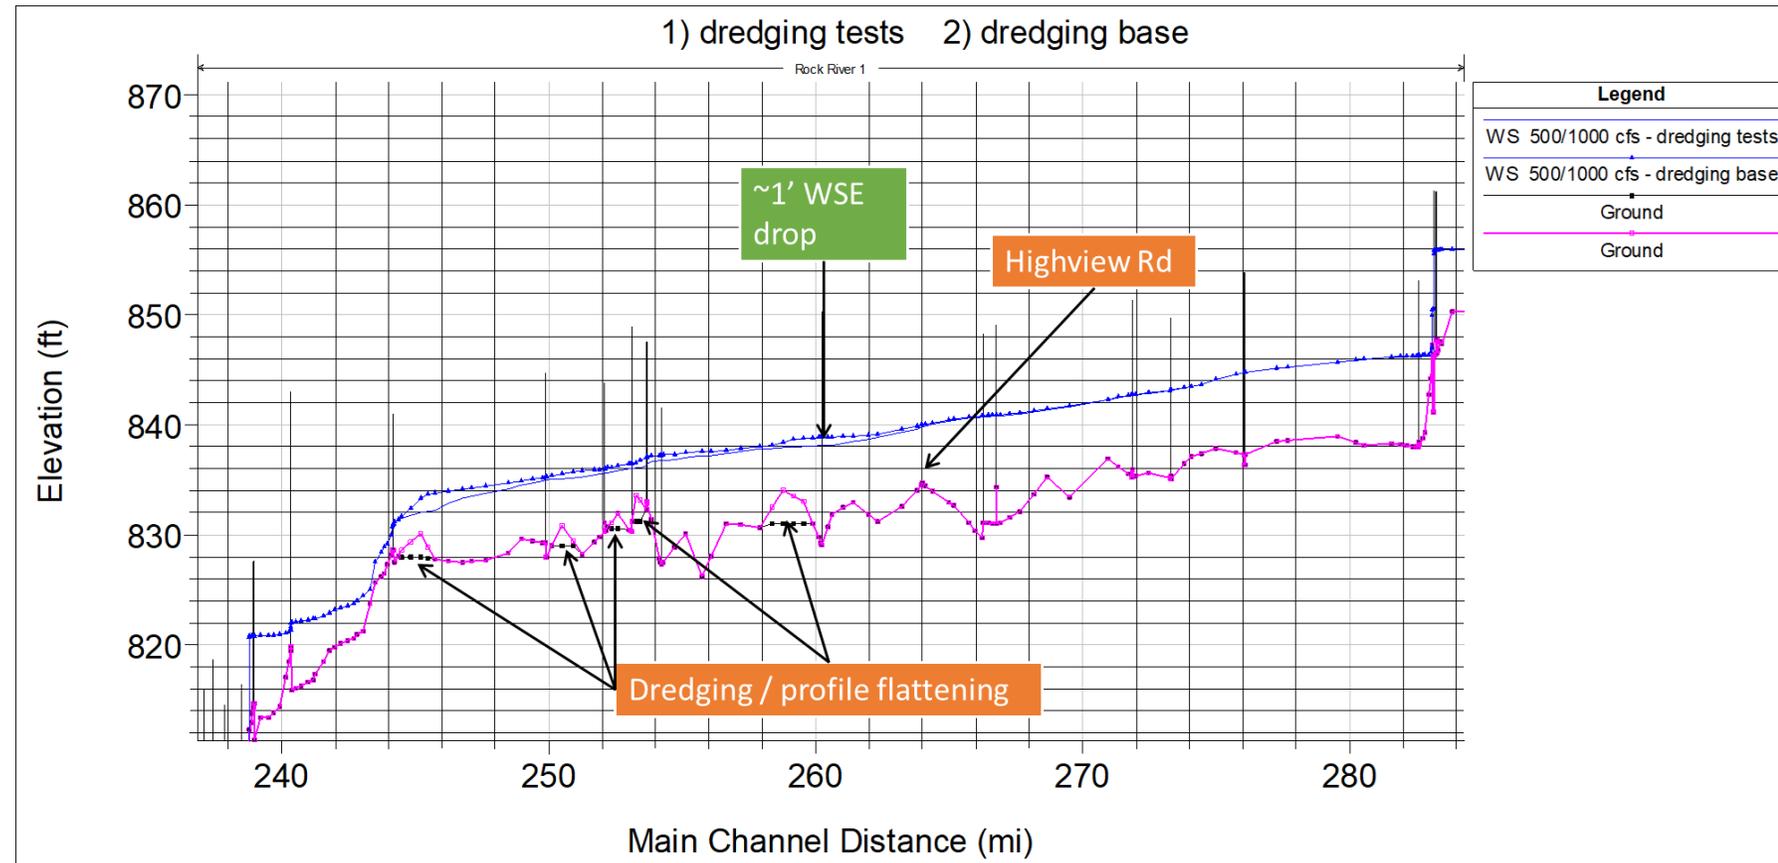
Initial Evaluation on POSSIBLE actions: Channel obstruction removal (cont.)

We removed more channel high points upstream, but impacts were still usually local and did not result in a substantial cumulative lowering throughout the river section.

It doesn't seem that identifying a single bridge constriction or channel obstruction will solve the problem, since the channel overall will still have a very low slope.

But there may be opportunities, like removing obstructions near bridges or designing any bridge replacement projects to have more low-flow capacity, that could start to provide cumulative improvements.
