FUNCTIONAL DESIGN REPORT

Resurfacing and Related Work on Route 9 Ware Town Line to Pierce Road

West Brookfield, Massachusetts

Project File No. 606517

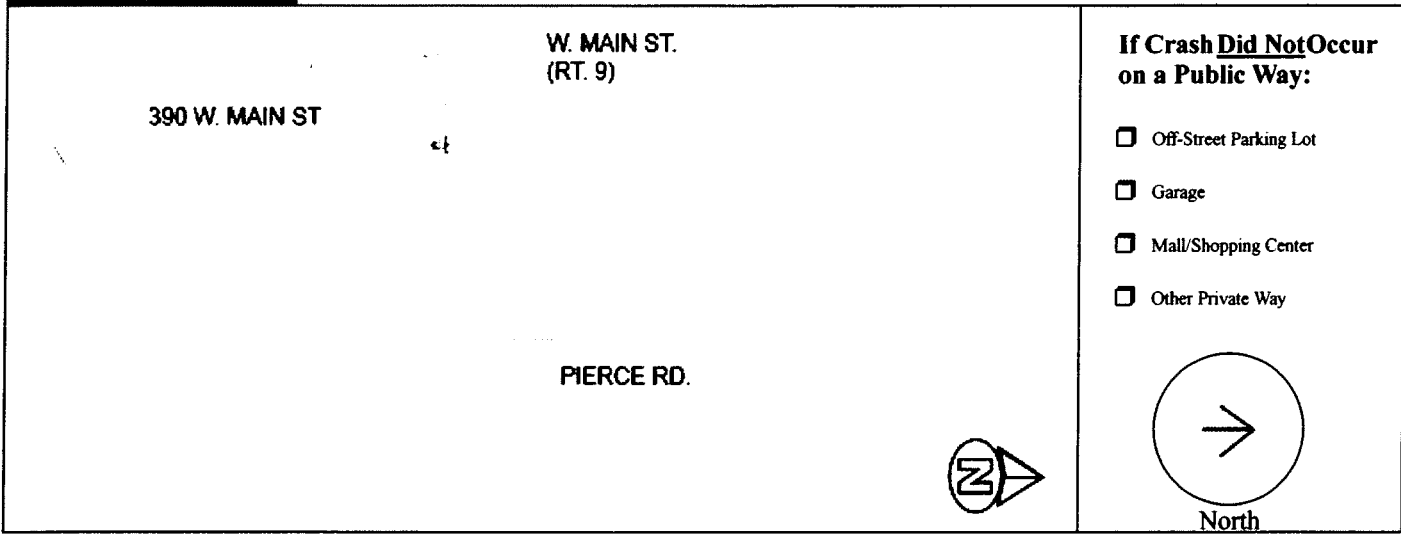
Crash Diagram:

Vehicle one was operating e/b on Route 9 (W. Main ST) when op attempted to break for vehicles ahead. Stated that his rear end began to sway and the m/c began to slide along roadway on its side, coming to rest ifo 390 W. Main st. Officer observed approximately 60' of scrape marks.

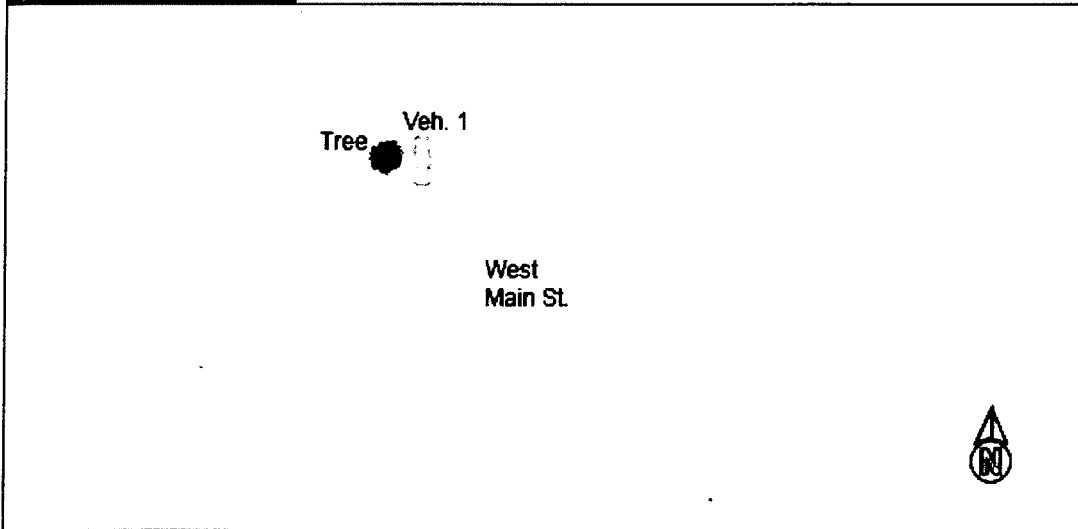
Crash Diagram:

Vehicle 1 was traveling on West Main Street when, due to the windy weather conditions, a branch from one of the trees along the roadway dropped a large branch onto the operators truck causing extensive damage to the bed and cab of the truck.

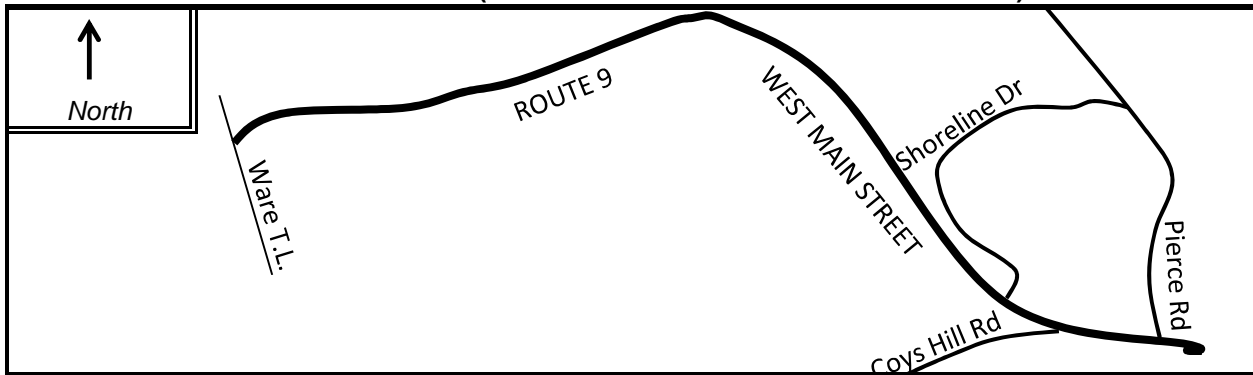
ROADWAY DIAGRAM (LABEL ROADWAY AND CROSS STREETS)

SEGMENT LENGTH IN MILES (L):	2.1
AVERAGE DAILY TRAFFIC VOLUME (V):	5,350

Comments : Crash rate on Route 9 approximately 3.5 times normal crash rate of 0.41

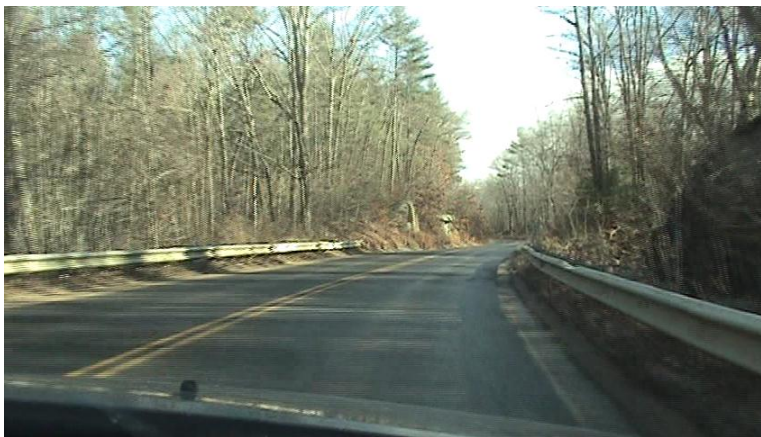
Route 9 Eastbound – Typical Roadway Cross Section

The project corridor is mostly undeveloped with wooded areas and steep slopes or rock ledge outcroppings at the edge of roadway. The Rock House Reservation is a 196-acre open space preserve on the north side of Route 9 within the project limits, and some residential properties are found at the eastern end of the project. Route 9 provides a single travel lane in each direction separated by a double yellow

centerline. A solid white edge line is provided in each direction with an edge offset varying between one and two feet, although the edge line and offset are often covered with sand or other runoff debris at the roadway edge. Guardrail is provided along much of the project corridor due to the steep side slopes. The total roadway width varies but is as narrow as 23 feet at certain points. This narrow cross section provides little recovery area for errant vehicles, and provides no room for vehicles to pull over to allow an emergency vehicle to pass. It was noted that this segment of Route 9 is the primary access route from West Brookfield to Baystate Mary Lane Hospital in Ware.

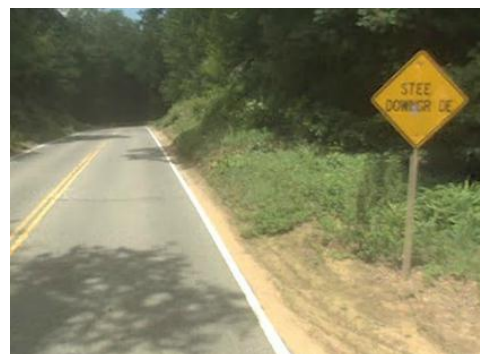
Substandard existing sign

- There is limited existing advance signage for curves and grades along the roadway, and what is provided appears to be older, faded and is not likely reflective at night.
- No chevron signage is provided on curves along the corridor. Town personnel noted that chevron signs have been posted but quickly get knocked down or stolen.

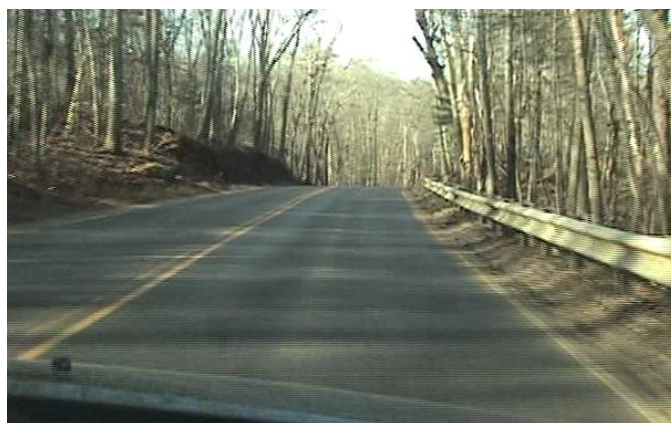
Edge Lines obstructed by sand

- Pavement Markings – Pavement markings are faded and are assumed to not be reflective at night. It was noted that centerline markings are typically repainted each year in the spring. Edge lines are faded and covered in sand, dirt and debris in many areas.
- Animals – It was noted that four recent crashes that are not included in the twelve reported crashes involved animal strikes (three deer and one moose).
