Restoring Migratory Species and Habitat in Maine

Sabattus River

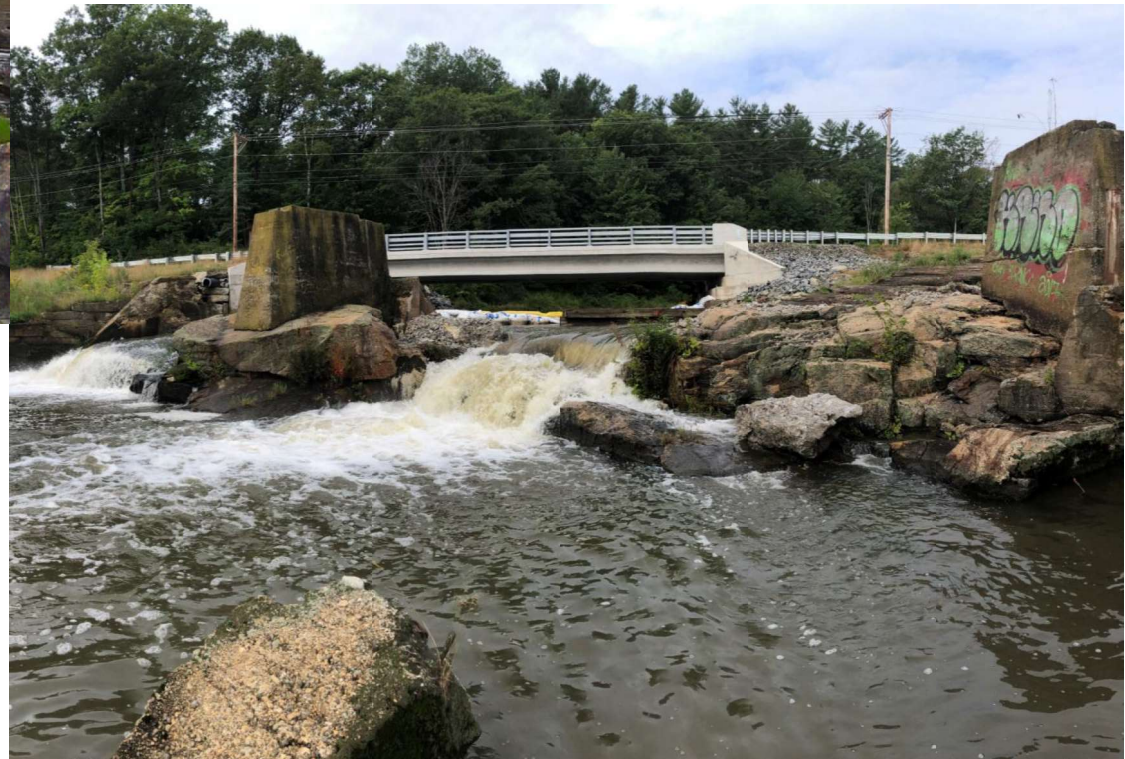
Farnsworth/ Joliet/ Mill Street

- DEP removed mercury from the stream in 2019
- DMR removed the dam at the same time to lower water levels and allow for mercury removal
- DMR is working at the site again in 2024 to remove concrete and improve passage

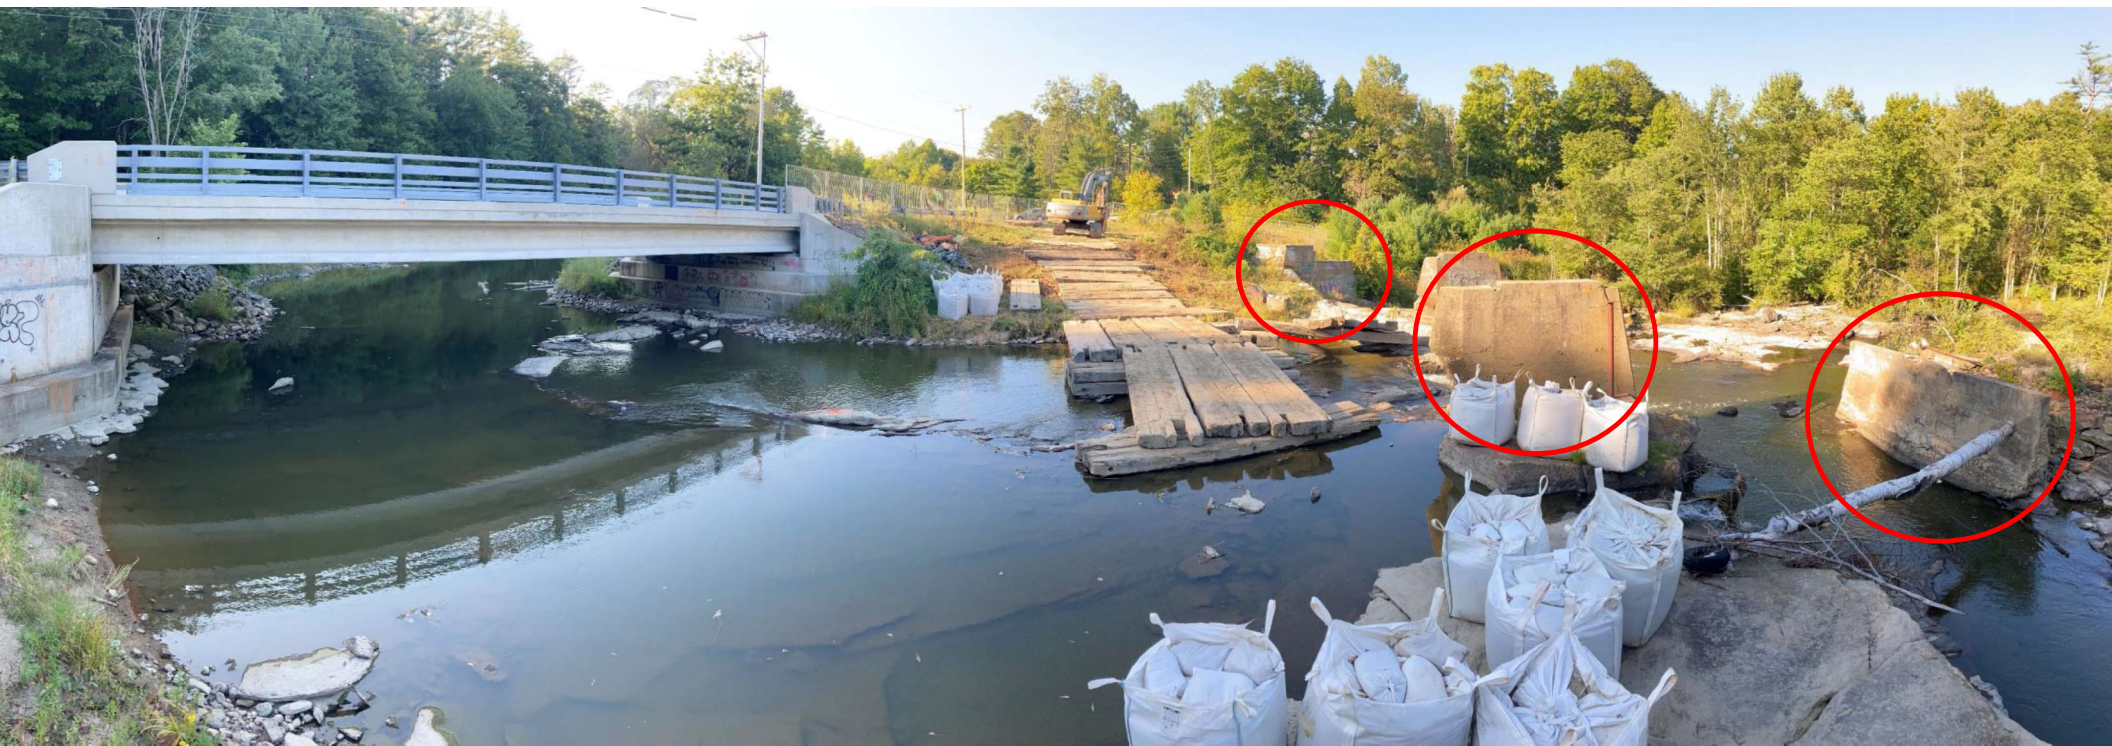
Farnsworth/ Joliet/ Mill Street

DMR is working at the site again in 2024 to remove concrete and improve passage

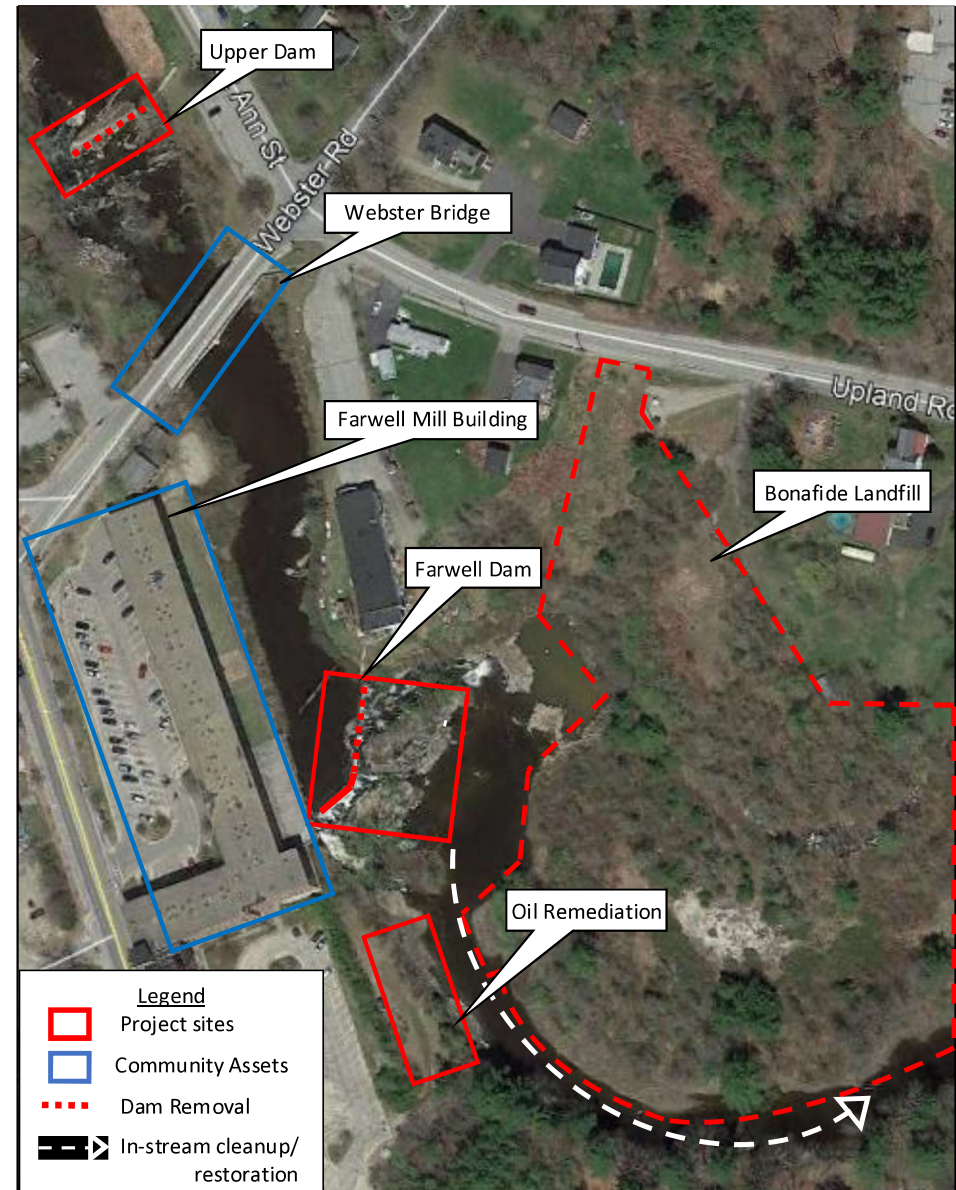
Farwell Dam and Bonafide Landfill

- 1) Farwell Dam
Partial Dam removal and construction of a fishway
- 2) No 6 Oil Remediation
Stream cleanup, streambank restoration, and appropriate landfill cleanup and closure
- 3) Bonafide Landfill
Stream cleanup, streambank restoration, and appropriate landfill cleanup and closure

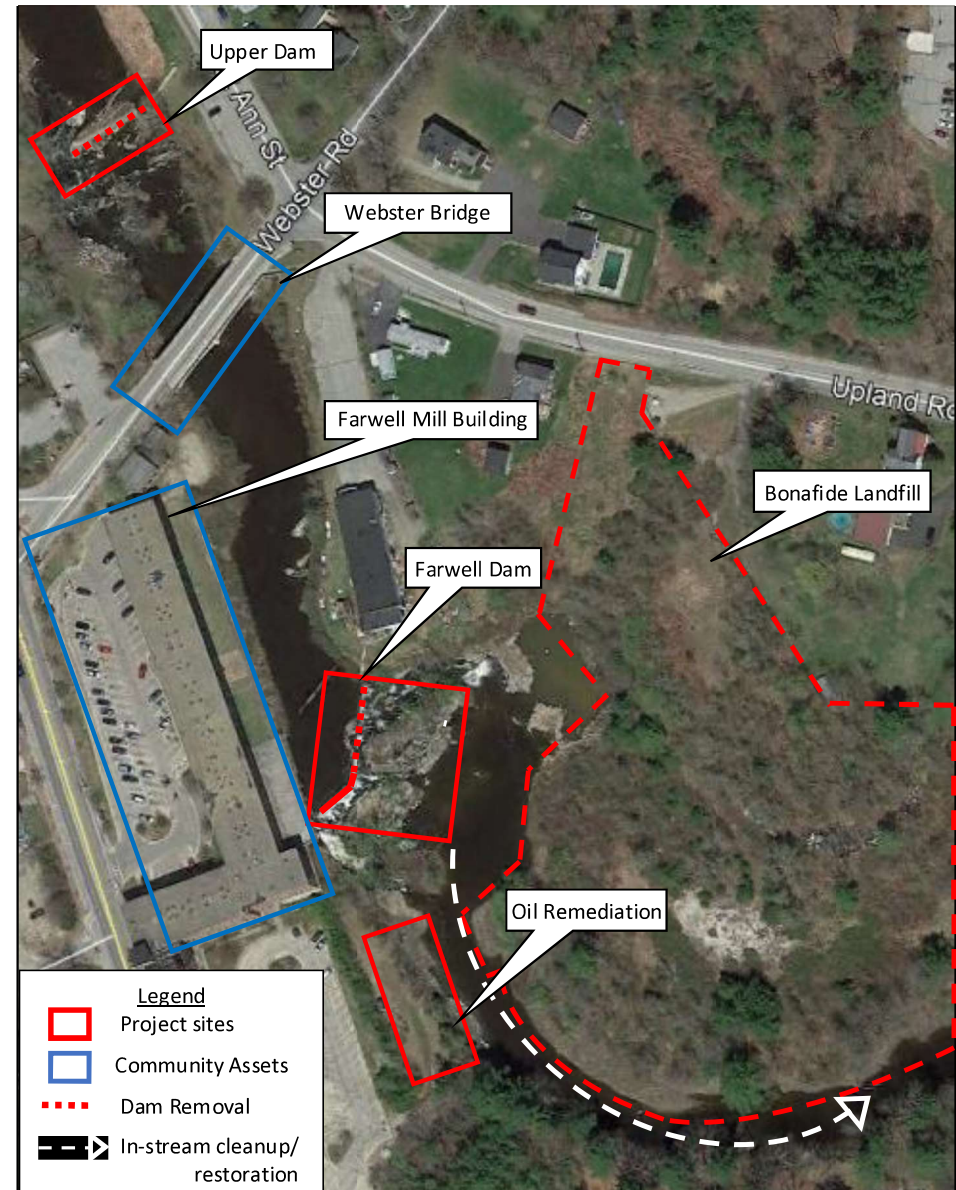
Farwell Dam and Bonafide Landfill

Dam removal and fishway construction in tandem with cleanup of landfill and streambed

- River is likely not in historic channel
- Dam is structurally tied to Farwell Mill Building and spillway is under the building
- Bonafide Landfill cleanup/closure overlaps with fishway location

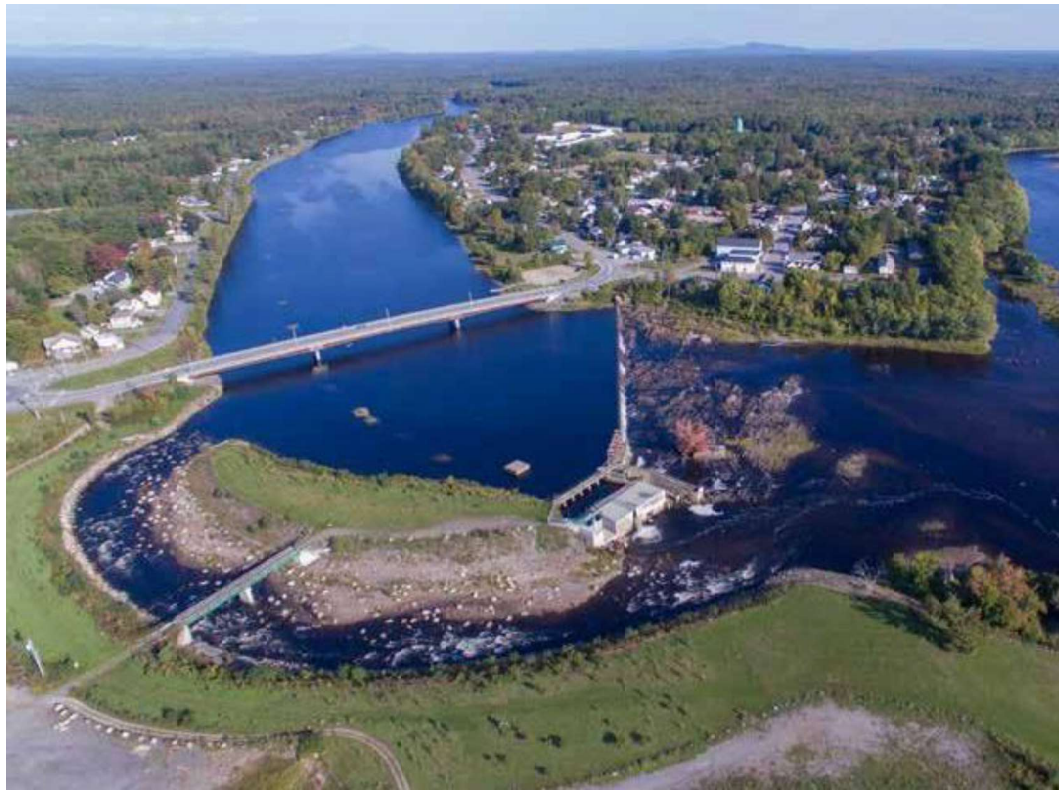
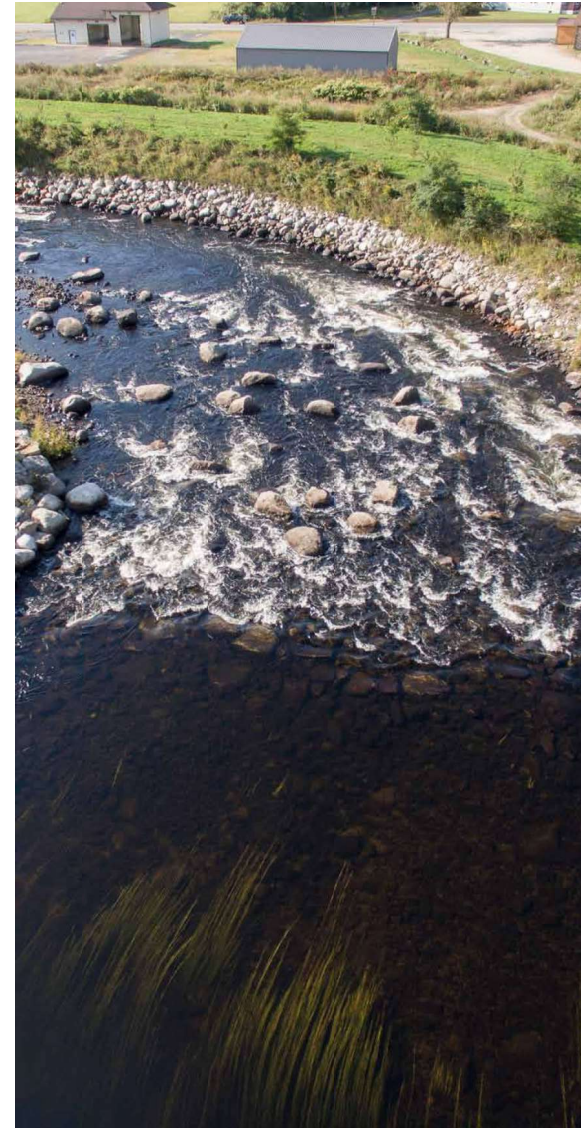
Nature-Like Fishway Example

Photos by Inter-Fluve of the Howland Nature-like Fishway. The fishway was designed to pass fish, to be stable during flood events, and includes public access.

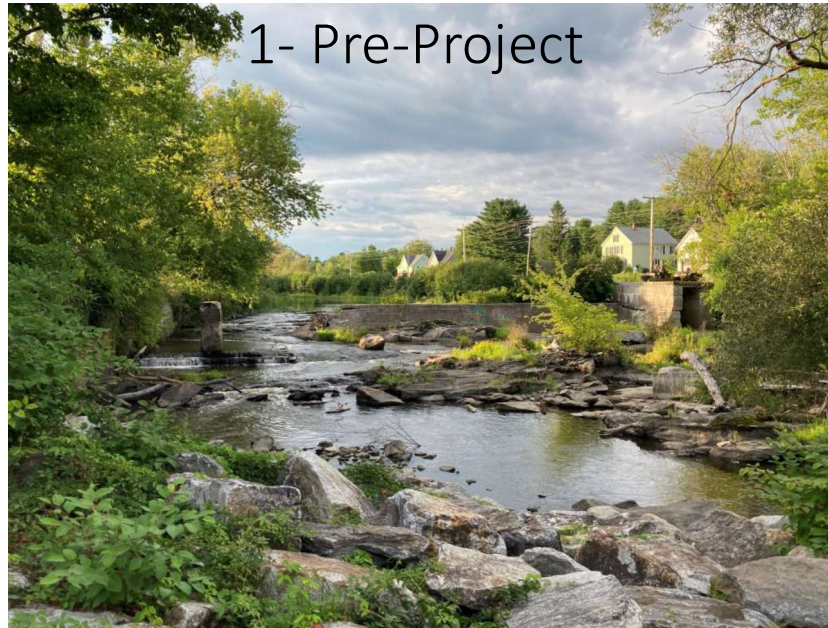
1- Pre-Project

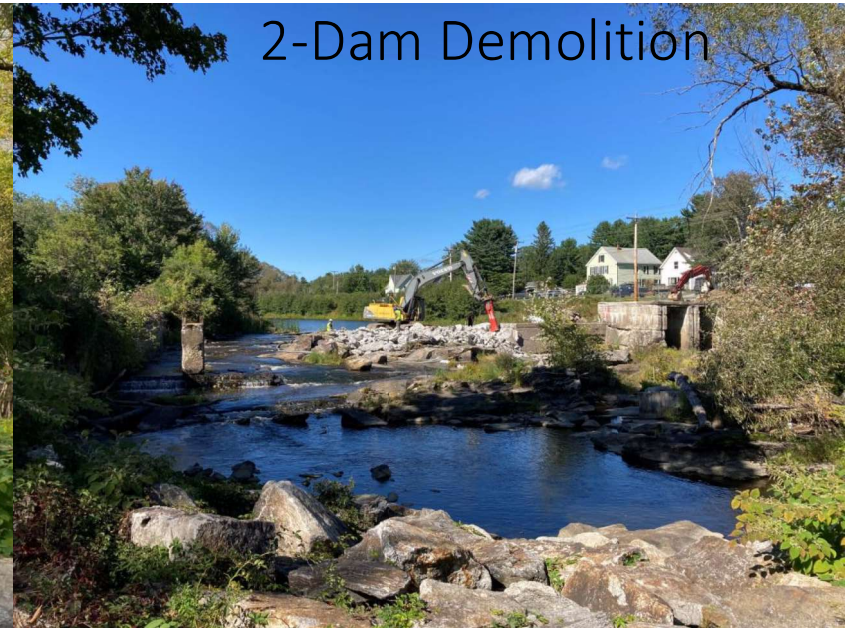
2-Dam Demolition

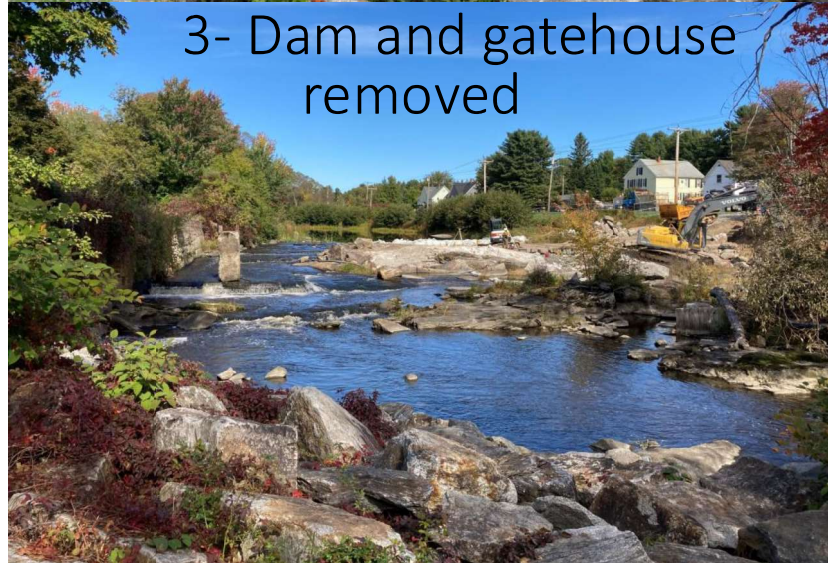
3- Dam and gatehouse removed

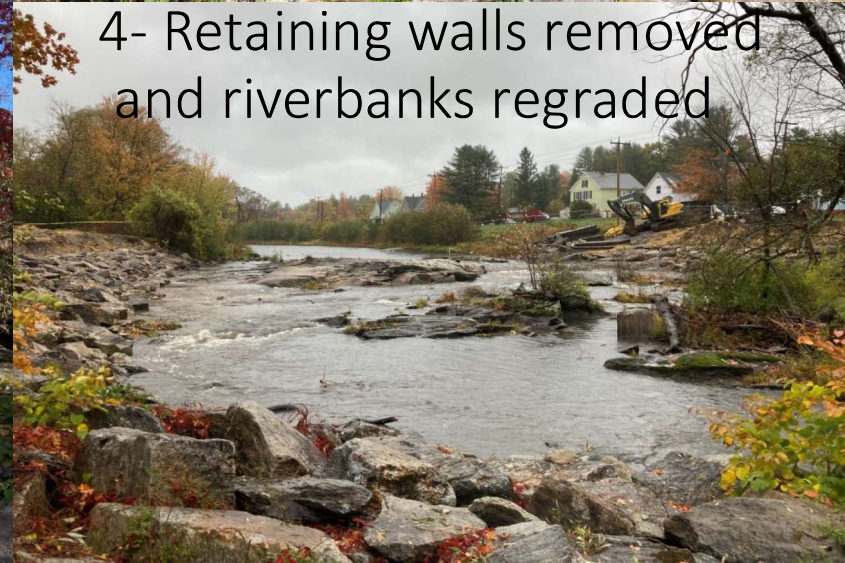
4- Retaining walls removed and riverbanks regraded

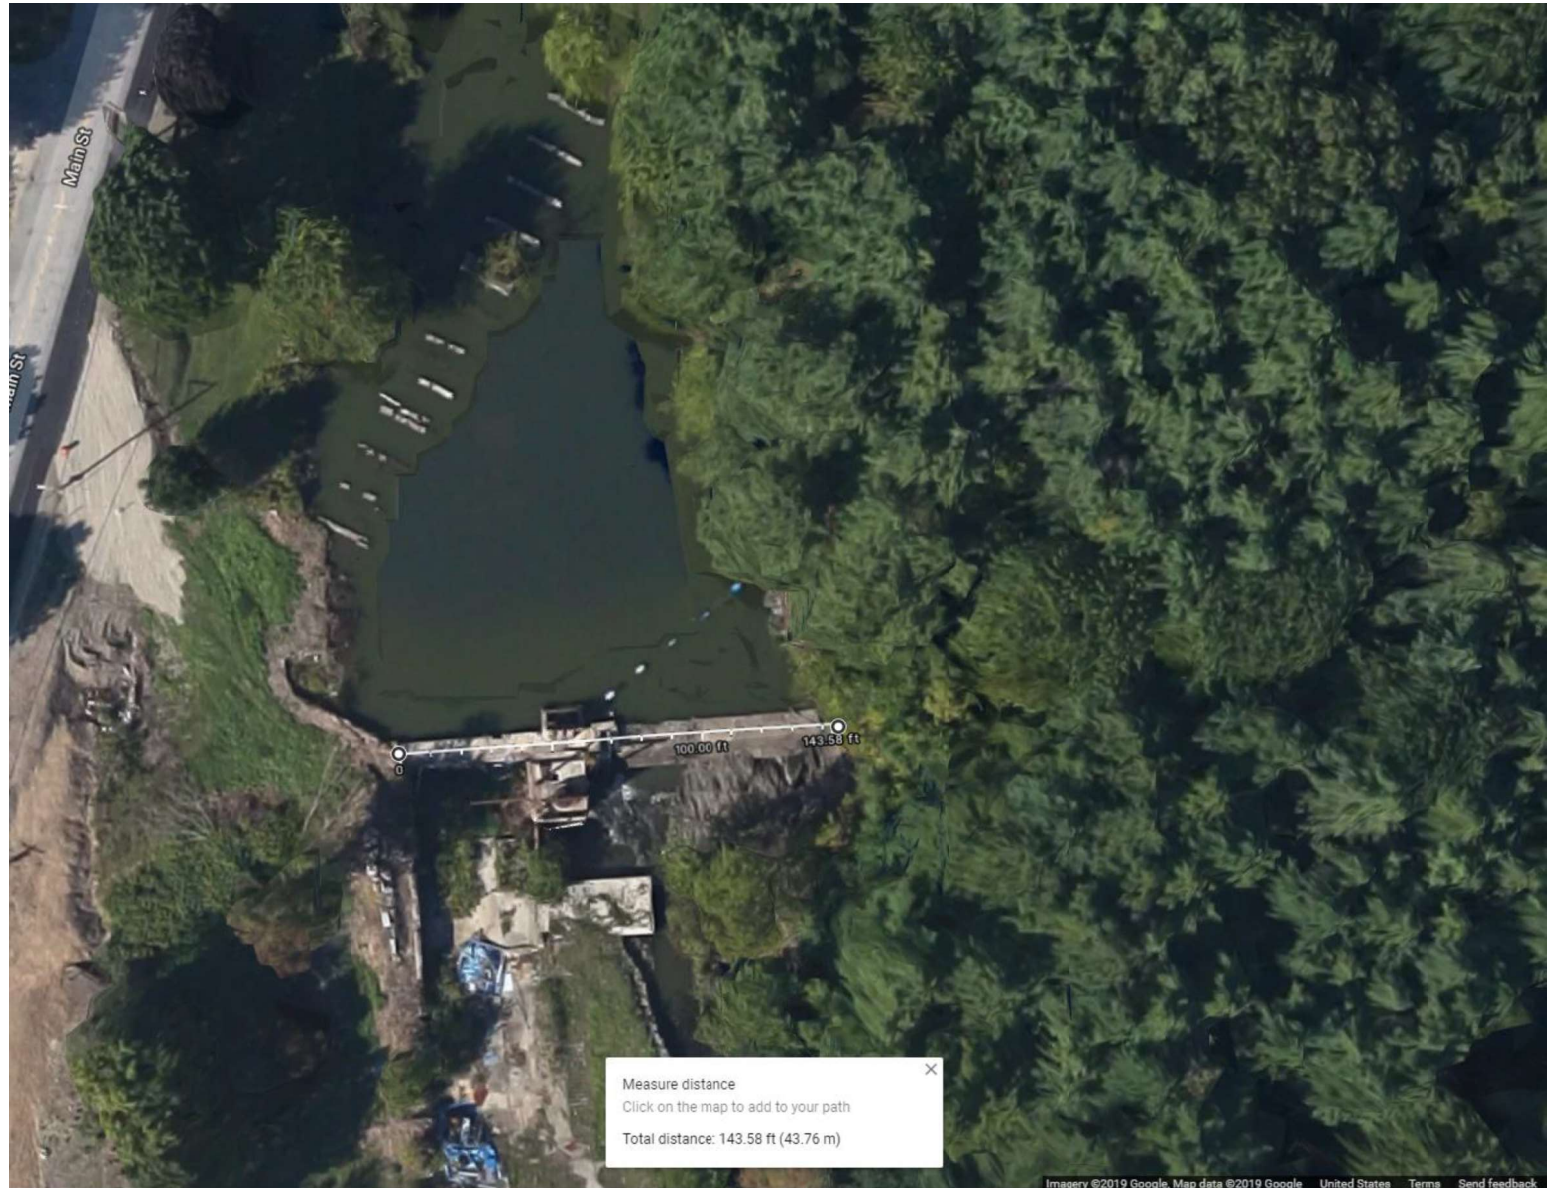
Mill Pond (Main Street) Dam

- Dam, concrete deck, and abutments to be removed
- Riverbed to be regraded, stabilized using stone and native vegetation
- Dam safety issues to be addressed
- Sediment to be tested for contamination and removed as needed
- Upper pond area to revert to natural wetland/river conditions
 - o MDIFW Consultation has been initiated
 - o MNAP wetland mapping/review has been requested

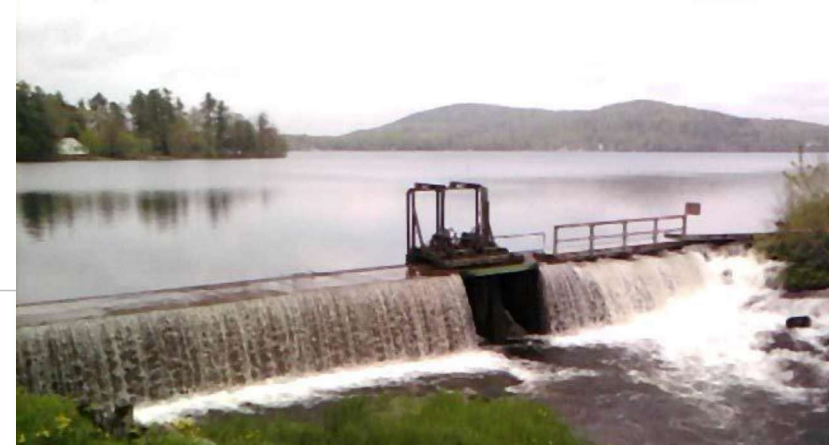
Sleeper Dam

Upgrades to the dam and new fishway

Upgrades include:

1. Buttresses
2. New concrete cap
3. New gates
4. New concrete spillway

Upgrades will not change water levels
