Village of Ontonagon Drinking Water State Revolving Fund Project Plan

WICKWIRE, P.C. 715 Selden Road Iron River, MI 49935 Office: 906-265-9865

Ontonagon Regional Water System Water System Improvements Drinking Water State Revolving Fund Application

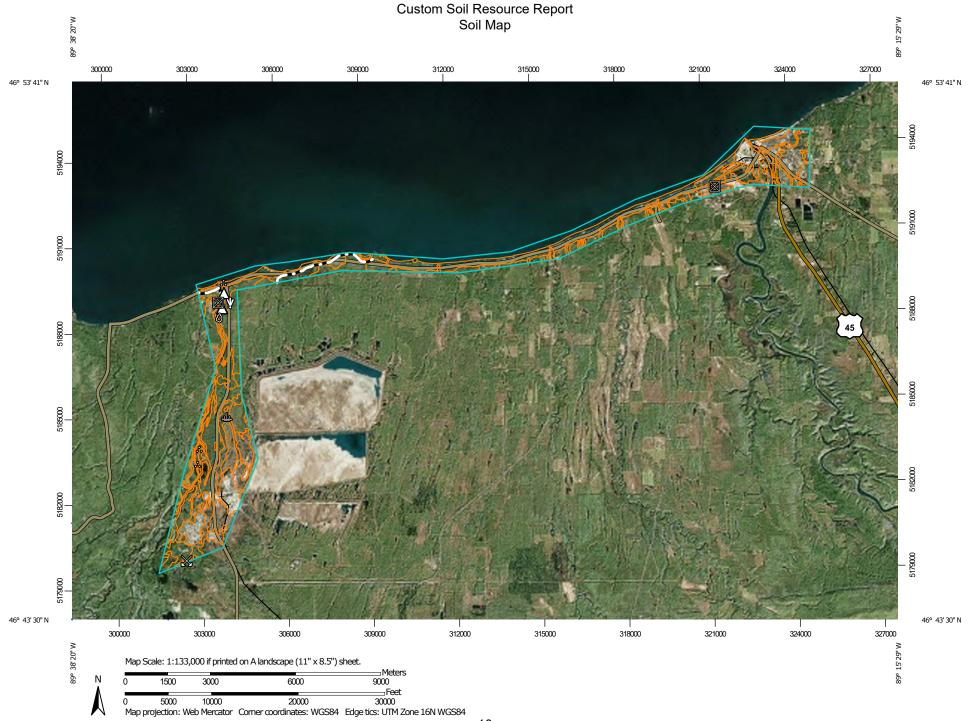
Soil Map

The soil map section includes the soil map for the defined area of interest, a list of soil map units on the map and extent of each map unit, and cartographic symbols displayed on the map. Also presented are various metadata about data used to produce the map, and a description of each soil map unit.

A soil report for the project area generated by the United States Department of Agriculture can be found in Appendix G.
