Wouldn't it be Nice to Never Clean an Ion Source? Ion Source Robustness on the StayClean[®] Ion Source

Lorne M. Fell, Todd S. Richards, and Joseph E. Binkley | LECO Corporation, Saint Joseph, Michigan, USA

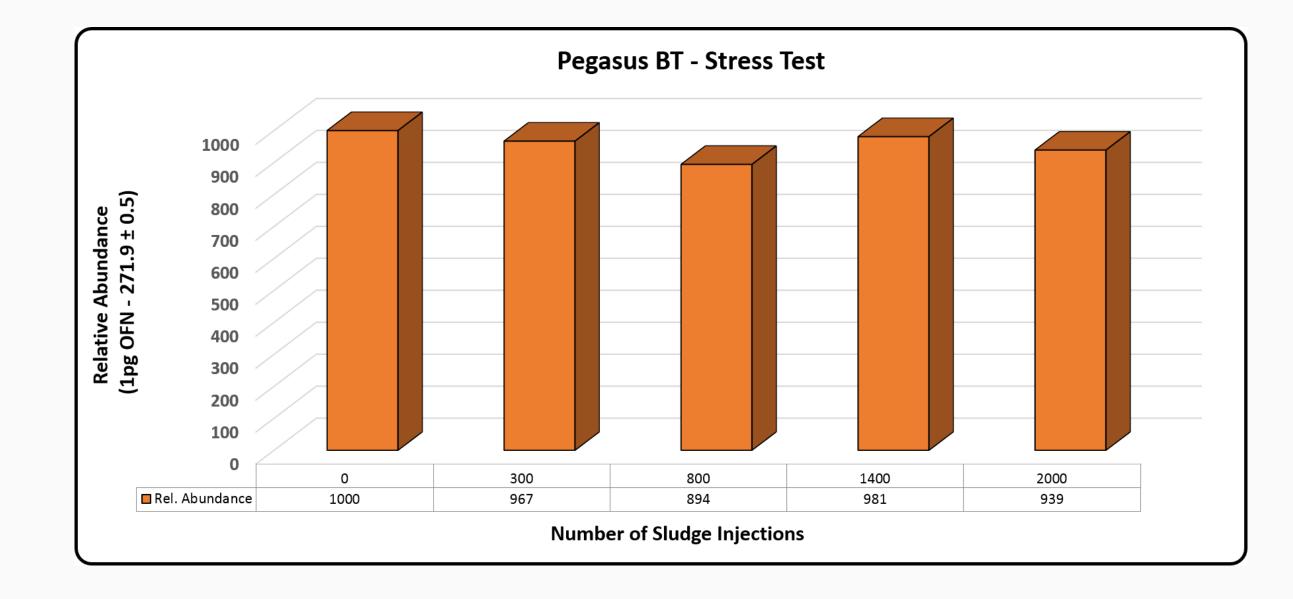
3000 injections

In a separate experiment, raw sludge samples were Soxhlet extracted for 4 hours, the neat extract was diluted 100 fold, and then injected into a StayClean source through an uncoated capillary column. After each set of several hundred sludge extract injections, an analytical column was installed and OFN was injected to monitor sensitivity. As shown in the bar graphs, no performance degradation was observed even after 3000 sludge extract injections.
