## ROCKFALL PROTECTION SYSTEM FOR ROUTE NM1016, KORAT NAKHON RATCHASIMA (AKA KORAT), NAKHON RATCHASIMA PROVINCE, THAILAND

### Dynamic Barriers

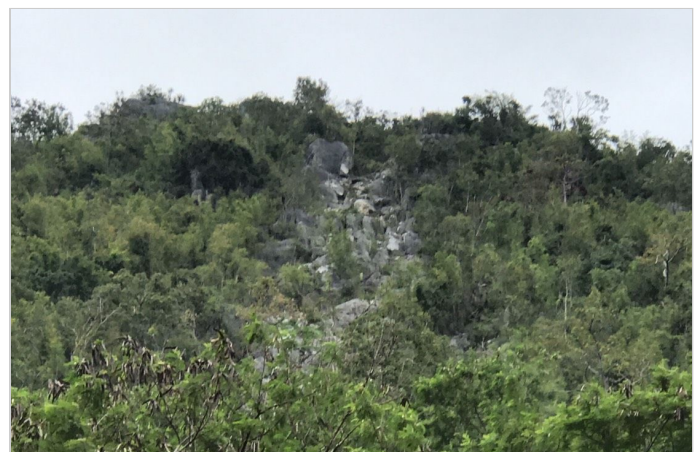
Source of Rockfall (Photo Taken From Road Level)

The source of rockfall is traced back to the point located approximately 160m above road level. The boulder measured about 2.0m x 1.0m x 1.0m fell about 20m to 30m away from slope toe. The impact caused damage to the road pavement. No loss of life or other damages to property was reported.

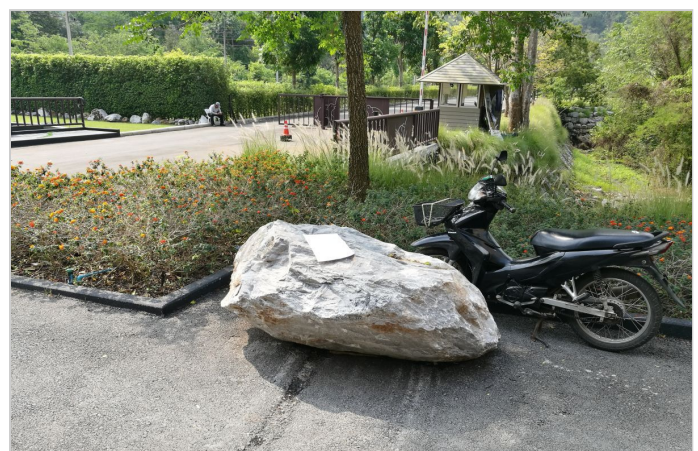
Runway Rockfall Debris Landed at the Other Side of Road

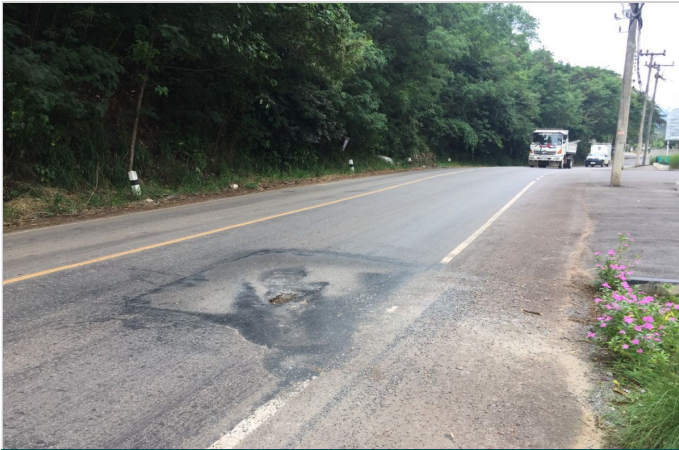
Damaged Pavement Due to Rockfall Debris Impact

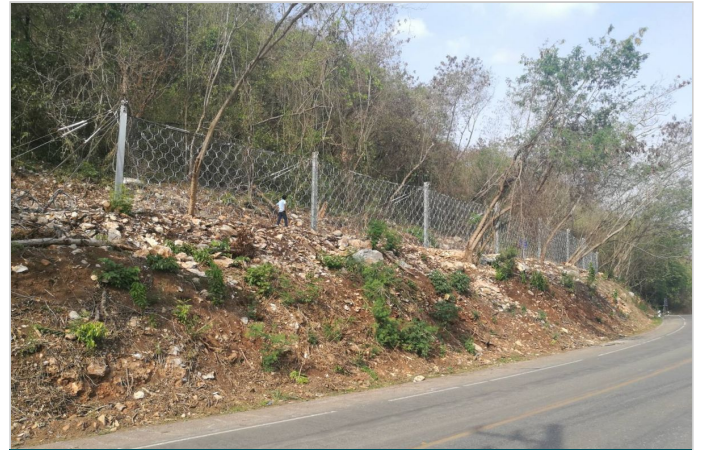
Rockfall Barrier Completed Installation

The location of barrier alignment is easily accessible by the contractor as it is just beside the road. Rockfall barriers come in a prefabricated assembly kit that are easy and fast to install. The installation was completed successfully in a few weeks.

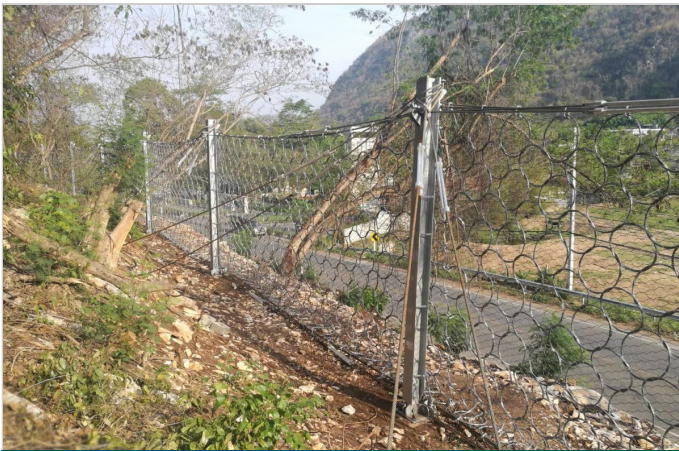
Rockfall Barrier Completed Installation
