## MISSTANBUL RESIDENTIAL PROJECT İSTANBUL, MARMARA, TURKEY

### Mass Gravity Retaining Walls

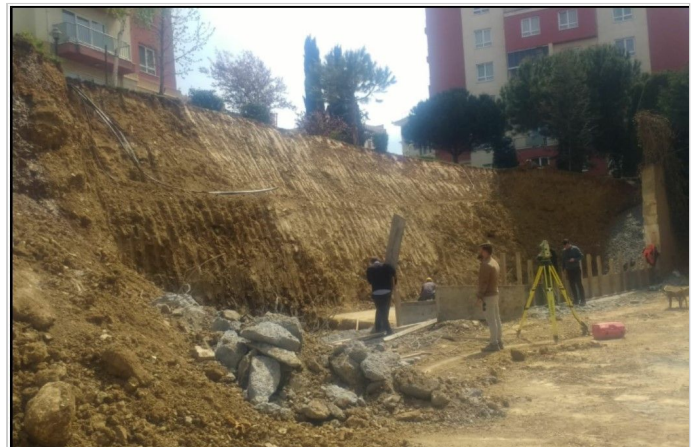
Excavation of the foundation

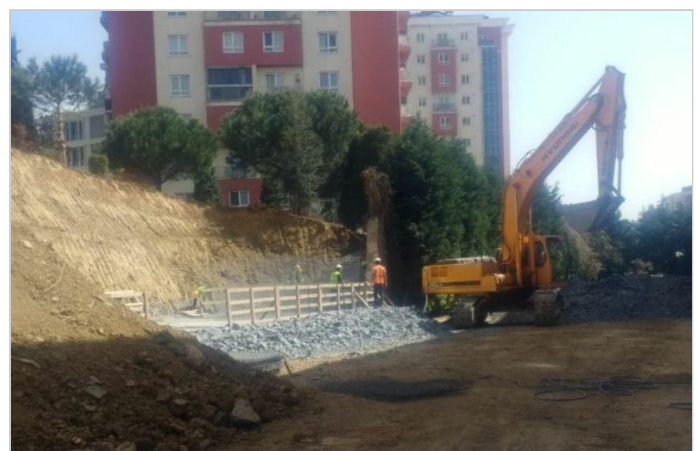
Installation

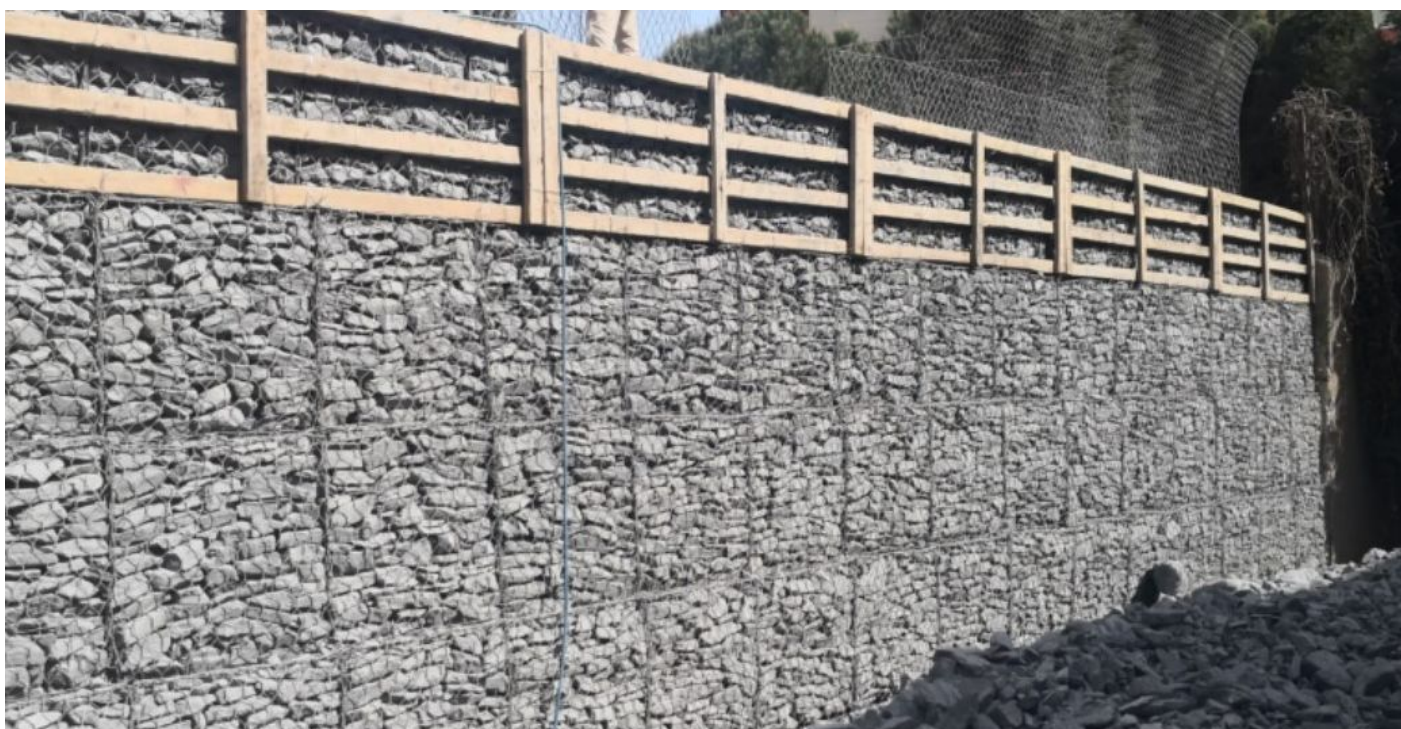
Installation
