## EUSTATIA ISLAND BEACH RESTORATION

### EUSTATIA ISLAND - BRITISH VIRGIN ISLANDS, BRITISH VIRGIN ISLANDS, BRITISH VIRGIN ISLANDS

#### Breakwaters and Groynes

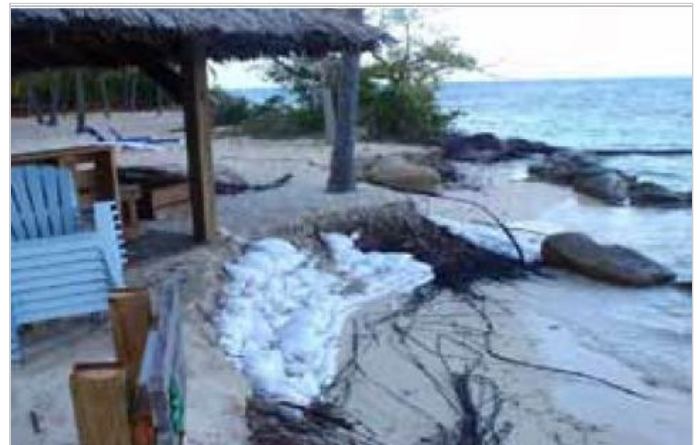
Pre-Project shoreline conditions at dining pavilion

The beach at Eustatia Island was eroding; erosion was progressing at an alarming rate by 2008, threatening upland infrastructures, including the loss of trees. The erosion line got as far as the beach dining pavilion, 20 yards from the original shoreline from a few years prior.

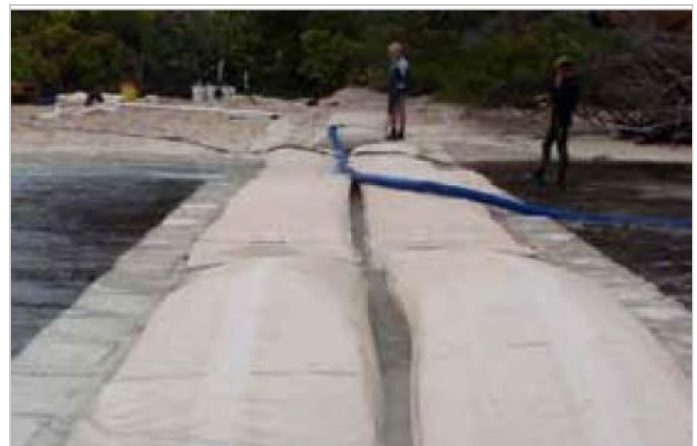
Installation of top row of MacBags on groin

The second design element was a low, sloping wall designed to protect the upland from direct wave attack during storms associated with high water levels. Both design elements relied on sand-filled Maccaferri Macbags as the primary construction material. The two elements acted together to retain upland sand, protect palm trees and beach pavilions, and provide a relatively stable sandy beach. Presently, OCC is executing a monitoring plan that includes beach surveys and aerial photography. The project was tested within months of completion as Hurricane Earl passed directly over the island. Neighboring beaches and properties suffered a great amount of damage, while the owner's beach suffered nearly no detrimental effects. Perhaps the most interesting aspects of this project are that it functions in harmony with the carbonate beach and reef system, is visually non-obtrusive and did not require the carbon footprint typically associated with barging rock or sand to the site. The Eustatia Island Beach Restoration project was the first of its kind in the BVI and "is now the poster child for environmentally favorable beach restoration projects in the BVI" as Michael Hahn (property/project owner) has put it. This project has won the 2011 COPRI Project Excellence Award.

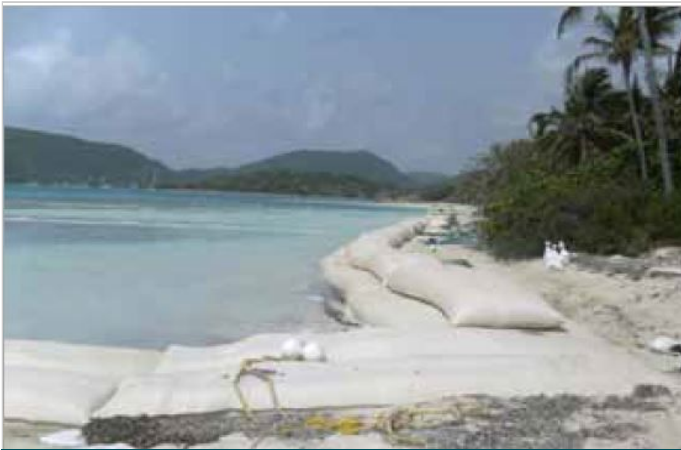
Revetment and groin with MacBags during construction

The preferred design alternative was a very low profile groin to allow regeneration of the beach through retention of sand migrating in from the reef. During the permitting phase, however, erosion progressed, prompting the need for a revetment to be added to the design. The final design of this project incorporated a groin field consisting of 9 low profile groins designed to reduce oblique wave energy and retain sand in the area of influence of the groins. During storms it is likely that sand will be lost from the beach, but the groins will act to rebuild the beach width to its pre-storm equilibrium.

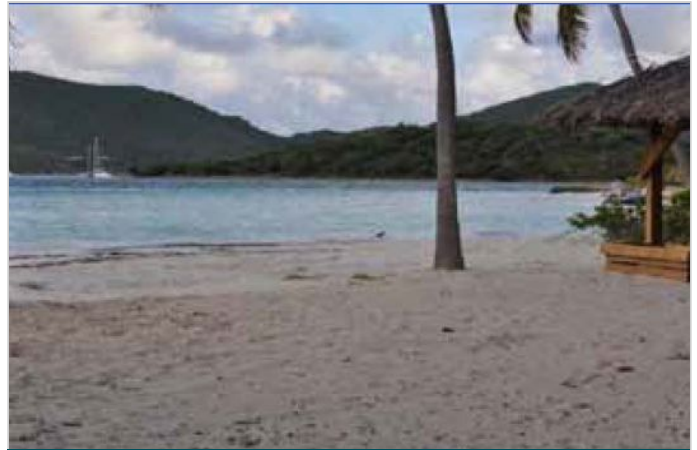
Condition of beach 5 months post construction

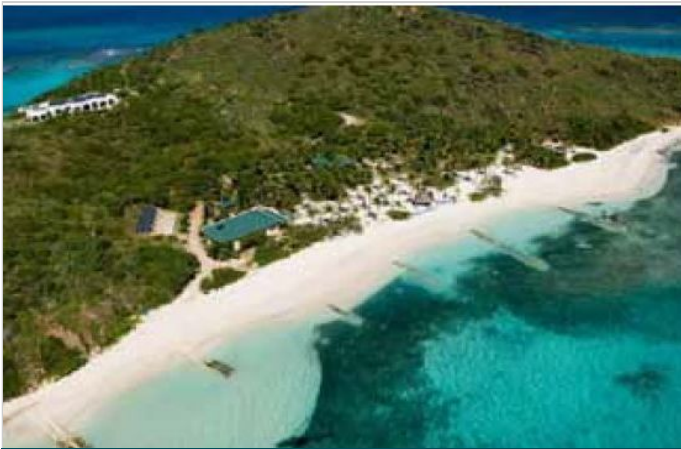
Aerial photo of February 2011 monitoring period
