## DUDLEY WARD ROAD REOPENING

### DUDLEY WARD WAY, GIBRALTAR, UNITED KINGDOM

#### Dynamic Barriers

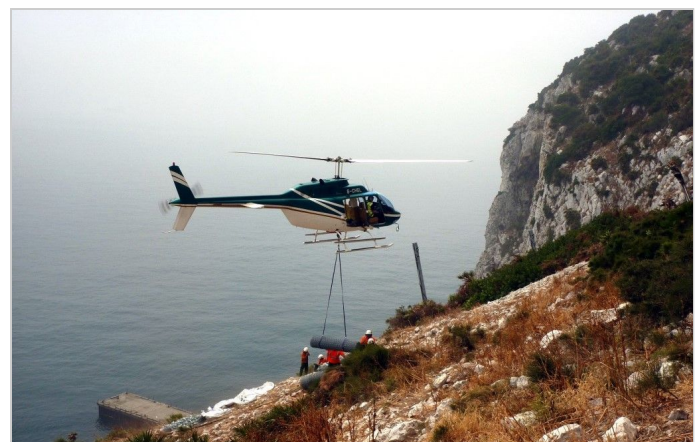
Rolls of debris mesh being lifted to project site

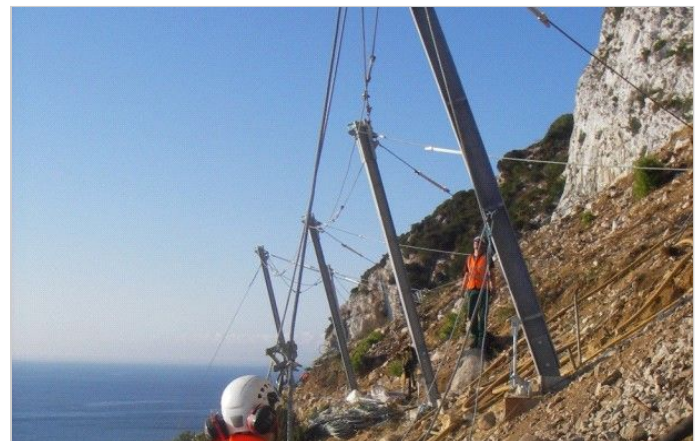
Raising catch fence posts into position

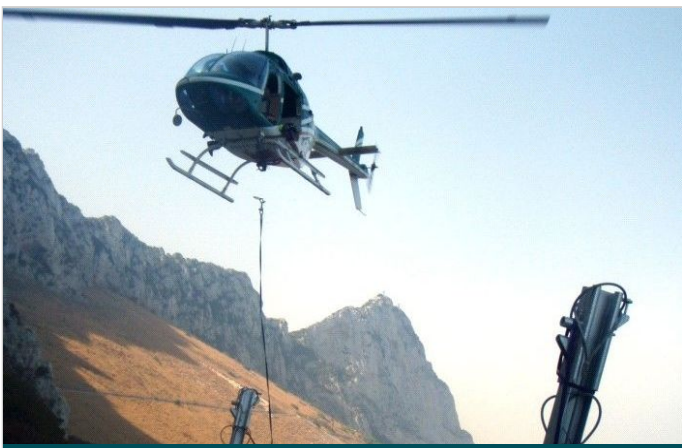
Using helicopters to lift posts into position

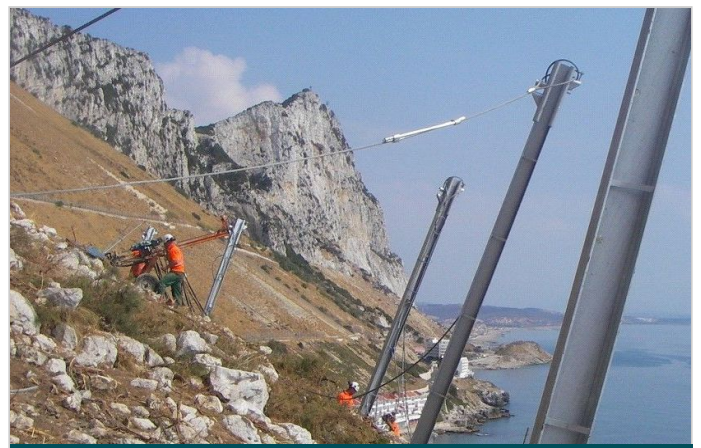
Erecting catch fence posts / drilling anchors

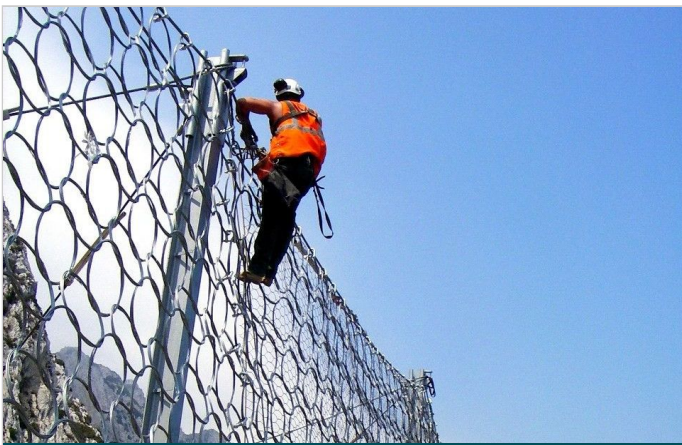
Securing main absorption panels to upper cables and posts

Maccaferri supplied their OM CTR 30/04/A 5m high catch fences to the project, capable of withstanding 3000kj maximum energy level impacts, or multiple lower energy impacts. This is one of the highest capacity barriers within the Maccaferri range from 500kj to 5000kj fences which is the equivalent of stopping a 16.5-tonne lorry travelling at 57mph.
