**EROSION PROTECTION WORKS ALONG BANKS OF
BRAHMAPUTRA RIVER
ROHMORIA, ASSAM, INDIA**

Longitudinal Protection

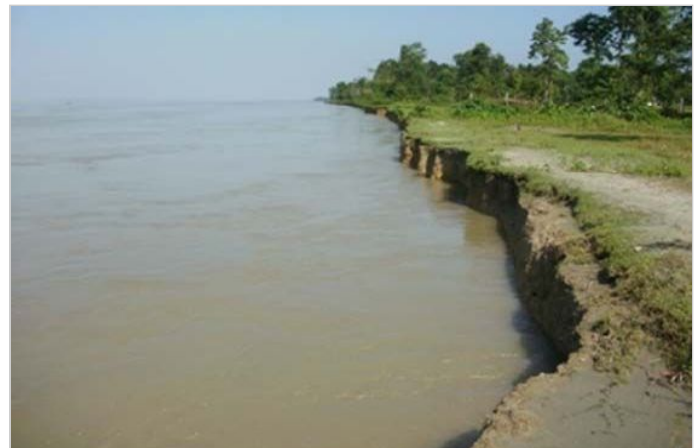
Photo 1: Scouring of the banks of Brahmaputra river

Brahmaputra River is one of the major and highly aggressive rivers in Asia. It flows through China, India and Bangladesh. In India, it enters North East state of Arunachal Pradesh and then widens as high as 10km in the state of Assam. Over the past 20 years, the river has destroyed many paddy fields, homes, schools and plantations in the village of Rohmoria.

Rohmoria located in the upper reaches of the Brahmaputra River in Assam, is an area most severely affected by river erosion. The area has witnessed erosion for the last sixty years and more than 25 villages have been wiped out by erosion.

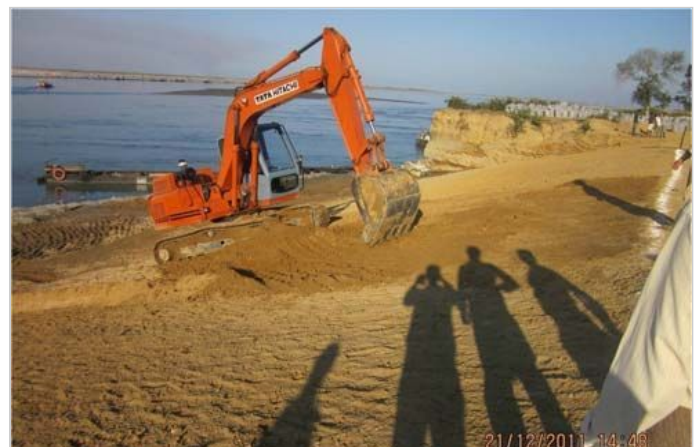
Photo 2: Dressing of slope during construction

The height of slope was approximately 5.5m. The bank and bed protection were carried with MacBag® placed on a geotextile filter layer.

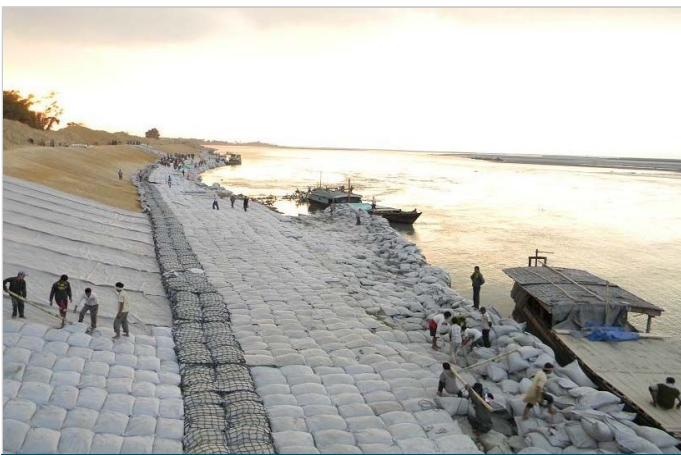
Photo 3: Placement of MacBag® on the river bank

Water Resource Department suggested the use of MacBag® for the bank protection, which is one of the most practical and viable solutions. Maccaferri's MacBag® is a geotextile bag filled with sand and commonly adopted for hydraulic protection works. These geotextile bags are produced from either woven or non-woven polypropylene geotextile or non-woven polyester geotextile.

Peripheral strips of steel gabion and PP rope gabions filled with layers of geotextile bags were placed at regular intervals to impart further stability to the scour protection measure.

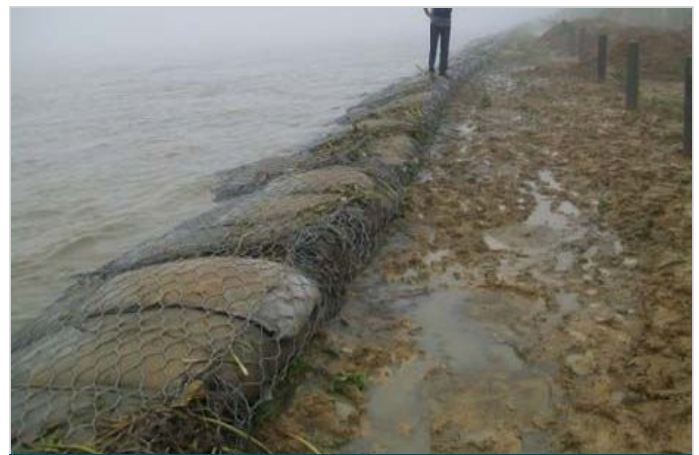
Photo 4: Condition of MacBag® and river bank during flood

In June 2012, major floods occurred in Assam and the anti-erosion work was totally submerged under water and in some parts flood water passed over the protection work. The erosion protection measures constructed with MacBag® survived the flood and protected the banks. After flood, considerable amount of silt deposits was noted which is an indication of success of anti-erosion works along the river banks.

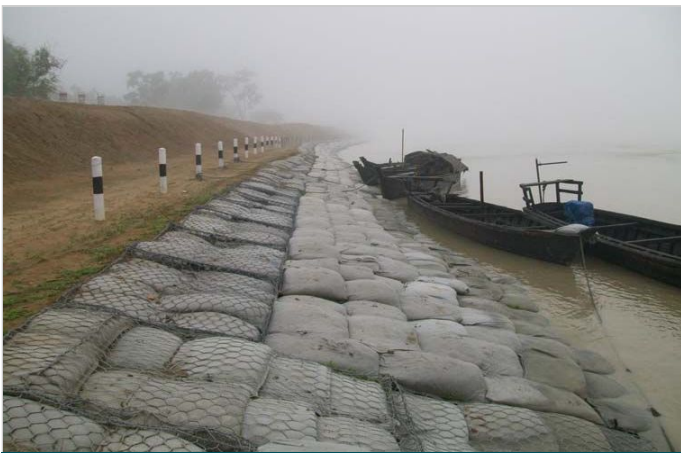
Photo 5: Condition of MacBag® and river bank after flood

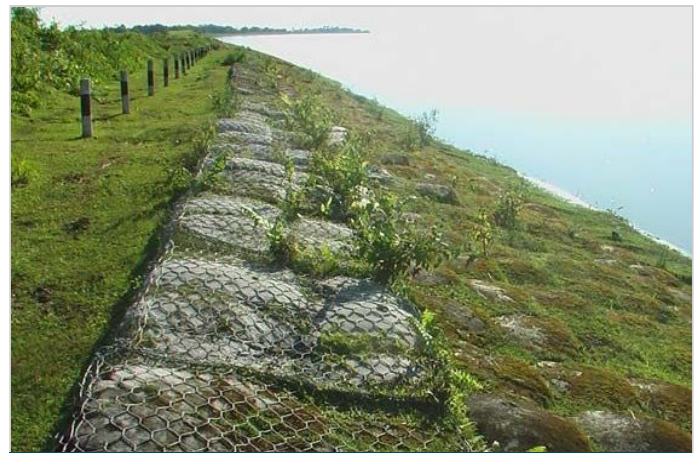
Photo 6: Condition of MacBag® after 2 years
