## A2 DOWNHILL COLERAINE, NORTHERN IRELAND, UNITED KINGDOM

### Dynamic Barriers

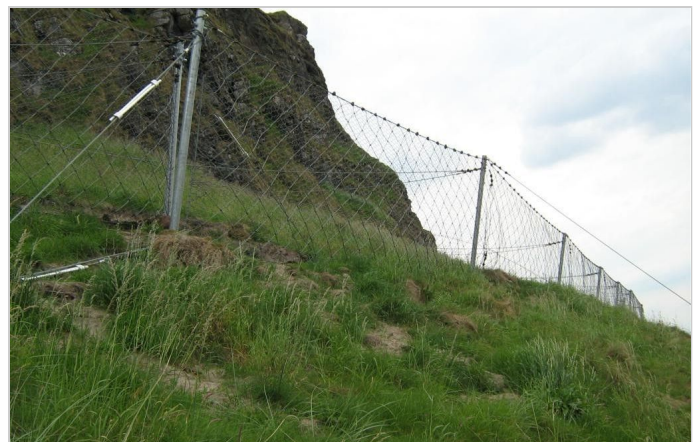
View of the catch fence installed

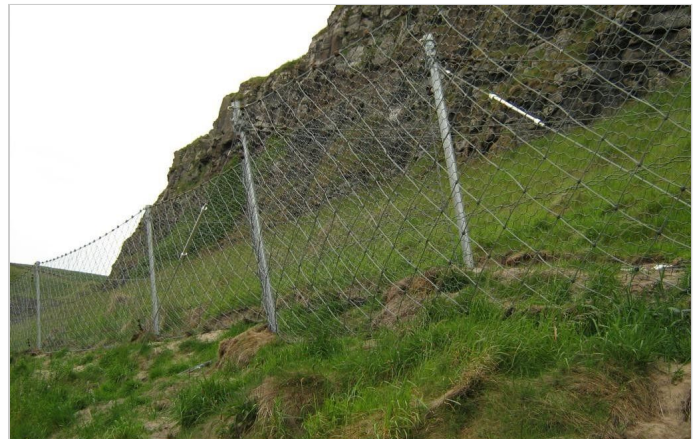
View of the catch fence installed
