**NICOLOSI DRIVE GABION WALL**  
**STATEN ISLAND, NEW YORK, U.S.A.****Slope Protection****Problem**

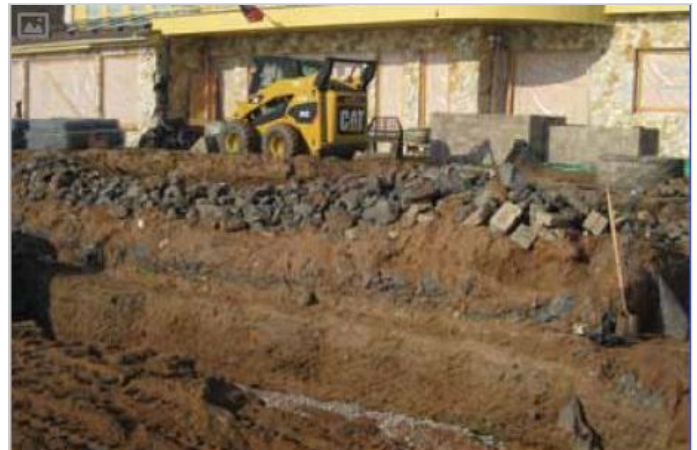
Gabion wall under construction

The solution was to add to the front of the existing gabion wall, widening its footprint so the wall's overall height could be increased from 9' to 12'. It was during this time that the wall was also extended in length to shield and protect the adjacent property.

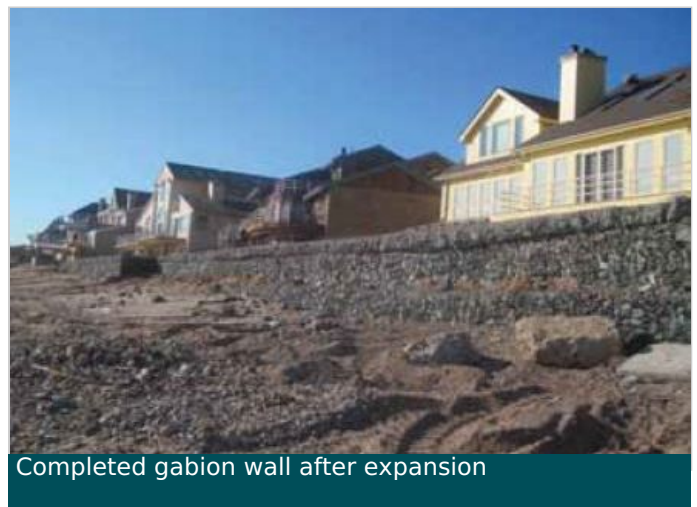
Completed gabion wall after expansion
