CATO MANOR PIPELINE & ROAD PROTECTION

BELLAIR ROAD, CATO MANOR, KZN, SOUTH AFRICA

Soil Veneer Applications

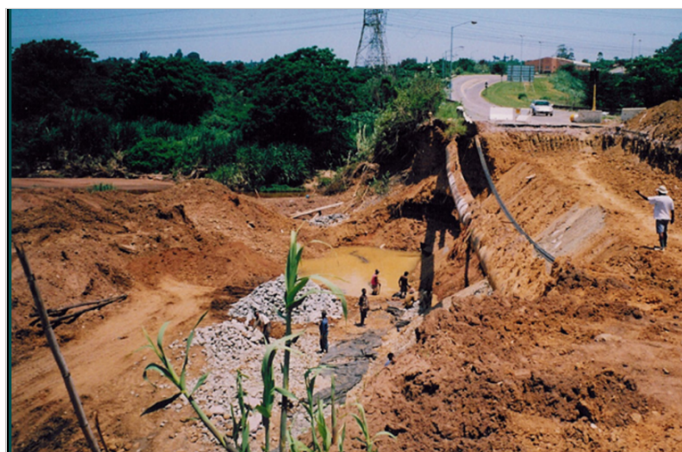
Before construction

Heavy rains experienced during October 1999, caused the Umkubaan and Umbilo rivers that flow through Cato Manor to rise to abnormal levels. This resulted in excessive erosion and subsequent failure of the eastern embankment along the Bellair road, just north of the Umbilo river bridge. The rise in the water table beneath the road resulted in further instability of the embankment compromising the road and a bulk water pipeline.

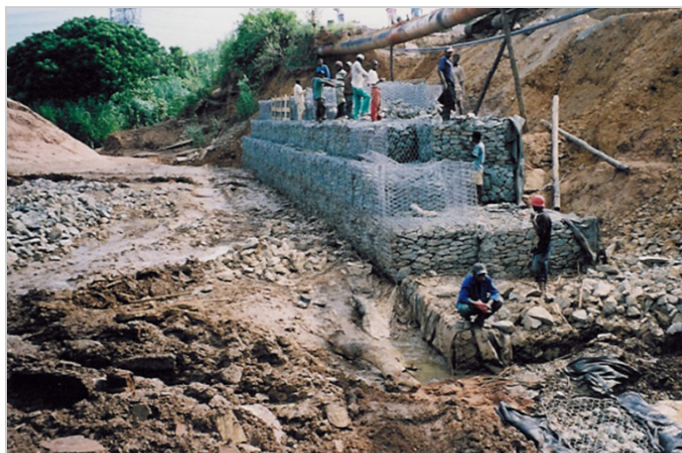
During construction

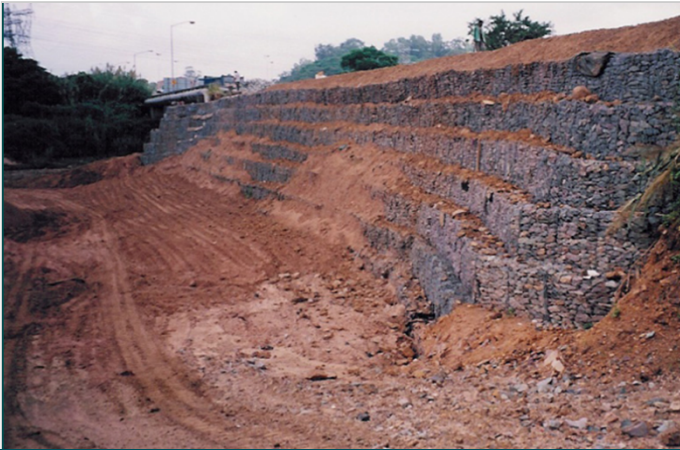
After construction
