BANK PROTECTION WORKS ALONG RIVER GANGA NEAR DAKHINESHWAR TEMPLE KOLKATA, WEST BENGAL, INDIA

Longitudinal Protection

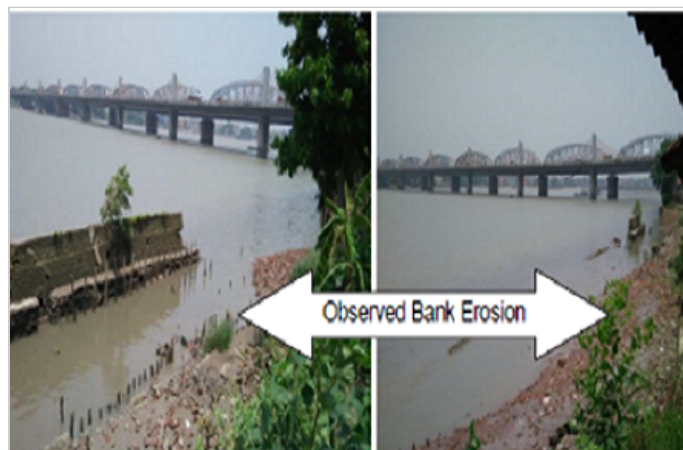
Photo 1: Severe erosion observed on the banks of river Ganga

Tidal bore phenomenon is prevalent in Hooghly river. During the tidal bore, the incoming tides are funneled into a shallow narrowing river (estuary zone), causing the river to flow in opposite direction. Due to the large tidal variation in the river, there was a turbulence at the base of the existing embankment structure. This caused excessive and continuous erosion damage to the bank portion of Dakhineswar temple. During the heavy rains, the water level in the river would rise, resulting in flooding of adjacent areas.

Bank erosion is often caused by natural processes but it can also be due to human intervention especially livestock management, vegetation management and river engineering. Bank erosion can result in a loss of land and threaten properties or structures. The deposition of eroded bank material further towards downstream also causes damage, both to structures and environment.

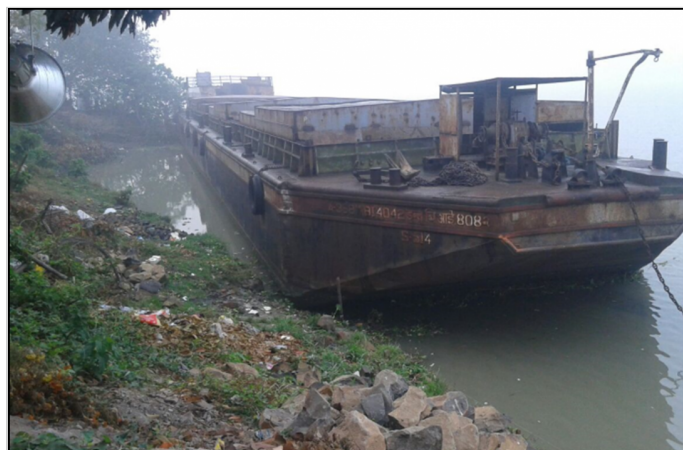
Photo 2: Site before construction

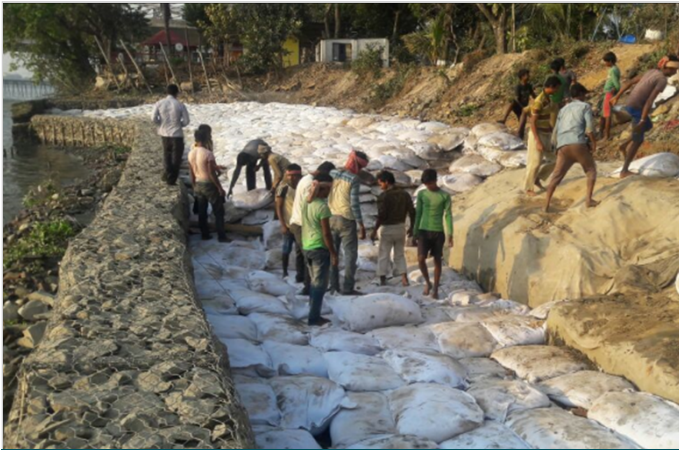
Photo 3: Placement of geotextile bags behind gabions

Maccaferri proposed a gabion toe wall along with a gabion mattress revetment over the slope. MacBags (geotextile bags) were used as filling material beneath the gabion mattress.

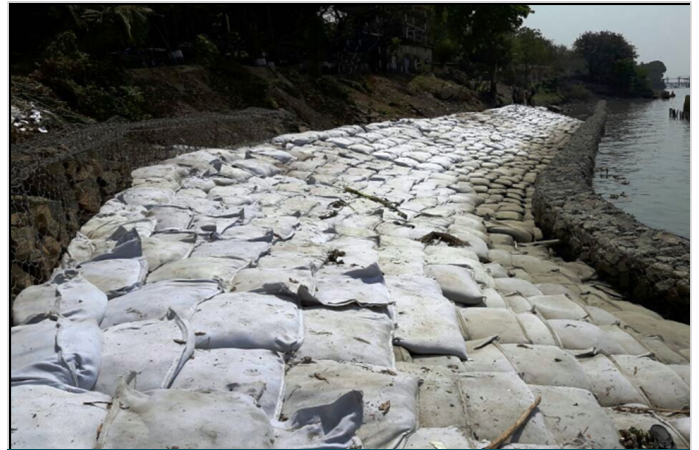
Photo 4: Installation of geotextile bags

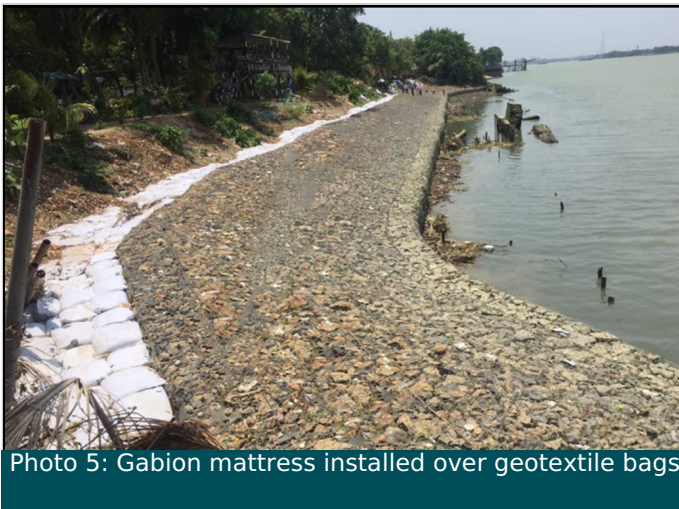
Photo 5: Gabion mattress installed over geotextile bags

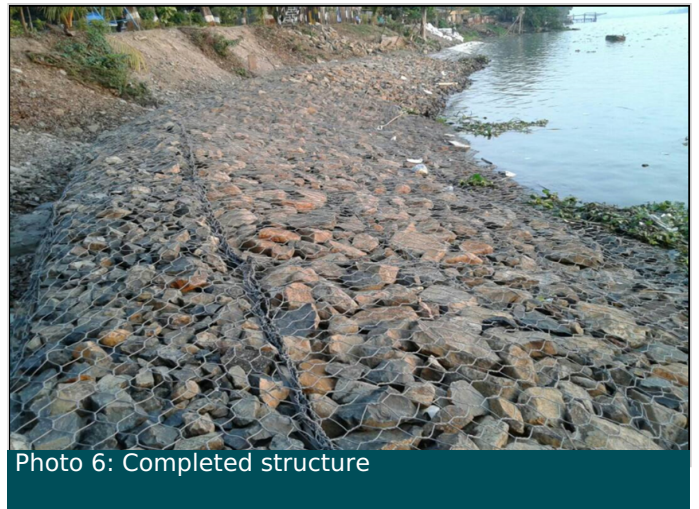
Photo 6: Completed structure

The solution proposed helped in controlling and reducing the successive erosion caused due to the tidal variation and flowing action of river.
