## MOSSMORRAN ROCKSLIDE PROTECTION FIFE, SCOTLAND, UNITED KINGDOM

### Suspended Drapery

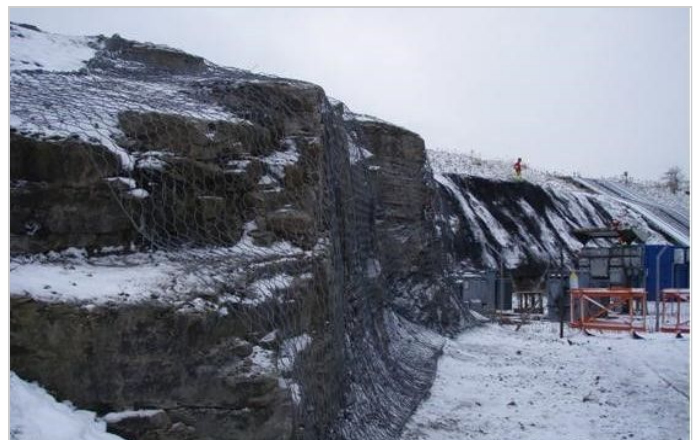
Installation in progress of MacMat® R & rockfall netting

The site was de-scaled and suitable blocks were removed by specialist contractor CAN. Following the installation of crest and toe cables the rock slopes were covered by a continuous 'curtain' of PVC-coated rockfall netting and the soil and rock slopes were by MacMat R®.

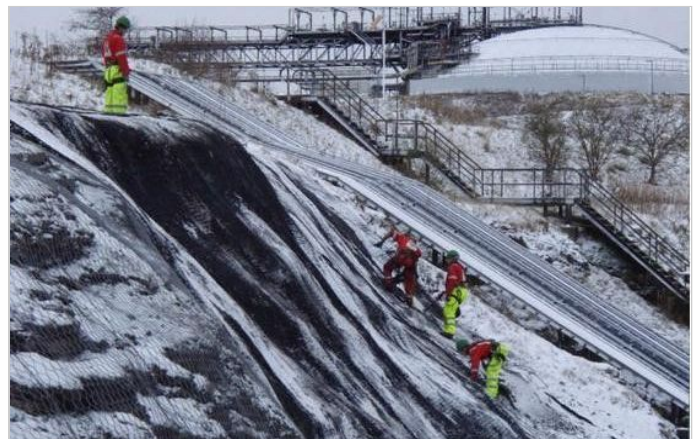
Installation in progress of MacMat® R & rockfall netting

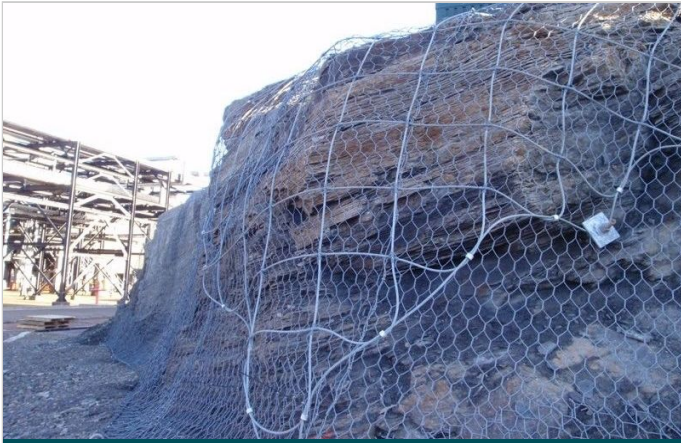
HEA panel (over RFN) securing large block on buttress

The two most vulnerable sections of rock slope (pervasively jointed and near sensitive installations) were each covered with an additional layer of high-strength HEA panels.

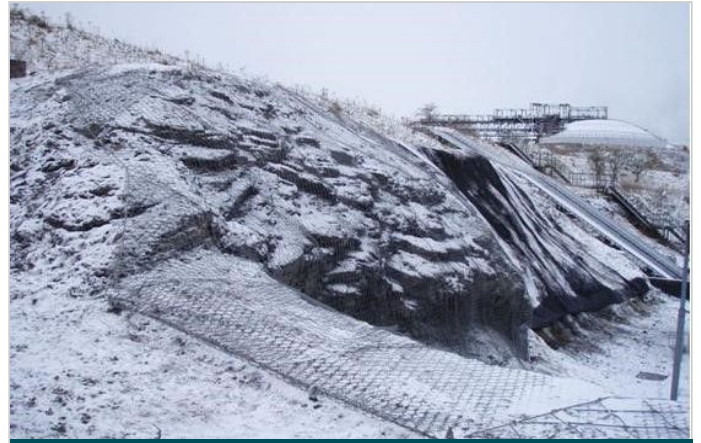
Completed installation of MacMat® R & rockfall netting
