# EROSION CONTROL AT RUSSELL HOMES, SALTERSFORD GARDENS

## HOLMES CHAPEL, CHESHIRE, UNITED KINGDOM

### Slope Protection

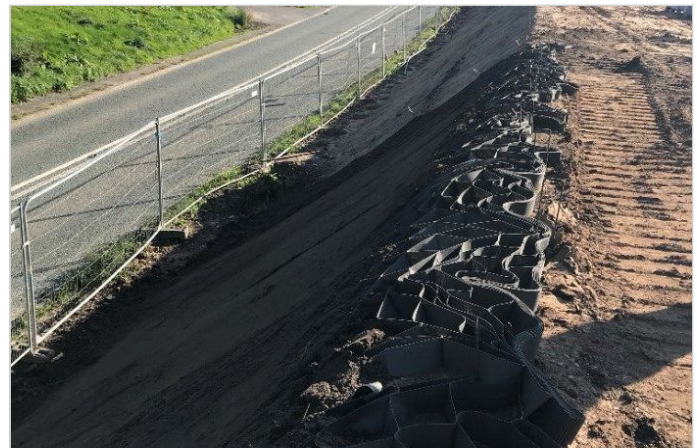
ParaGrid reinforced slope with MacWeb erosion control in 2018

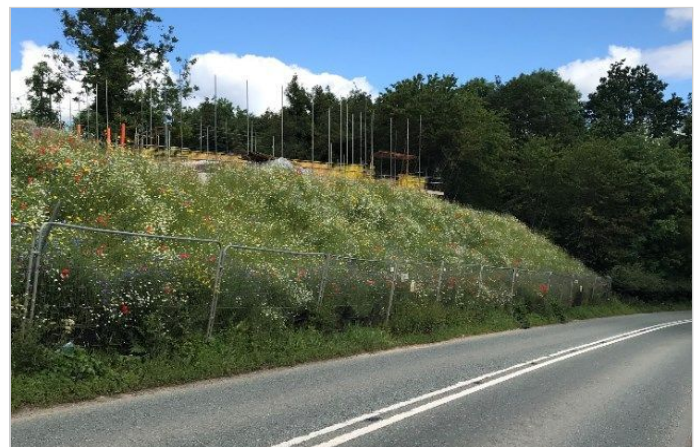
Fully established wild flower vegetation in June 2019

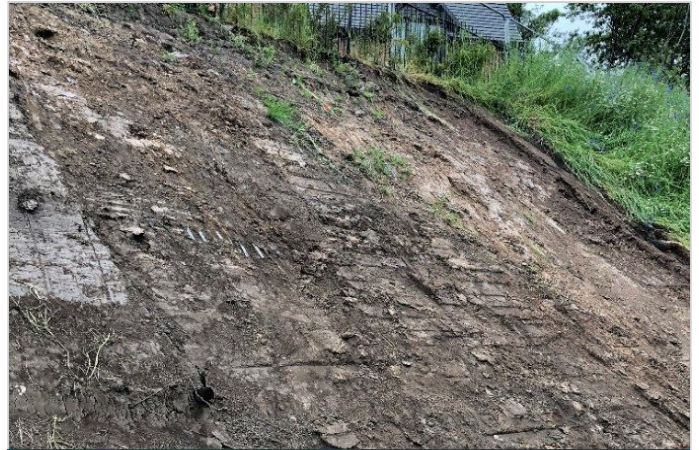
Maccaferri was contacted by Russell Homes in February 2021 because part of the topsoil surface of the slope had slipped towards the road below following a period of heavy rainfall. Following a site visit, it was determined that the ParaGrid reinforced embankment was stable and had not been adversely affected by the topsoil slip which had occurred as a result of an excessive amount of soil being placed on the slope during construction which measured approximately 400mm deep—an increase of 250mm on the designed depth of 150mm topsoil. Part of this overburden had become saturated following heavy rainfall and the erosion control measures installed in 2018 were not sufficient to prevent the additional weight of excess topsoil from eroding and slipping down the slope, which resulted

Slope face stripped of excess topsoil ahead of remedial works

Maccaferri was tasked with proposing remedial measures to reinstate the slipped topsoil layer and provide a long-term enhanced erosion control solution to prevent any further topsoil slips from occurring under similar circumstances in the future. Following a review of the original design, as-built site conditions and a range of potential solutions it was agreed that the best course of action was to scrape off the excess 250mm topsoil overburden from the slope face so that it would adhere to the planned design depth of 150mm, and where the MacWeb system had been damaged in the slip this would be reinstated with a new panel filled with the correct depth of topsoil which was imperative to mitigate the risk of future slips.

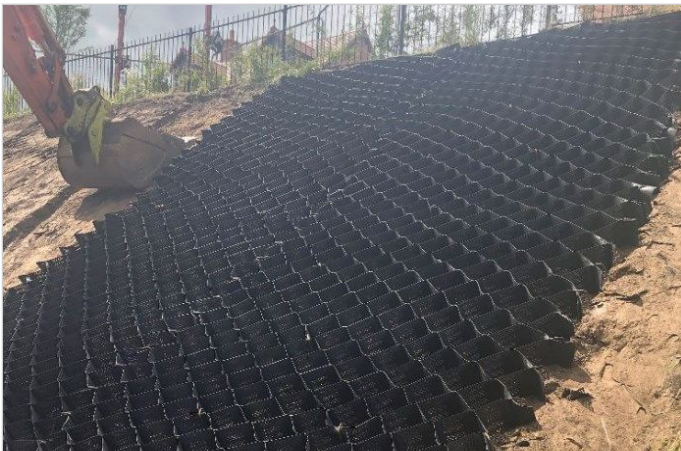
MacWeb cellular containment system ahead of topsoil filling

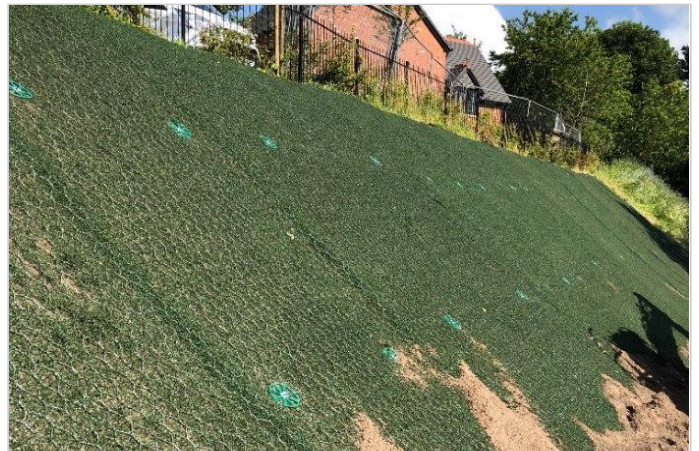
MacMat R Green and Gripple soil anchors
