## THE AVENUE STAGE 3 CHESTERFIELD , DERBYSHIRE, UNITED KINGDOM

### Soil Nailing

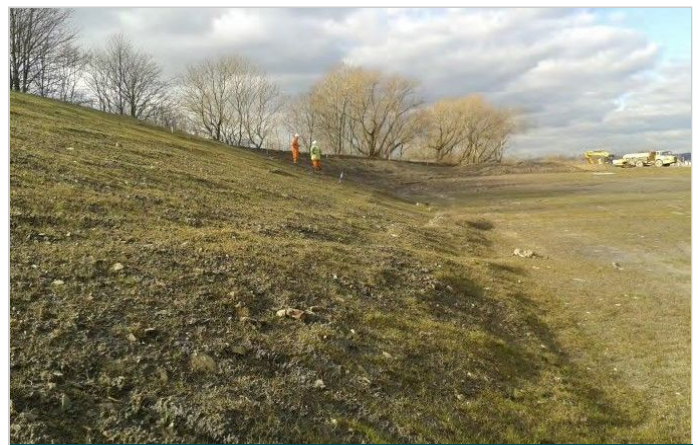
Wide tension cracks and superficial disturbances happened on the cut slope forming the western boundary of the site. The cut slope has a total length of 250m and the slope forms the western edge of the development area. The slope is approx. 6m high and was cut to a gradient of 1V:2.7H. The slope is composed of Made Ground underlined by the firm to still mottled clay and weathered coal measures deposit.

Bulging and tension cracks of the face slope in Winter 2016

An analysis by Amec FW concluded that groundwater was the main causal factor for the instability. The trigger for the slope failure was elevated groundwater level following a long period of heavy rainfall events, and consequent pore pressure build-up behind a surface layer of clay.

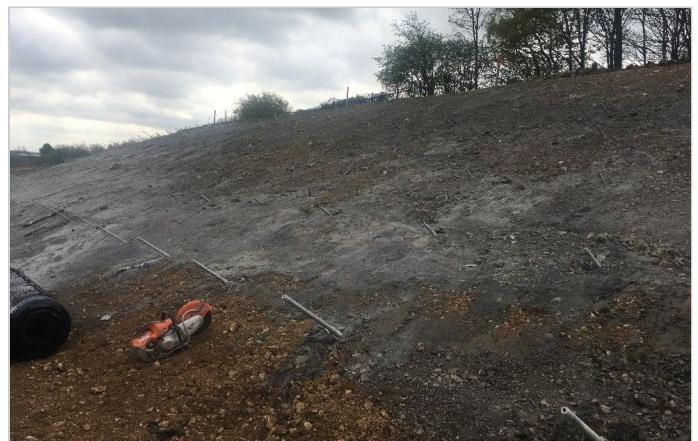
During installation of 32mm diameter soil nailing

Drainage was installed at the crest and toe as mitigation measure and a sequence of soil nailing at 2m c/c were designed by Coffey Geotechnics to provide assurance that the slope will remain stable in the long term.

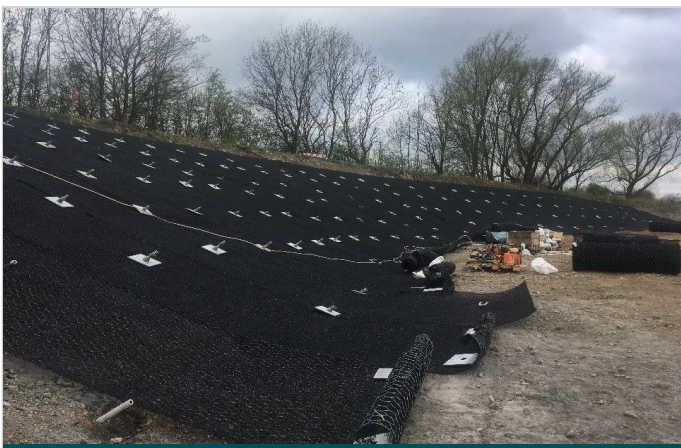
Soil nailing and MacMat® R installed

All the work were carried out by Vertical Access in accordance with BS8006-2:2011, BS EN 14490:2010 and MacMat® R was selected as the most suitable product for the soil nailing facing system.

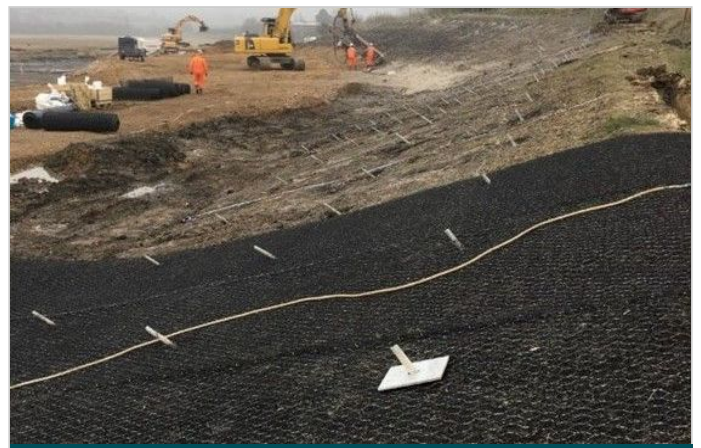
View of the site during installation

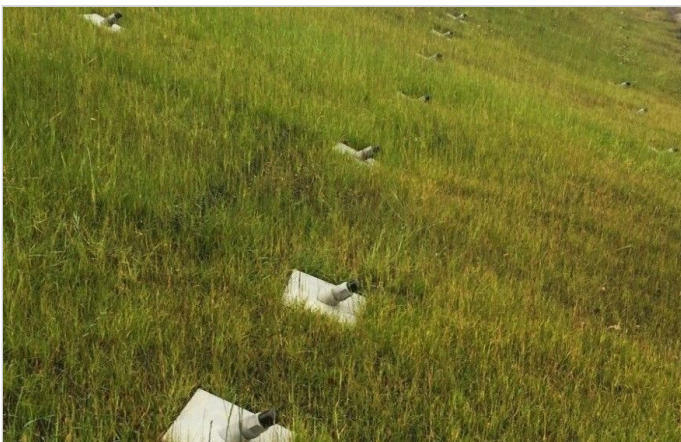
Vegetation is growing over the MacMat® R (summer 2017)

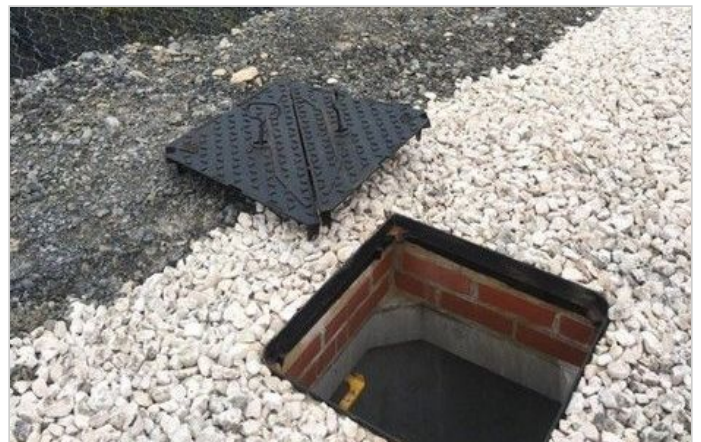
Drainage installed at the toe
