## TOLCARNE BEACH - CLIFF SLOPE STABILISATION NEWQUAY, CORNWALL, UNITED KINGDOM

### Suspended Drapery

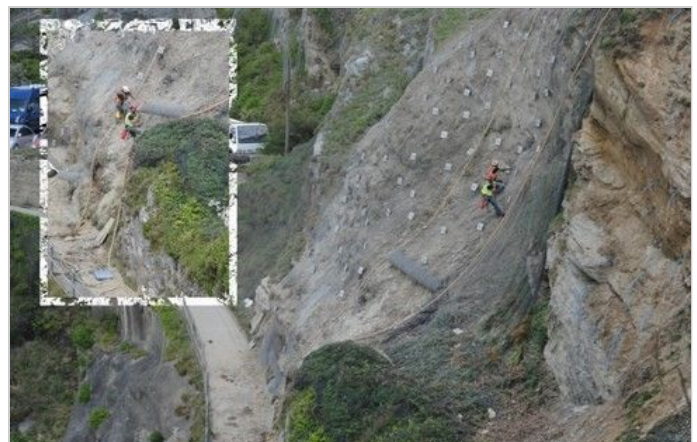
Abcas was installing the Maccaferri solution

Abcas (UK) Ltd was involved in this project at Newquay, installing 3m wide rolls of Steelgrid® HR polymeric coated. Phase one of the work was completed in July 2017 and stabilised the two priority sections of the cliff. Phase two was completed before the summer of 2018. The beach reopened to the public on 27th July 2018.

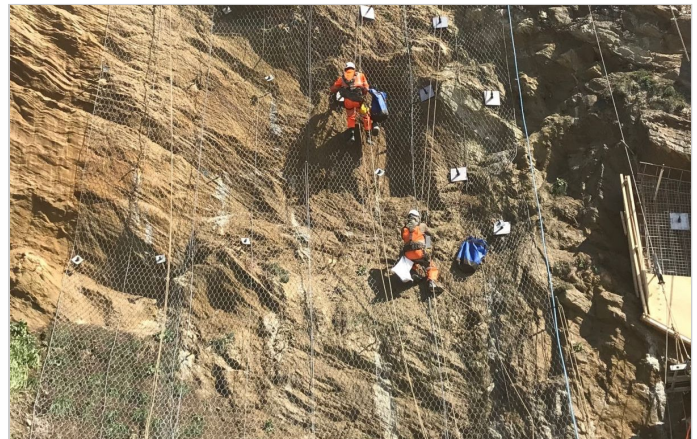
Securing the Steelgrid HR mesh with HR plates

Designed by John Grimes Partnership, the works involved drilling soil nails and anchors into the bedrock, some up to six metres in length. These will then have plates screwed onto the end which, when tightened, will hold larger parts of the failing cliff in place. Smaller pieces will be caught by the standard Maccaferri polymeric rockfall netting, which will also be attached to the anchors. These can be released under control by loosening the mesh, allowing them to fall safely.

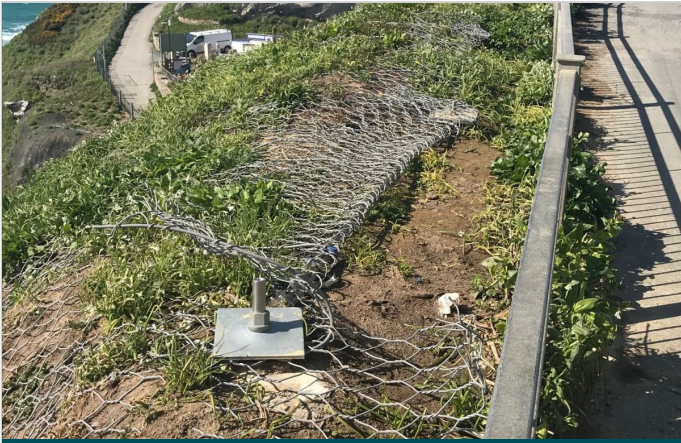
Steelgrid HR secured at the crest of the cliff

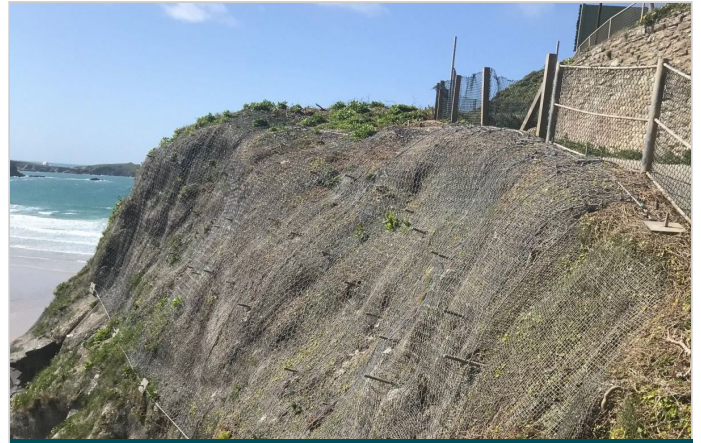
View of the stabilised cliff. A coastal environment

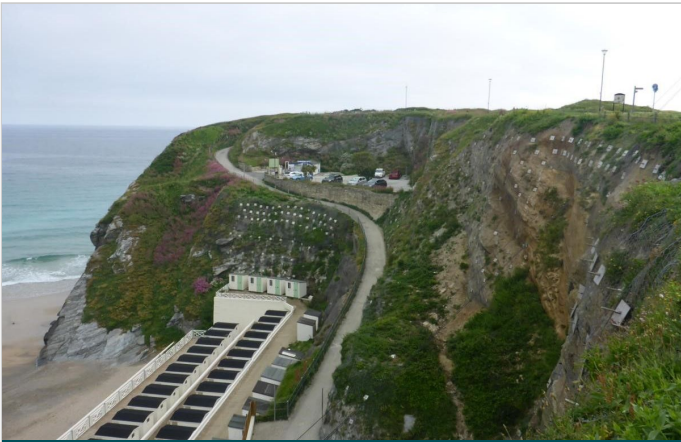
The solution was safely installed without impacting on the local fauna and flora

The solution had to be able to be safely installed without impacting the local fauna and flora, especially in the case of rare plants that could be damaged or nesting birds that could be disturbed.

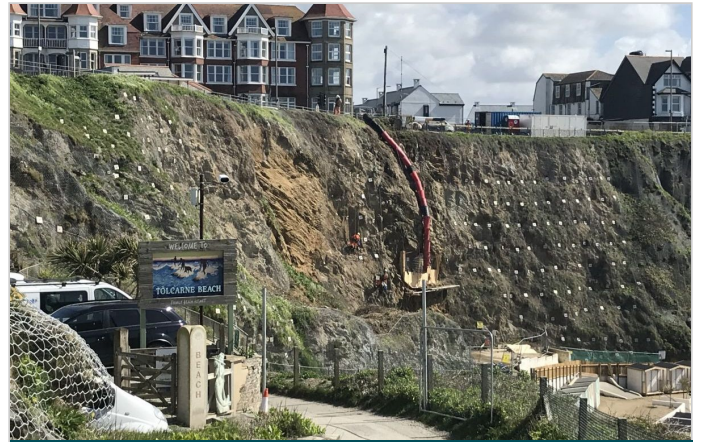
View of the works in Autumn 2017
