**KARIBA DAM REHABILITATION**  
**LUSAKA, ZAMBIA, ZAMBIA**

## Slope Protection

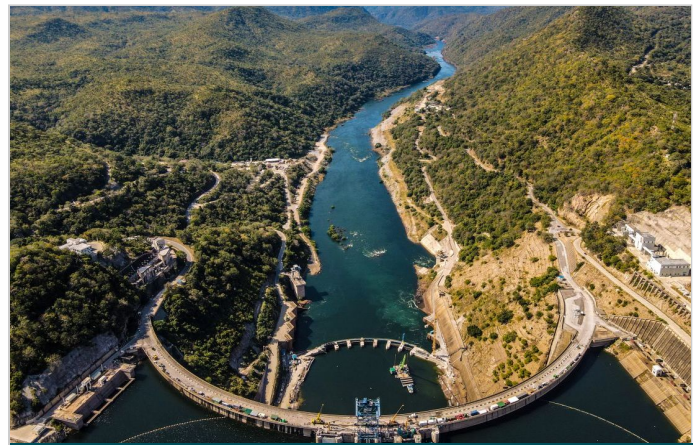
Completed Project

Razel BEC opted for the use of Maccaferri Polimac coated DT Netting utilizing laplinks and HD clamps for vertical bank protection. The netting was installed as dewatering for the development of the plunge pool - which took place over a period of 6 months. The netting was not removed after the rehabilitation work of the plunge pool.

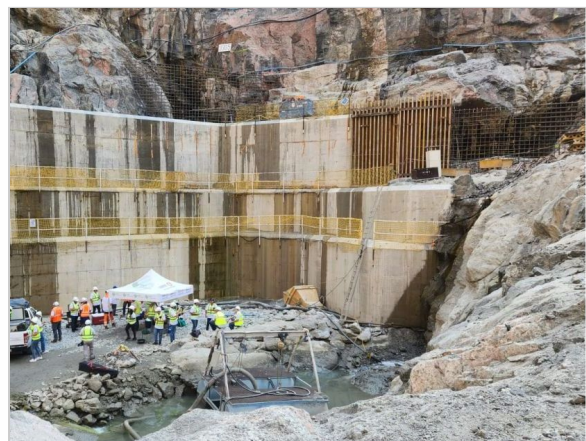
Concrete Stabilization Structure

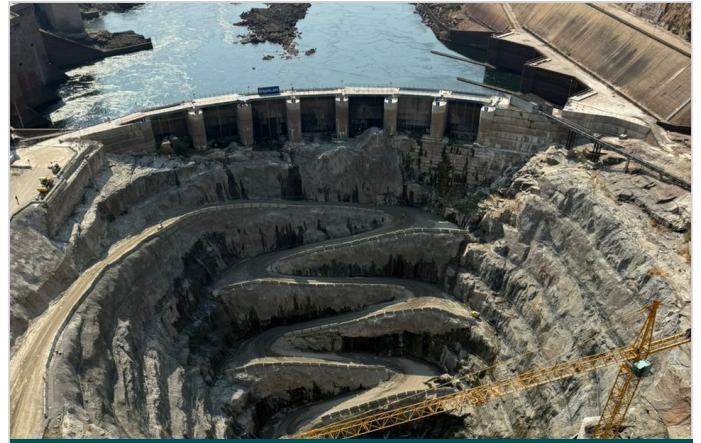
Dewatered Completed

- Completion of the cofferdam construction on 7 July 2022.
- Commencement of dewatering from level 385m ASL to the current 352m Above Sea Level (ASL).
- Dewatering to level 352m ASL was attained on 4 December 2022.
- Approximately 30000m2 Polimac DT netting was installed.

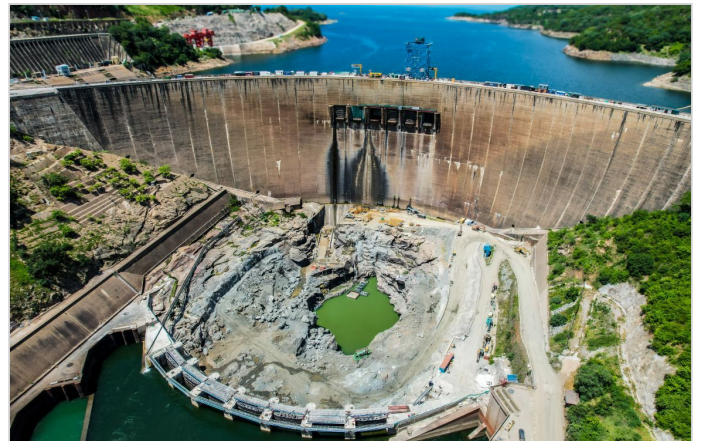
Dewatering Start
