DEBRIS FLOW APPLICATION RIZE, KARADENİZ, TURKEY

Debris Flow Barriers

Client: DSİ 22. BÖLGE MÜDÜRLÜĞÜ

Designer / Consultant: MACCAFERRI TURKEY

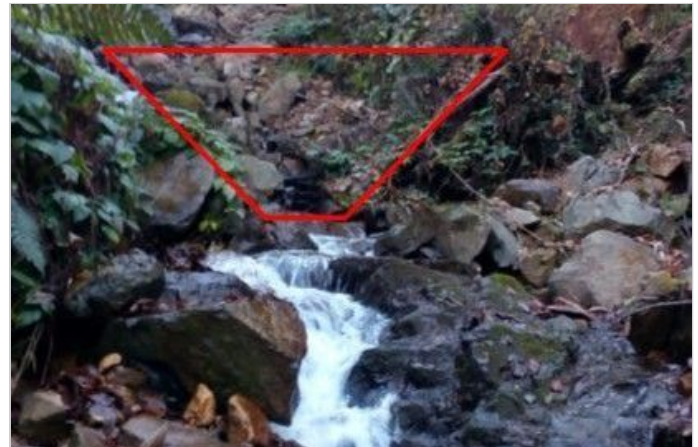
Before the construction

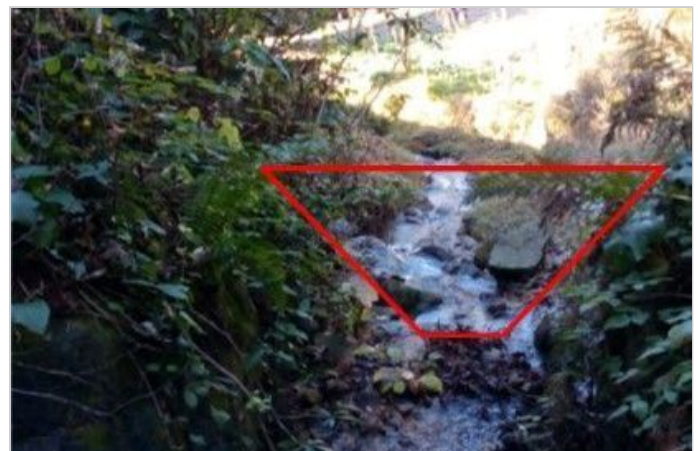
Before the construction

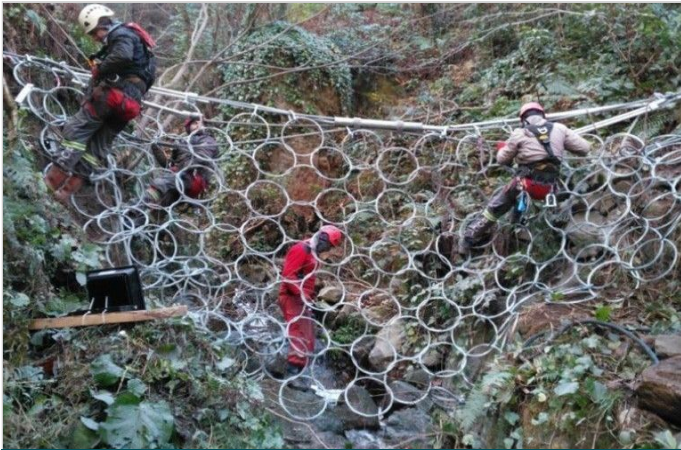
During construction

As debris flow barriers made of steel with an advanced energy dissipation braking system are new to Turkey, a test site was chosen by the authorities in the Guneyosu district of the Rize province in a tributary of the Potomya River In Bashkoy. Regarding calculations, the barrier was installed in a trapezoidal-shaped stream bed; the barrier has a height of 3 m, 9 m across the top and 3 m at the base with a resistance of 160 kPa. The test area was chosen after considering many criteria such as geological conditions, optimum anchorage location and site accessibility.

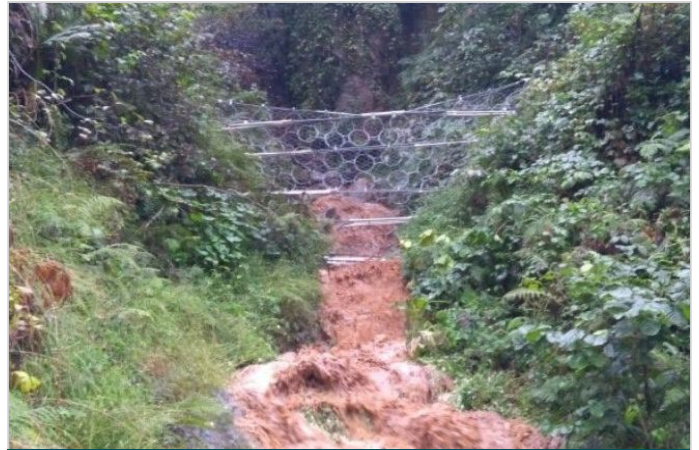
Flash flooding

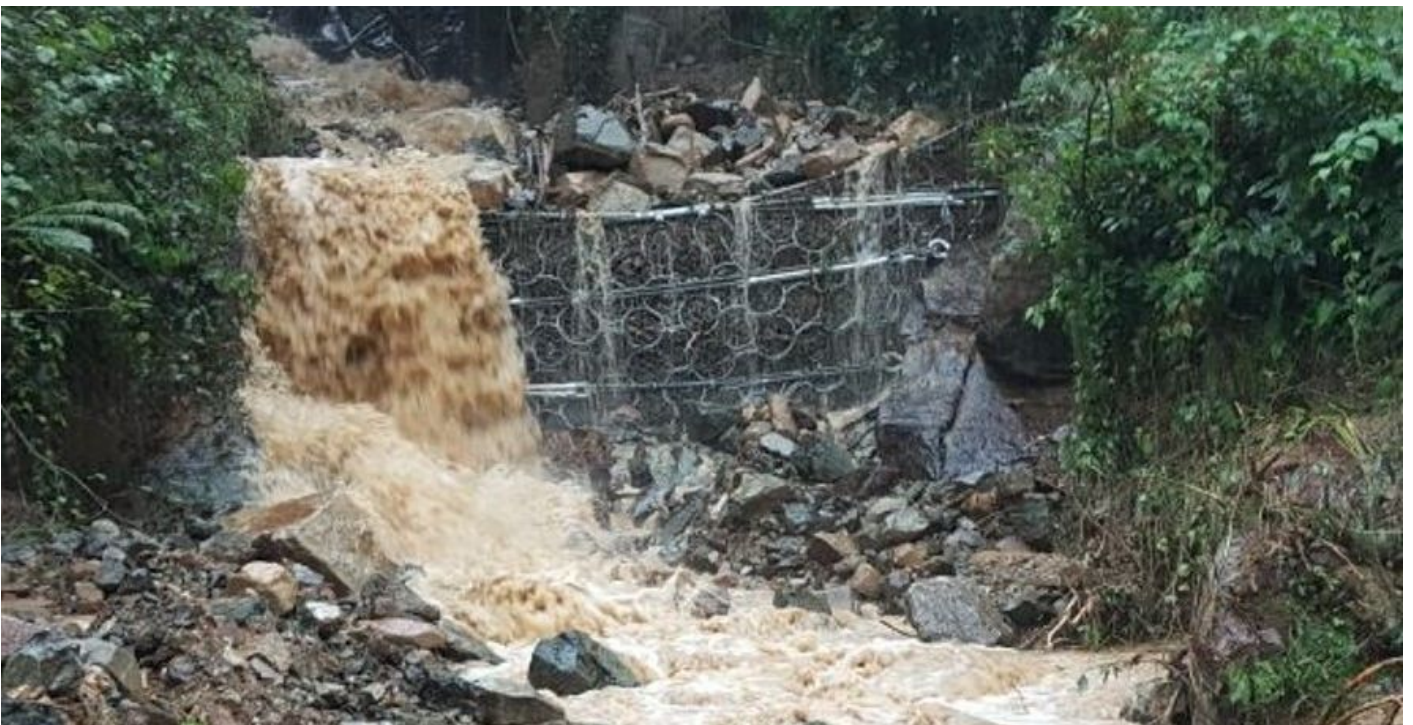
After flooding
