MHLANGA RIVER BRIDGE N2 FREEWAY, DURBAN, KZN, SOUTH AFRICA

Reinforced Soil Walls and Slope Reinforcement

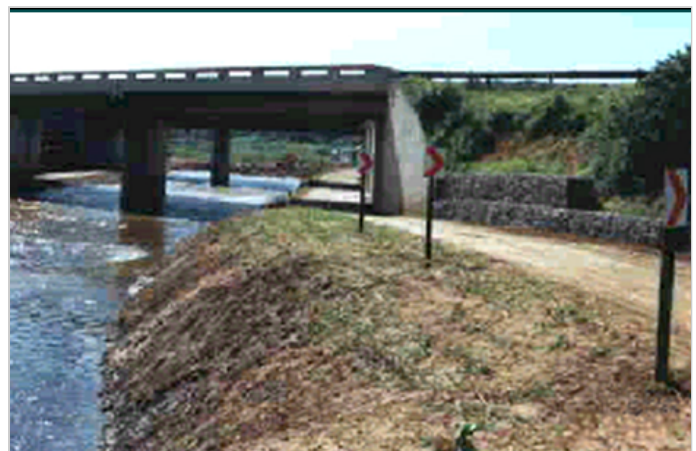
After construction
