ST. ANNES RAILWAY CUTTING PROTECTION BRISLINGTON , BRISTOL, UNITED KINGDOM

Dynamic Barriers

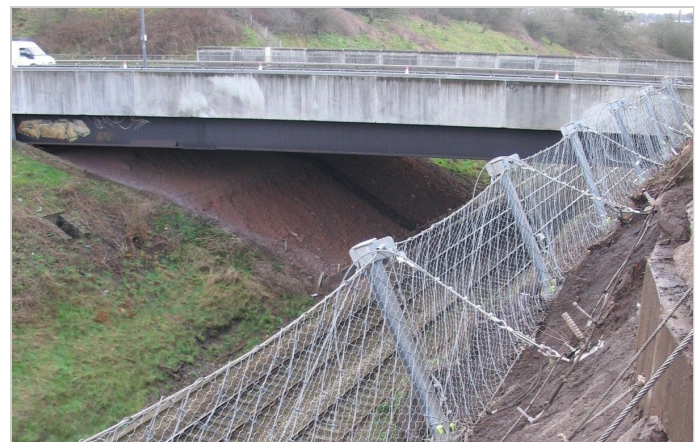
OM250 barrier installed above the Bristol - London railway line

Maccaferri suggested its OM250 Rockfall and Debris Flow Catch Fence, independently certified to offer an impact energy resistance of 250kj. The barrier would be 2m high and 35m long with support posts at 5m centres.

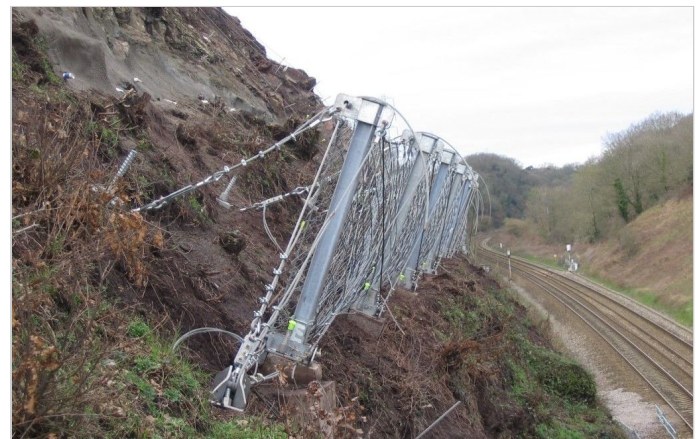
Barrier / Catch fence above railway line

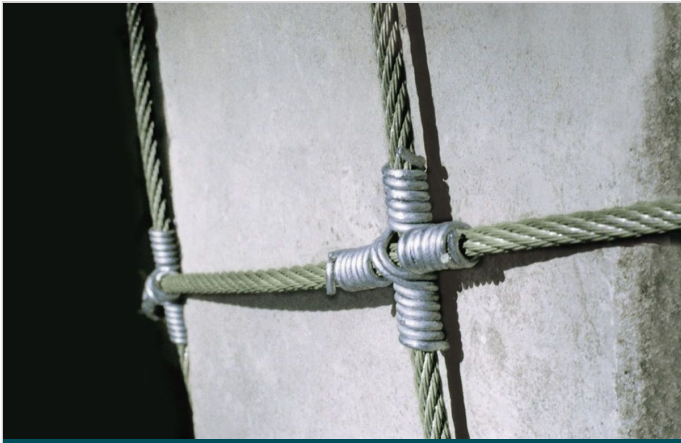
Detail of the cable connection used within the catch

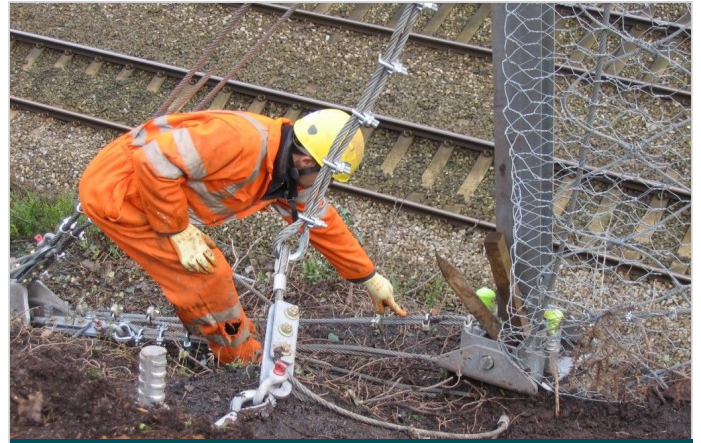
Adjustment of the cables and friction brakes during installation

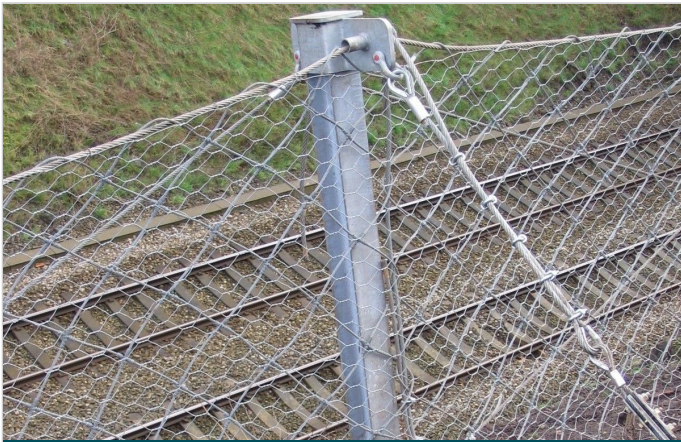
Intermediate fence post head detail
