**IGHTAM SANDS QUARRY**  
**BOROUGH GREEN, KENT, UNITED KINGDOM**

## Soil Nailing

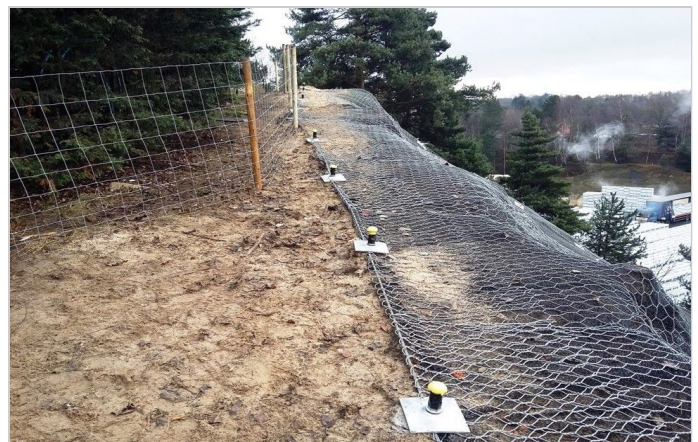
The top of the netting fastened by nailing into the soil

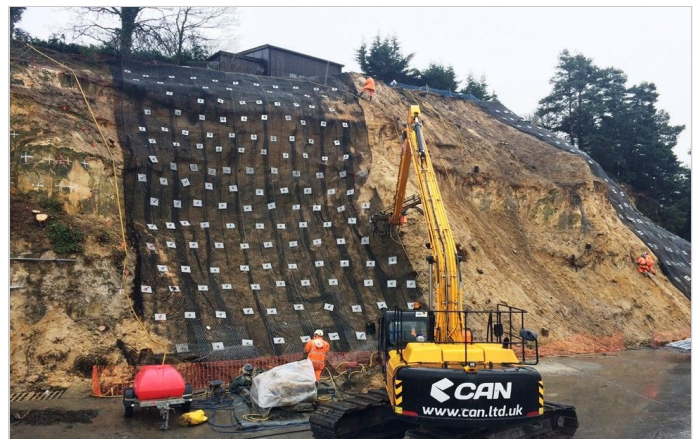
Preparing the netting along the rock face

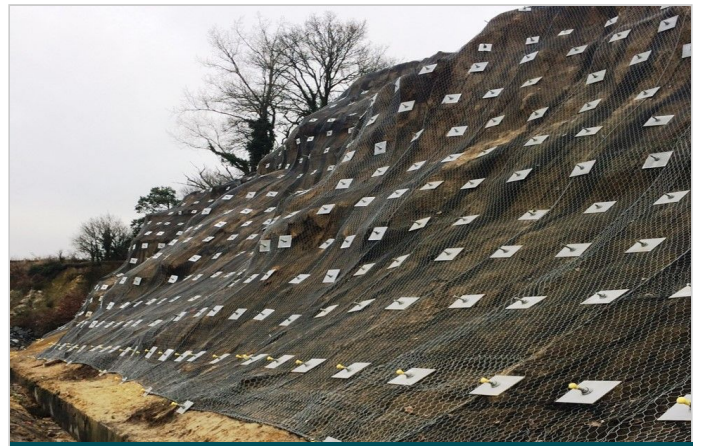
Securely nailed into the structure

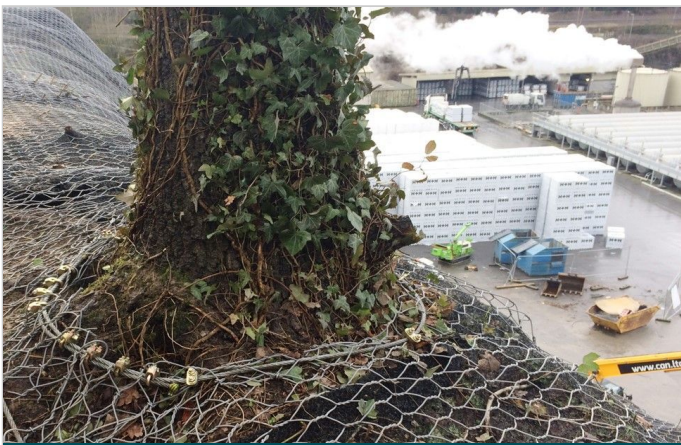
Close up of the netting around an existing tree
