## REMOTE RAILWAY ROCKFALL PROTECTION DRUMBUIE, SCOTLAND, UNITED KINGDOM

### Suspended Drapery

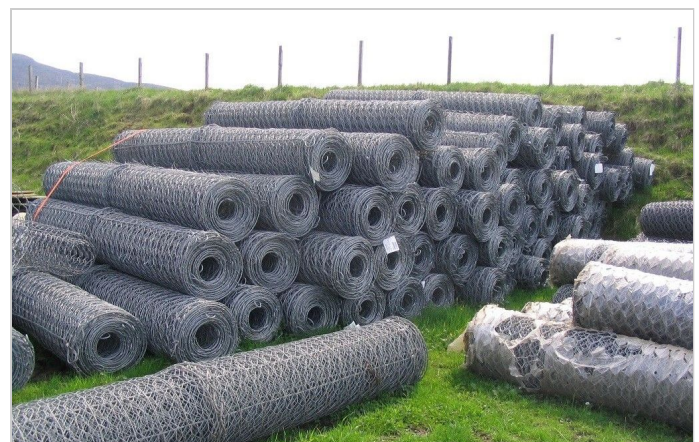
Steelgrid rolls ready for deployment into works

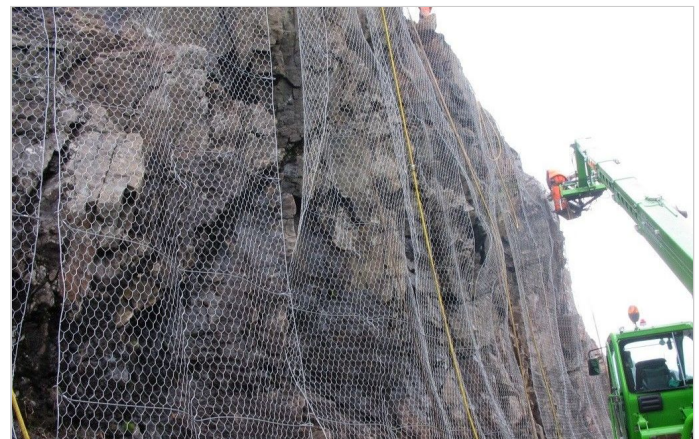
Hanging Steelgrid using trackside plant

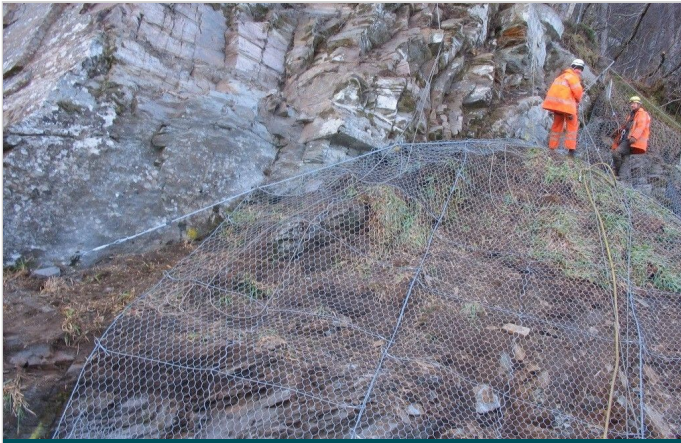
During construction using roped access specialists

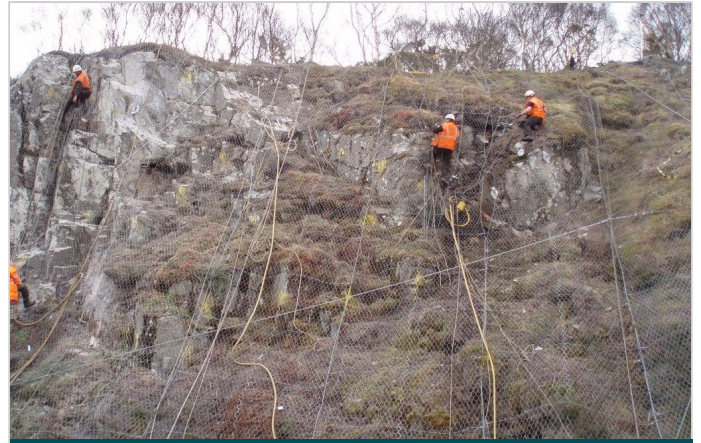
During construction using roped access specialists

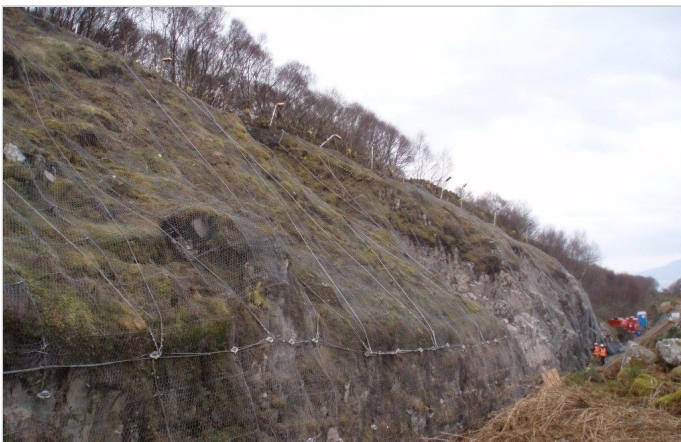
Project nearing completion

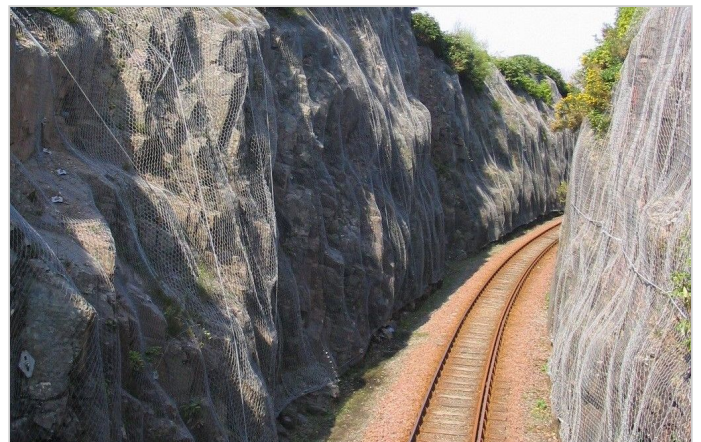
Completed project
