YELLOWSTONE HWY 20
CODY, WYOMING, U.S.A.

Dynamic Barriers

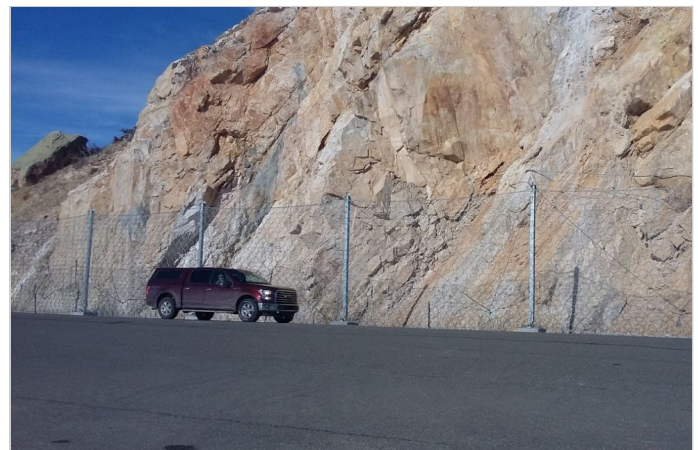
Finished Barrier

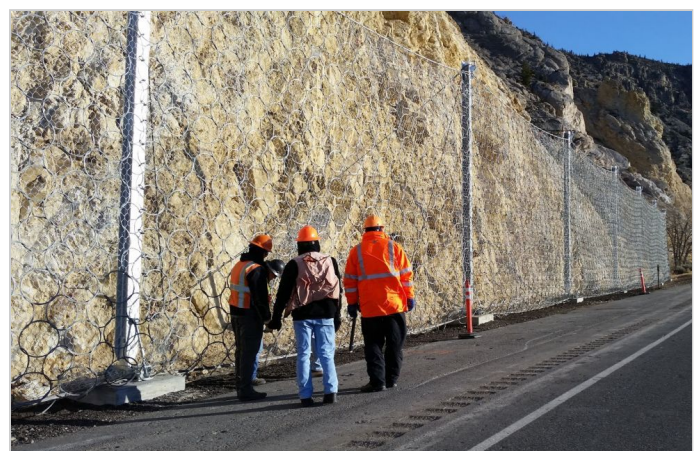
Completed Barrier

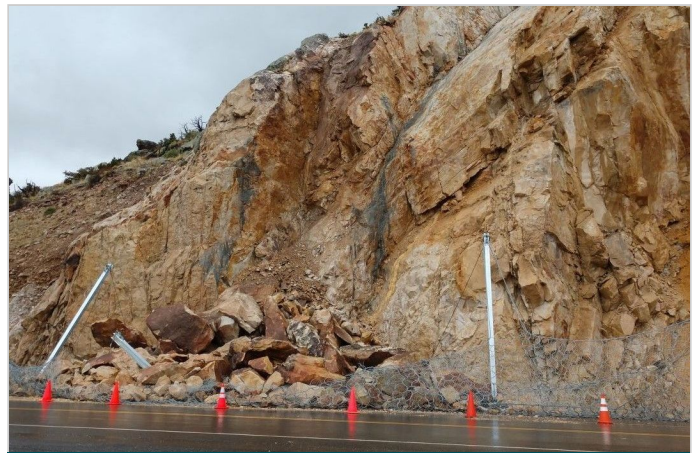
Impacted

The barrier was impacted on May 27, 2019, the opening day of summer travel to Yellowstone National Park. Wyoming DOT was notified of the large rockfall event that impacted the barrier, extending the ringnet to the shoulder of the road. Later Wyoming DOT engineers and geologists estimated the volume of materials that overwhelmed the barrier to be over 900 cubic yards of rock. Even though this volume of boulders toppled two support posts and ruptured the top support cables of the ROC barrier, no debris crossed the white shoulder line. The Department of Transportation did not have to close the westbound lane of the highway on the first busy day of the tourism season.

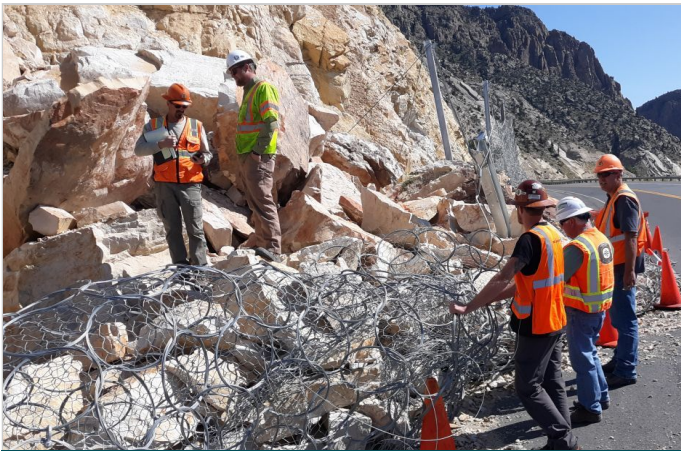
Impacted inspection

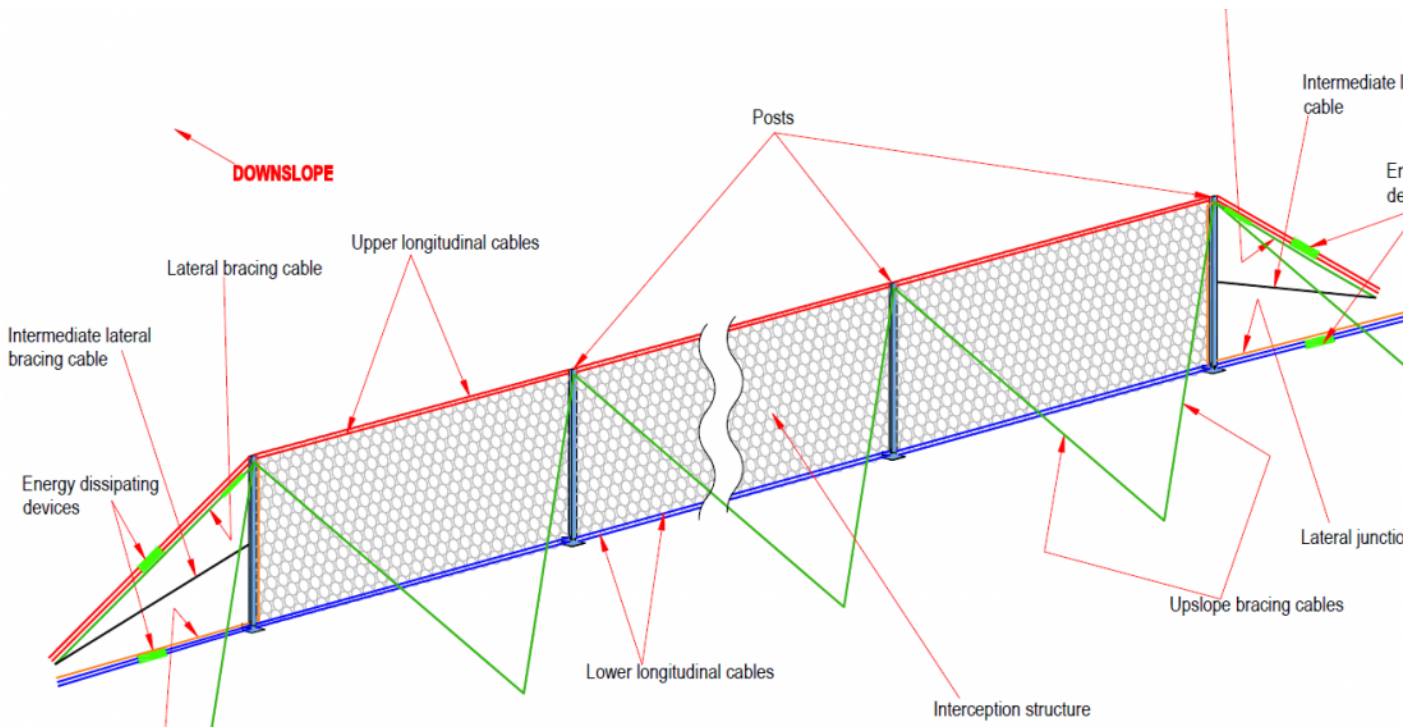
Schematic

Wyoming DOT was faced with a large outcrop of potentially unstable rock beside the very heavily traveled east entrance to Yellowstone National Park. The design showed that the dynamic rockfall protection barrier needed to be 20 feet high and protect over 450 linear feet of the highway. The Maccaferri ROC 2,000 kJ barrier was chosen and successfully installed after the summer tourist season of 2018. Due to space limitations, the barrier was installed exactly 20 feet away from the white shoulder line of the highway, the tested elongation of the ROC 2,000 kJ barrier is 19.7 feet during a maximum energy level impact event.
