## GABION GROYNES RIVER PROTECTION - RIVER OSUM BERAT, BERAT, ALBANIA

### Longitudinal Protection

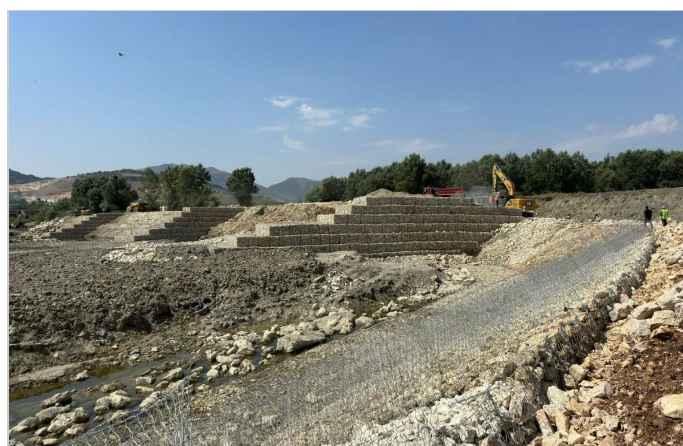
During construction

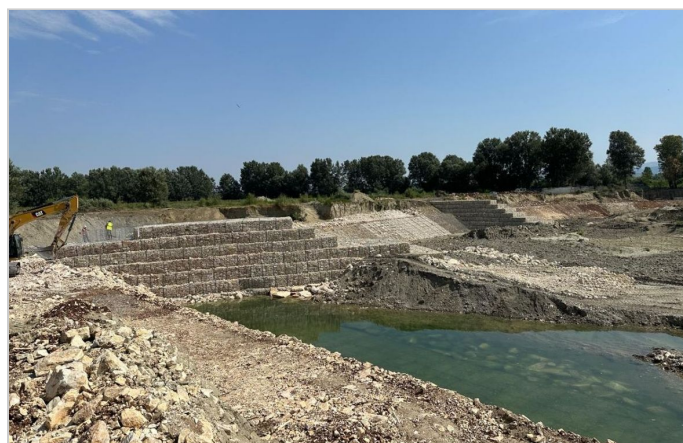
During construction

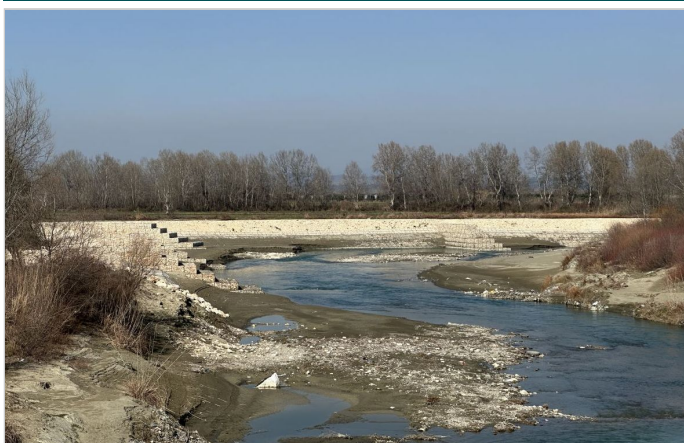
After construction

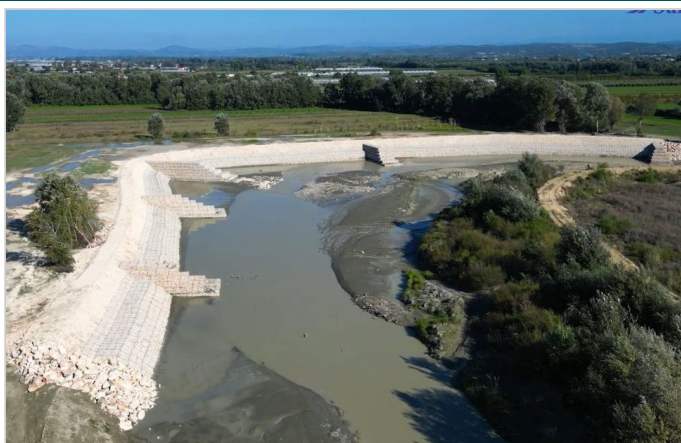
After construction
