ROCKFALL PROTECTION AT CHANGKAT JERING, PERAK, MALAYSIA

Simple Drapery

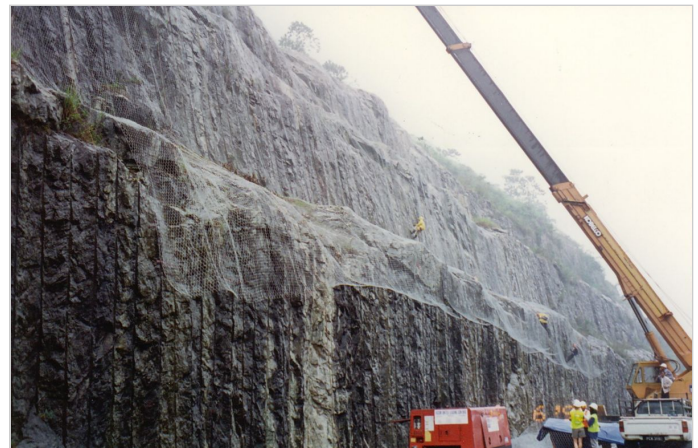
During Construction

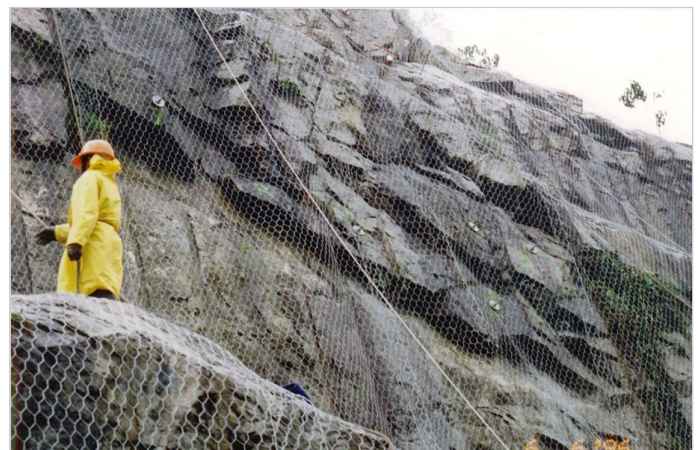
During Construction

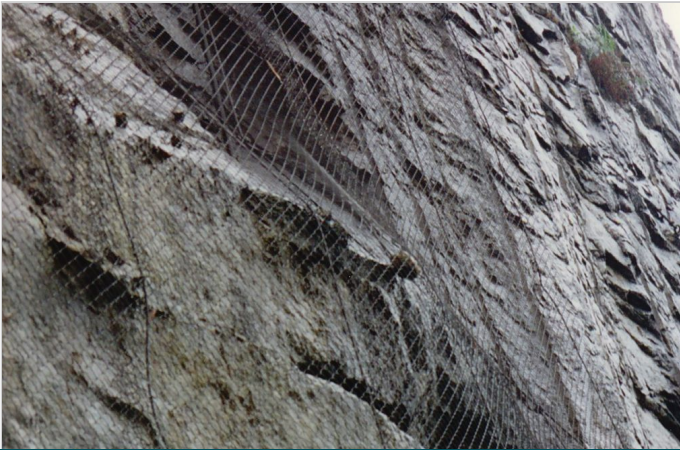
after construction

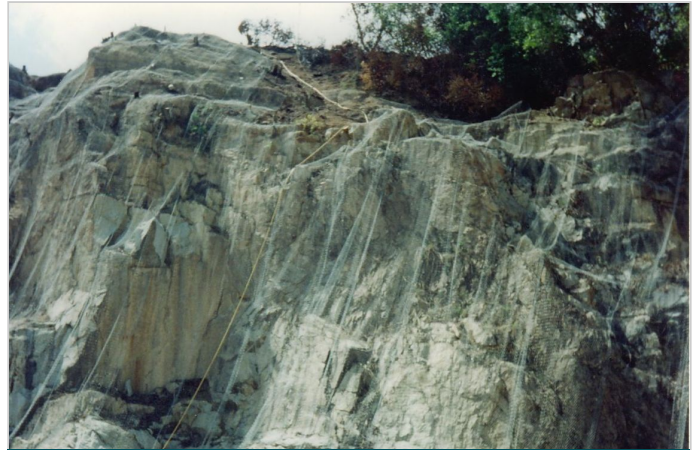
after construction
