ROCKFALL PROTECTION SYSTEM AT KAENG KHOI CEMENT PLANT THAP KWANG TOWN, KAENG KHOI DISTRICT , SARABURI PROVINCE, THAILAND

Dynamic Barriers

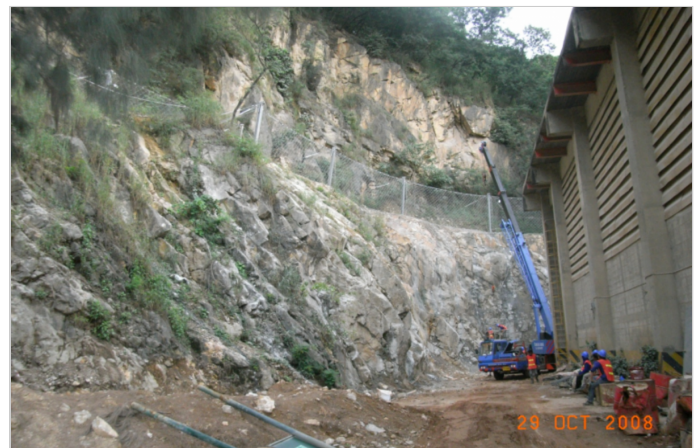
Barrier Installation In Progress

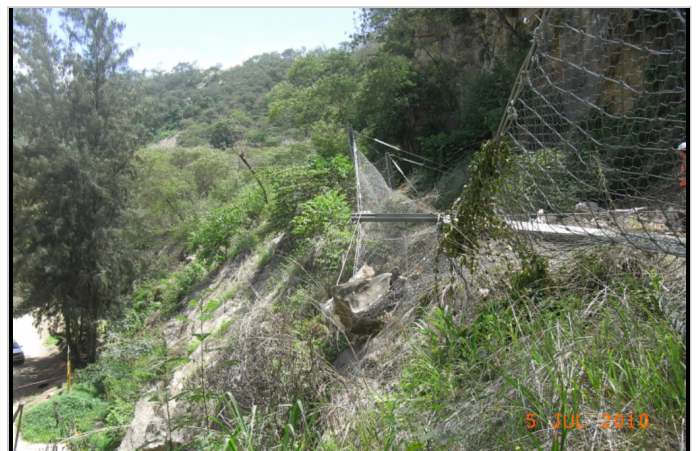
Rockfall Debris Impact on Fence

Almost 2 years post construction of barriers, a rockfall event occurred. The barriers were put to test and successfully intercepted all incoming debris from impacting the manufacturing facility. A large limestone boulder measuring about 3.0m x 1.4m x 1.3m detached from the rock slope and crashed into the 2,000kj barrier from a height of about 20m.

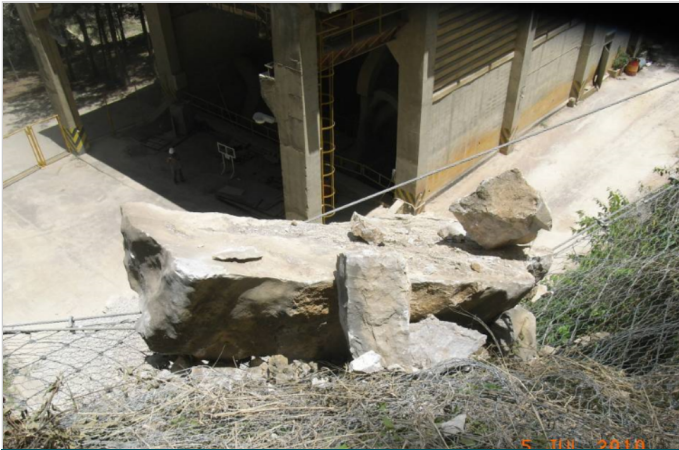
Rockfa View From Top Slope

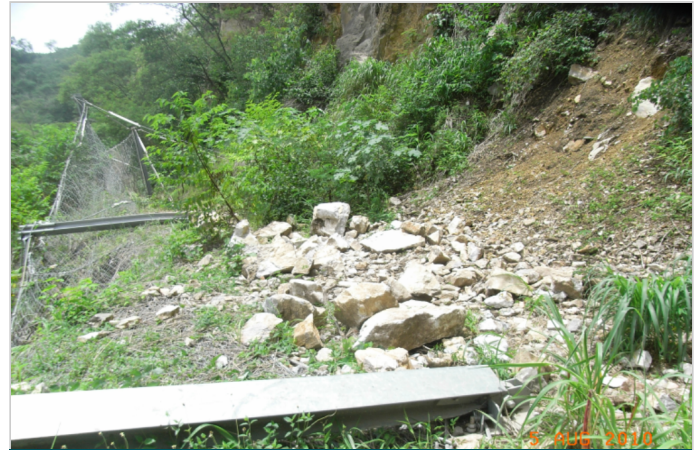
Rockfall Debris Impact at Base of Post

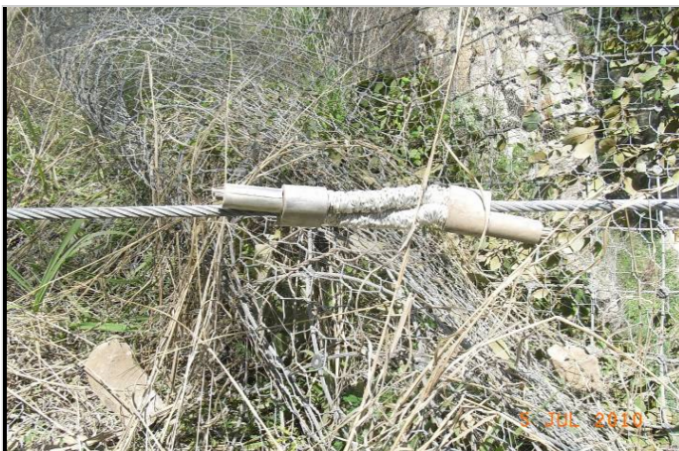
Patented Compression Brake After Full Impact

The client was pleased that the barrier performed effectively which prevented damage to plant infrastructure, no impact on plant operation and no loss of life. Only the damaged barrier parts need to be replaced which reduces the cost of rockfall barrier remedial works.
