**A75 TRUNK ROAD ASPHALT REINFORCEMENT
DUMFRIES & GALLOWAY, SCOTLAND, UNITED KINGDOM**

Sub-grade Improvement

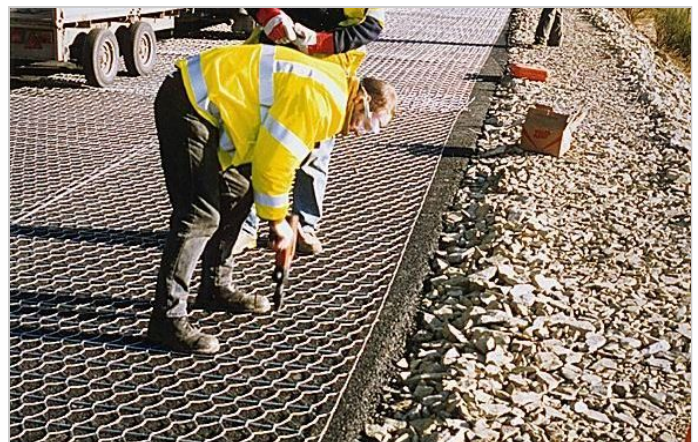
Locally fixing Road Mesh™ to the regulating layer

Road Mesh™ is intended for installation within the bituminous bound layers of the pavement. In remedial overlays, the old wearing course is usually planed-off and the Road Mesh™ is placed on the exposed surface, then overlaid with a new base course plus wearing course. Road Mesh™ causes the overlay to work as a cohesive mass, absorbing the horizontal tensile stresses and spreading the imposed traffic loadings over a wider footprint, thus reducing its damaging effect.

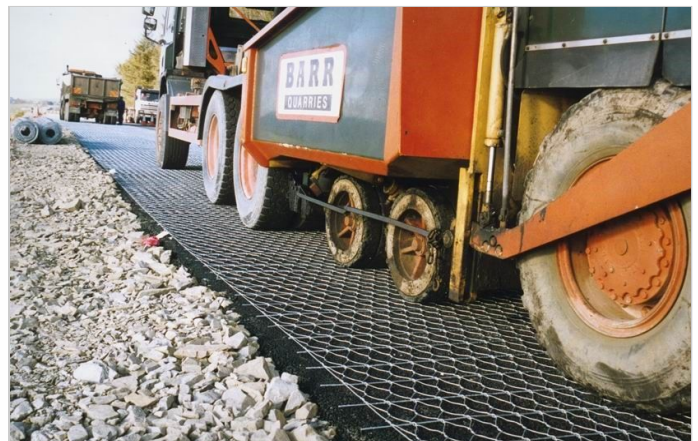
Close-up view of paving machine receiving asphalt

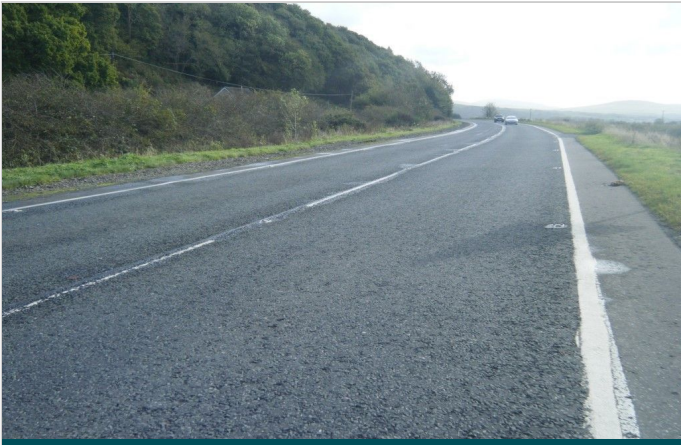
October 2010, The pavement performs well with no visible distress after 11 months

On the A75 project, the reinforcement system was installed by Dumfries & Galloway [D&G] Council with Barr as the main Contractor. Since its installation in 1999, the road surface has performed as intended with no repeat of the wearing course damage, previously experienced.

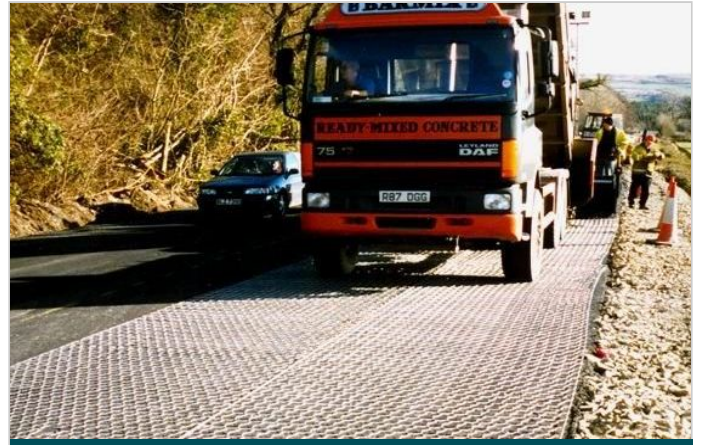
The paving operation continues

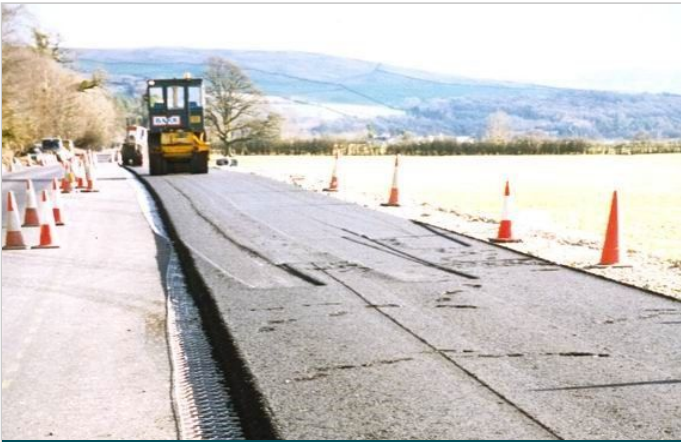
Rolling the wearing course
