## CUT SLOPE STABILISATION NEAR A HOSPITAL AT PONDA, GOA, INDIA

PONDA, GOA, INDIA

### Soil Nailing

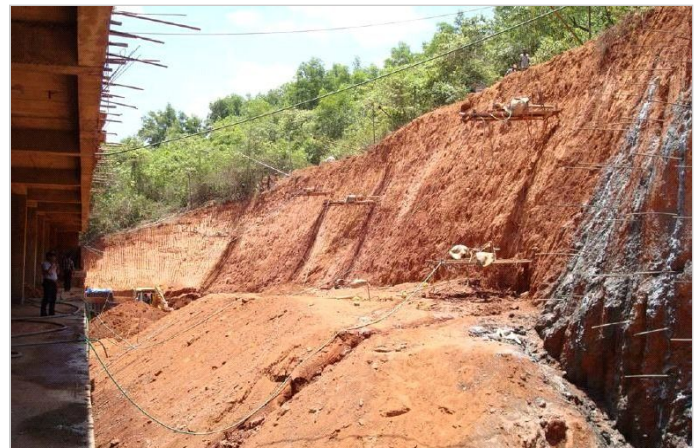
Photo 1: Photograph showing the vertical cut near hospital building

Ponda is a small town centrally located in North Goa. The strata found in the region is comprising of lateritic soil due to which the cut slopes are highly prone to slides. The site near the hospital used to face the problem of slip failures. The cut slope face was vertically cut. A pipeline of diameter 0.75 m was passing over the vertical cut. The soil had very low shear strength parameters.

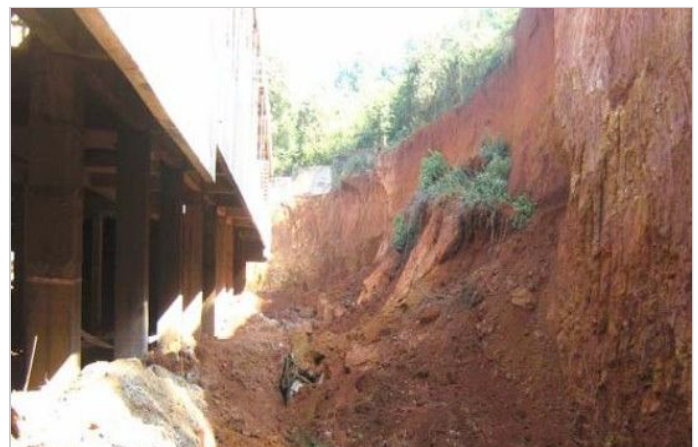
Photo 2: Site photograph - before construction

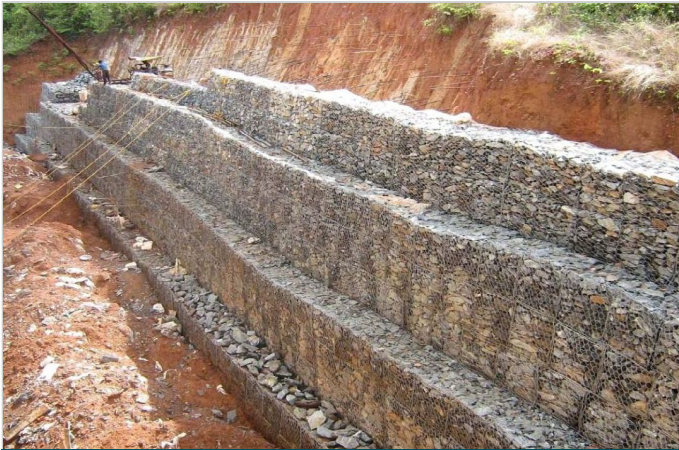
Photo 3: Site photograph - during construction

Considering the need to protect the vertical cut, soil retention works with soil nailing was suggested for the above problem. The height to be retained was approx. 12m and available base width was approx. 4m. Soil nailing technique, in which in-situ soil/strata is reinforced by the insertion of slender reinforcing elements called soil nails was used. Soil nails made of steel were installed into a pre-drilled hole and then grouted simultaneously and inserted using a displacement technique. A flexible facing (gabion units) was used on the surface of the slope. Soil nailing with gabion facia was found to be the best feasible solution considering the site constraints. Frictional soil as structural fill was filled up in the gap between the gabion facia and vertical cut. Concrete base was provided at the bottom of the gabion facia.

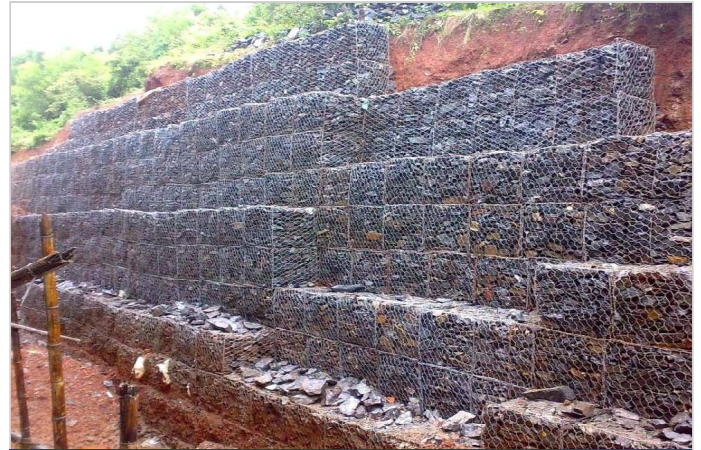
Photo 4: Photograph showing the gabion boxes filled with stones

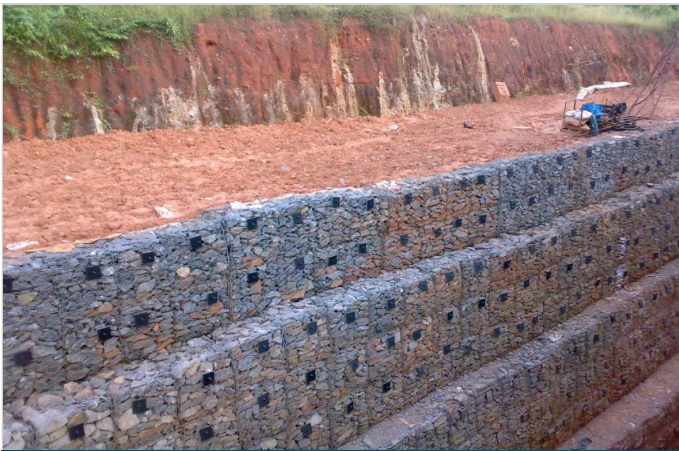
Photo 5: Photograph showing after construction view May 2008

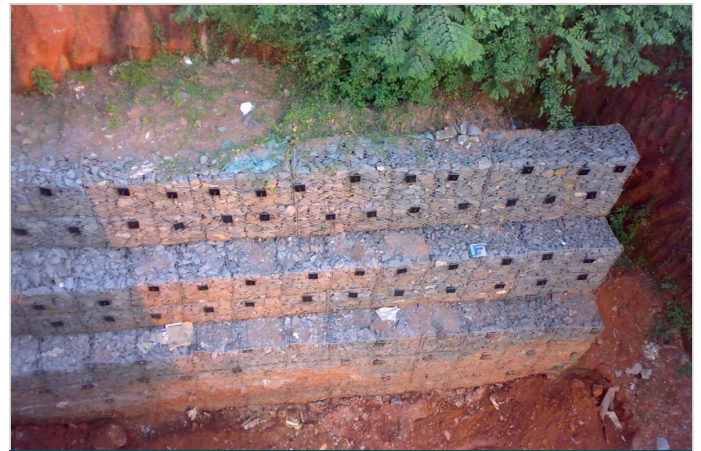
Photo 6: Photograph showing after construction view May 2008
