# Rock Slope Stabilization of the Historic Centre of Castignano

CASTIGNANO - MARCHE - Italia

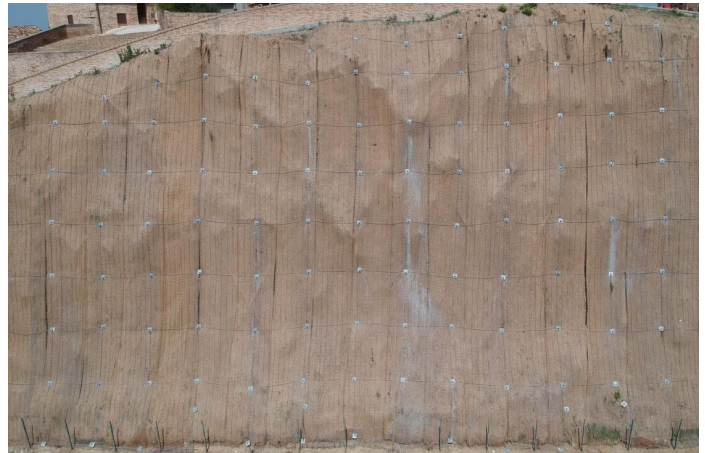
Detail of the works

In order to protect the buildings of the historic center of Castignano and secure the road located below the cliff, a stabilization intervention was carried out on the upper portion of the sandy slope not supported by the existing wall. The works involved a surficial reinforcement system using Steelgrid HR30, anchored to the stable substrate with passive nails, together with the installation of a biomat to provide additional erosion protection.

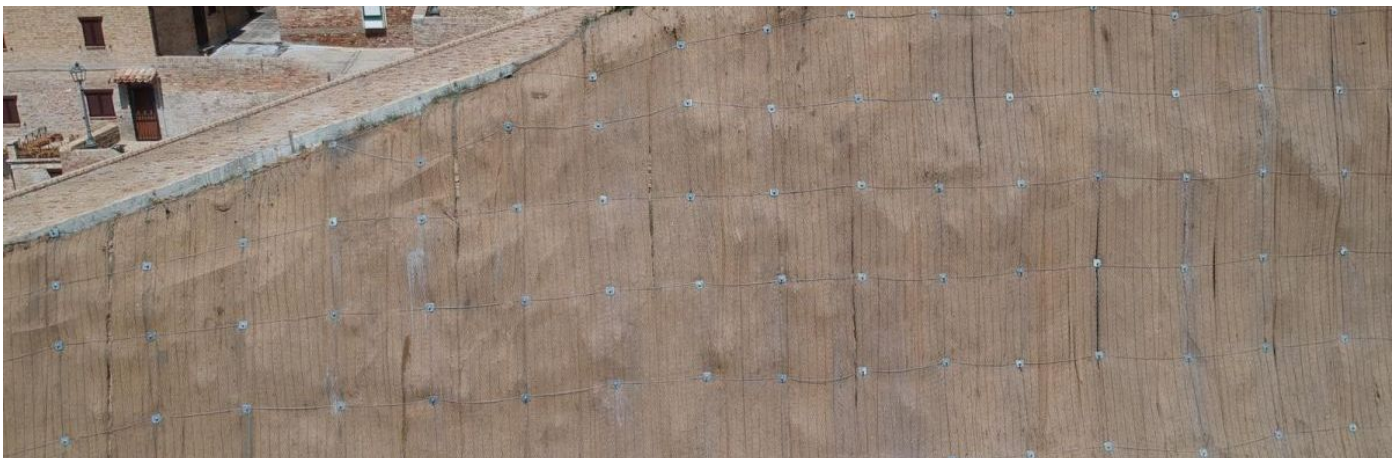
Overview of the site
