# Westlake River, Kirstenhof Duckpond and the Keyzers River

## KERA Inland Water Quality Report - May 2026

Prepared by Barry Tranter

6 May 2026

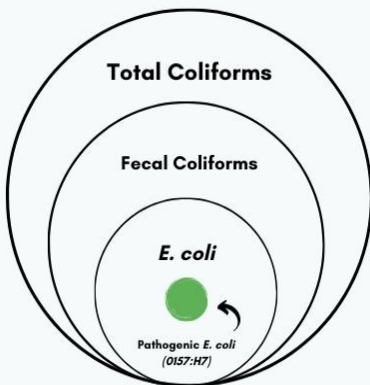
## Coliforms Explained

- **Coliform Bacteria:** A group of mostly harmless bacteria found in the environment. Used as a general indicator of water quality.
- **Faecal Coliforms:** Indicate faecal contamination from warm-blooded animals. Commonly used in assessing water safety.
- **Escherichia coli (E. coli):** A species within faecal coliforms, indicating recent faecal contamination. Some strains can be harmful.

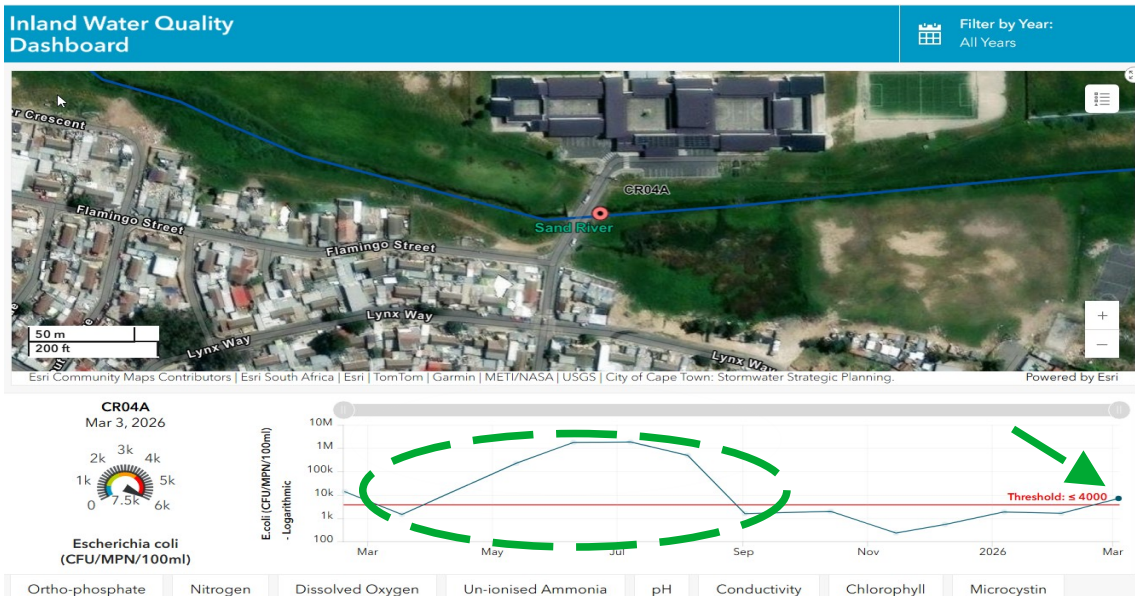
The river is subject to sewage polluting events originating in the Westlake area, the Pollsmoor area and failures of the Raapkraal Sewage pump station. Some of these events are visible in the City of Cape Town Inland Water quality data. This screen capture shows a very large increase of Escherichia Coli measured next to the Westlake Junior School during the winter rainfall months. This is likely to be repeated in 2026. (Arrow).
