## Case Study: BHS Battery Room Floors and System Stands Increase DC Productivity, Avoid Downtime

Occasionally, clients ask their BHS Supplier Teams to address problems in battery charging areas built by competitors. This was the case in 2014, when a multinational Fortune 500 company asked BHS to investigate battery room conditions at one of their major North American distribution centers (DCs).

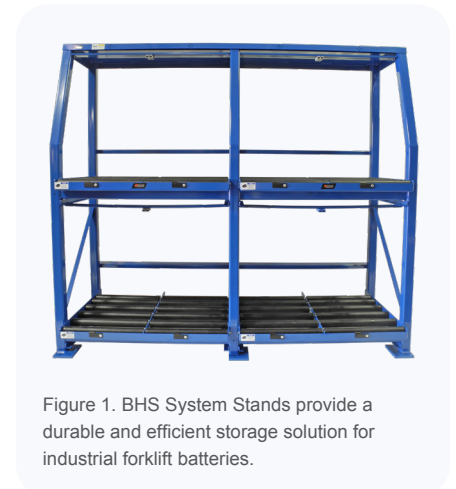
Figure 1. BHS System Stands provide a durable and efficient storage solution for industrial forklift batteries.

This equipment would need to be replaced by BHS System Stands (BS). Rugged steel construction, an acid-resistant powder finish, and poly-sleeved rollers prevent corrosion and acidic build-up on BHS System Stands, ensuring that the solution would be permanent.

1. Replace damaged battery racks and charger shelves with acid-resistant steel BHS System Stands. BHS System Stands are built to provide dependable, long-term service in the harsh environment of a battery room. They resist electrolyte spills, scratches, and impacts, ensuring that the client’s battery room will never reach the state of deterioration the BHS team found it in.
