Vacuum Cup Replacement

Models Affected: All Vacuum Equipped Units

Tech Tip
TT-901

Vacuum cup damage and replacement.

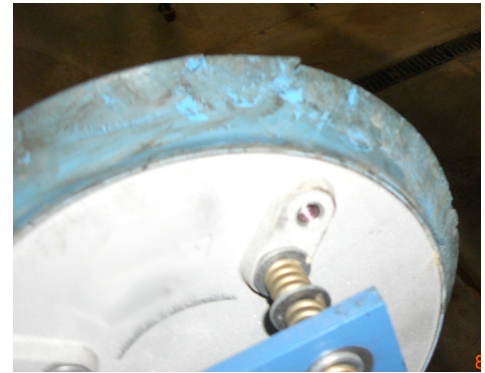
On units which utilize vacuum extraction, the vacuum cups are the most frequently replaced items. This is due to tearing of the sealing edge of the cup, separation of the rubber from the metal backing plate, or bending/breaking the metal backing plate.

Vacuum cup damage due to elevation adjustment after attachment to battery

When extracting a lift truck battery from either a lift truck or a charging stand, do not change the elevation of the roller bed, or rotate the extractor arm once engaged on a battery case. This causes the cup to slide along the battery case, typically leading the edge of the cup to curl or roll under. Repeatedly doing so will eventually cause damage to the cup assembly. To prevent this from happening, verification of the roller bed height and extractor arm position is critical prior to engaging the cup to the battery case. To help reduce curling of the cup edge, BHS recommends a silicone type lubricant be applied on the face of the cup to help the cup slide on the battery case. Using the vacuum cup as a hook to extract the battery by “hooking” the battery eye with the back of the vacuum cup will also lead to cup and mounting hardware damage. The vacuum cup should never be used in this manner.

Replace the vacuum cup if it has been torn or is separated from the metal backing plate. BHS offers multiple cup options with a standard mounting layout. All options are available for use on any BHS vacuum equipped extractor. For more information on available vacuum cup options, refer to Tech Tip TT-937. To find out more about proper mounting and hardware, refer to Tech Tip TT-913. These, as well as all of the latest Tech Tips, inspection forms and planned maintenance information, are available online. Go to BHS1.com and click on “Technical Literature” under the “Library” tab for the latest available information.

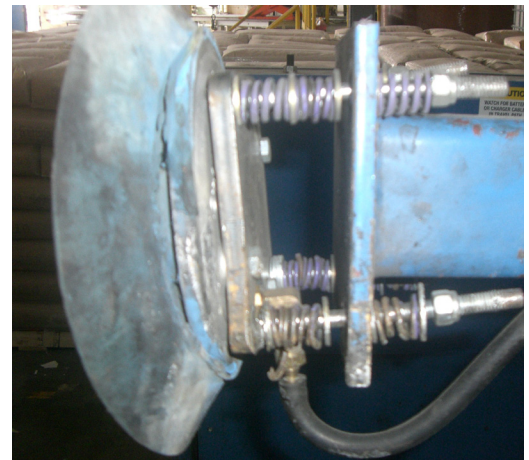
Vacuum cup and mounting hardware damage due to “hooking” battery eye with cup for extraction
