Folder: Parcel No. 72A. 185 East Indiana Avenue.

Project Area 1B
Parcel No. 72.A
185 East Indiana

Project Area 1-B
Parcel No. 72A

Address: 185 East Indiana
Owner: Mrs. S. Silver

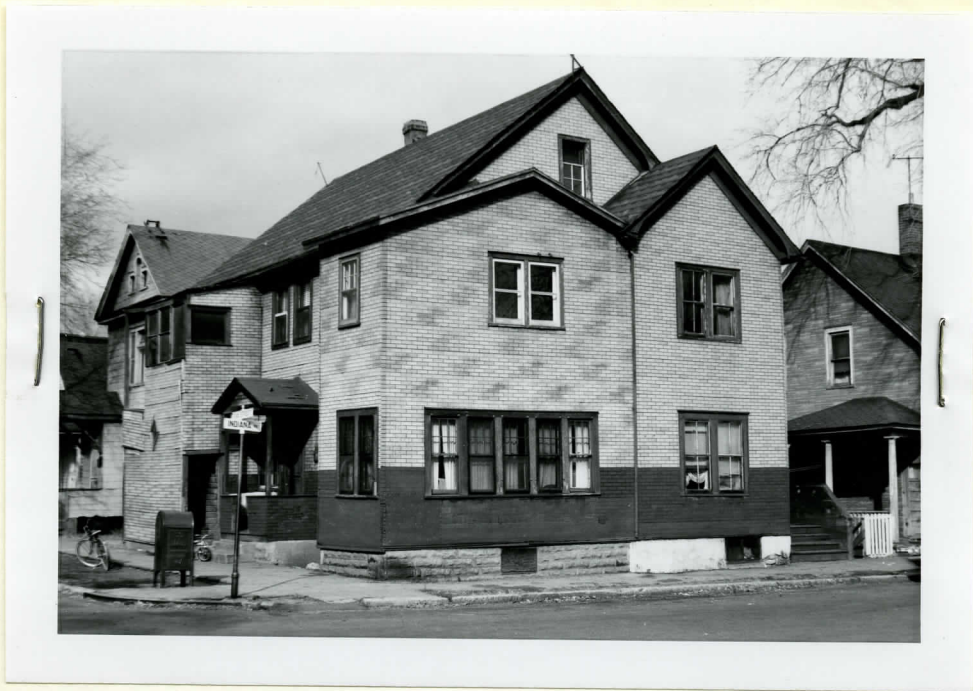
Front View

This building is located on the Northeast corner of Eva Street and East Indiana. It is bounded on the North by East Fairfield, on the East by Robertson and on the South by East Indiana and on the West by Eva Street. This is a rectangular two story frame building. The exterior is imitation brick asphalt siding and is in fair condition. There is no set back on Eva Street and there is no set back on East Indiana. The lot at Eva Avenue is about two feet below street grade and drops below grade to about eight feet at the rear. There is a composition rolled roof. At the rear of the building there is an exposed stairway to the first and second floor. The wood in this stairway is badly weather beaten and there are definite signs of dry rot. The lower Southwest apartment consists of two bedrooms, living room, dining room, kitchen and sun porch and bath. This unit is heated by an Oil Circulating Stove Heater. It has hardwood floors. There is a hand fired gas water heater. According to the tenant she pays \$38.00 a month rent, and furnishes her own heat and utilities. The condition of this apartment runs from fair to poor. The lower southeast corner apartment on first floor contains a bedroom and kitchen and a toilet. According to the tenant she pays \$30.00 a month, and furnishes her own heat and utilities. This apartment is heated by the cooking stove or oven in the kitchen. The condition of this apartment runs from fair to poor. There is an apartment in the basement which is entered from the rear. This apartment consists of storage room, bedroom, toilet and a living room. This unit is heated by a wood stove. This unit is in extremely poor condition. There is a full basement, stone wall foundation and partial concrete and dirt floor. The basement has no utility except for the above mentioned apartment. According to the tenant in the basement apartment he pays \$12.00 a month, and he pays his own heat and utilities. The upper south apartment is entered by the rear stairway and has just one entrance. This apartment consists of two bedrooms, a sitting room and a kitchen. There is a hand fired hot water heater. It is heated by an Oil Circulating Stove. There are hardwood floors, lath and plaster walls which are in very poor condition. The full bath for this unit is up a very steep narrow stairway on the third floor and is very difficult to get to. It is entered by walking through the attic to the room finished for the bath. According to the tenant she pays \$25.00 a month, and furnishes her own heat and
