Project Area 1B
Parcel No. 119A
198-200 East Indiana

Project Area 1-B
Parcel No. 119A

Address: 198 and 200 East Indiana
Owner: Isaac Simes

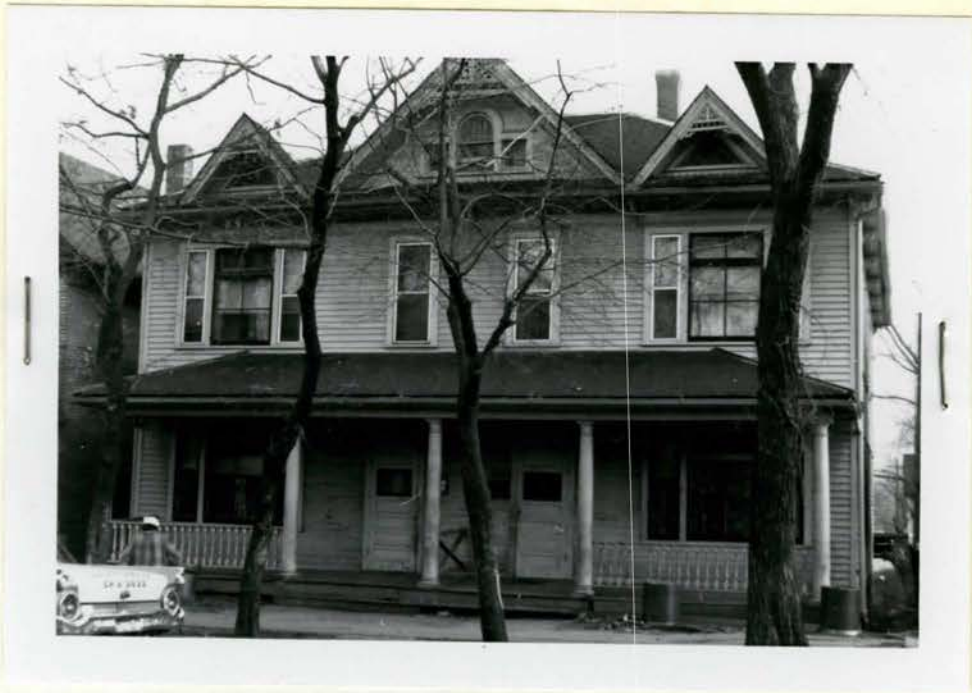
Front View

This property is located on the South side of the street and is North facing. It is bounded on the West by Eva Street, on the East by Robertson, and on the South by East Chicago. The building is a rectangular two-story frame four-plex. The exterior is a wood lap siding and there is a composition roof. There is an open one-story porch across the front. The exterior of this building is in very good condition. There are combination storms and screens around the second floor. There is a two-story stairway and open porch across the rear of this building. The porch is in very good condition and appears to be fairly new. The lot is level at the front and it slopes to about five feet below street grade at the rear. There is no building set back on East Indiana. There is an old storage shed across the rear of the lot. At one time this was used as a garage, but at the present time it has been boarded up and made into pigeon coupes with mesh cages. 200 East Indiana which is the lower East apartment consists of two bedrooms, living room, dining room, kitchen and full bath. This apartment has natural oak trim, hardwood floors, and is in very good condition. According to the tenant she pays \$40.00 a month rent and furnishes her own heat and utilities. This unit is heated by a new gas hot water furnace in the basement. There is also a new automatic gas hot water heater for this unit. The upper East unit at 200 East Indiana is entered by an inside stairway. This unit contains two bedrooms, living room, dining room and kitchen and full bath, and has hardwood floors. The condition of this apartment is fair. It needs some decorating and there are a few cracks in the walls and ceilings. It has natural oak woodwork. According to the tenant, she pays \$47.50 a month and pays her own heat and utilities. This unit is heated by a new gas hot water furnace located in the basement. This unit also has a new gas automatic hot water heater. The upper West unit is known as 198 East Indiana, is entered by an inside stairway, and consists of living room, dining room, kitchen, two bedrooms and a full bath. In order to enter the living room and dining room you must walk through one bedroom. There are hardwood floors and the condition of this unit is poor, as it needs decorating and there are bad cracks in the plaster. According to the tenant of this unit she pays \$60.00 a month and the owner furnishes the heat, but the tenant pays her own utilities. In the hall there is a ladder which reaches to a crawl space in the attic. This is a full attic with rough flooring. The information about the attic was given to us by the owner. The lower West unit at 198 East Indiana contains one bedroom, living room, dining room, kitchen and full bath. There are

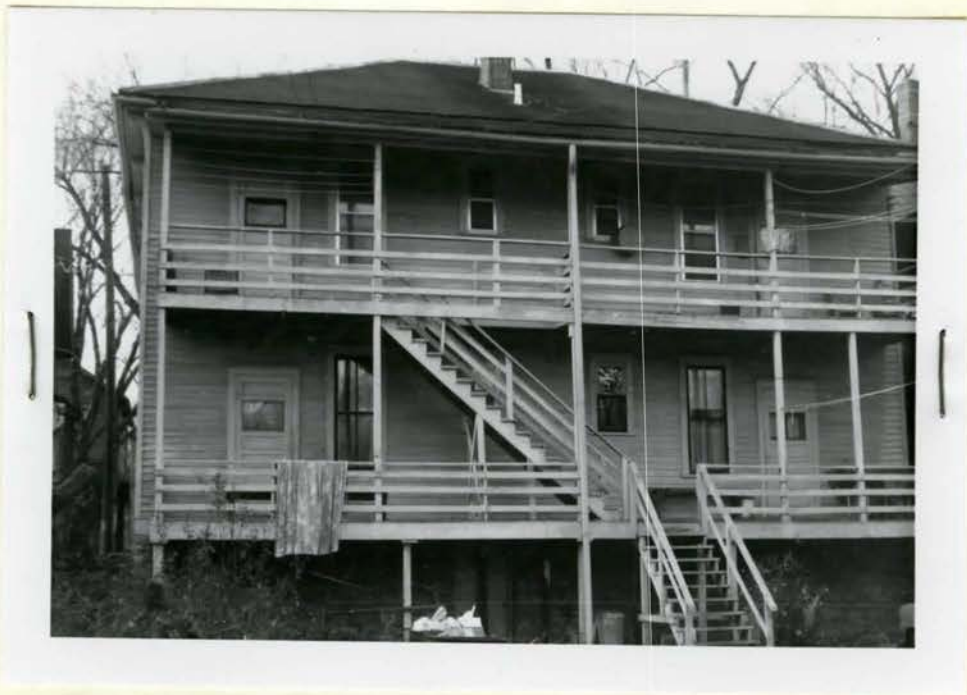
Rear View

hardwood floors. The condition of the walls and ceilings is poor, as they need decorating badly. On the ceiling in the hallway of this apartment the plaster has fallen off leaving a large hole where the lath underneath is exposed. According to the tenant in this apartment she pays \$60.00 a month and pays her own utilities. The owner furnishes the heat. There is a full basement with stone wall foundation and cement floors. There are two new gas hot water heating plants in the basement. The basement has separate storage lockers for the tenants and there is a laundry room. This basement is also reached by an outside stairway as well as an inside stairway. The total monthly rent of this building is \$207.50, gross. According to the owner he paid \$8000.00 for this building about five years ago. He paid \$4000.00 down and borrowed \$4000.00 on a mortgage from the Twin City Federal. Since buying the building he has put in two new gas automatic hot water heaters and two new gas hot water furnaces on 200 East Indiana Avenue in the East section of the building. This owner also put on the combination storms and screens on the second floor. He also rebuilt the open stairway and porches on the rear of the building.
