Folder: Parcel No. 140A. 163-167 E. Chicago Street.

Project Area 1B
Parcel no. 140A
163 - 167 East Chicago

Project Area 1-B
Parcel No. 140A

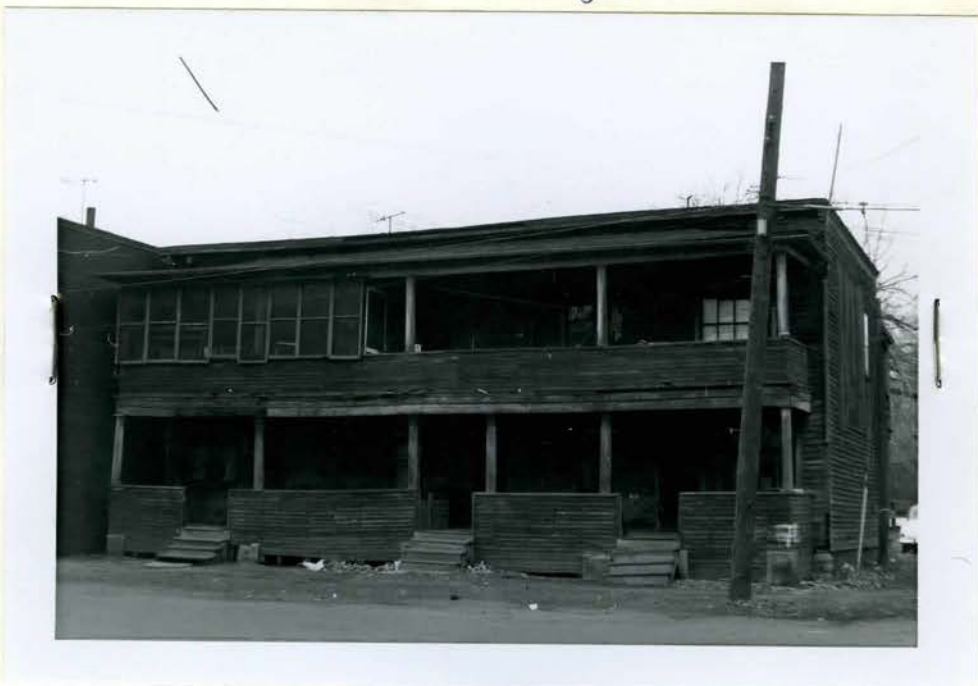
Front View

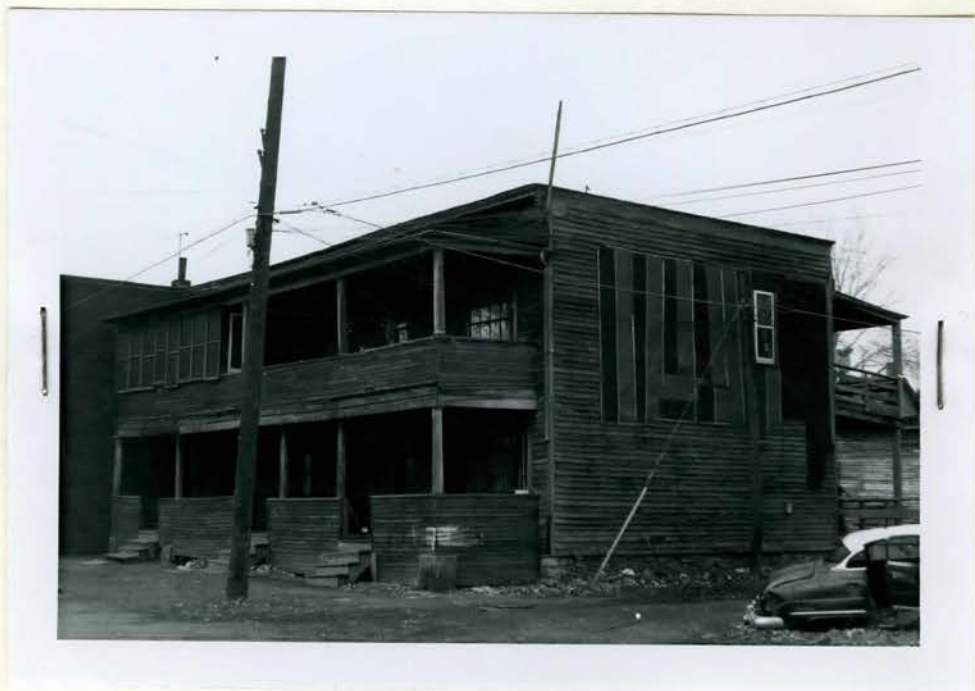
Front and Side View

This property is located on the North side of the street and is South facing. It is bounded on the East by Eva and on the North by Fairfield and on the West by Eaton. The building has a nine foot set back from the street. This is a rectangular frame two-story four-plex. The exterior is a wood lap siding and the condition of this siding is very poor. It is quite evident that the exterior has not been painted for many years. It is badly weather beaten and there are many spots that show definite signs of rotting. There is an open two story porch across the front. There is an open stairway and two story porch running across the rear of the building which is irregular in size. This porch and stairway are in very bad condition and the wood is rotting. The building has four rental units. The lower East unit consists of one bedroom, living room, kitchen and toilet only. This building is suffering from settlement and the floors in this unit have a definite sag to them. The condition of the walls and ceilings is very, very poor. There are many cracks and chips in the plaster. This unit is heated by a wood stove. According to the tenant he pays \$22.00 a month rent and pays his own heat and utilities. The lower West unit consists of one bedroom, living room, dining room and toilet only. The floors show definite signs of sag. The condition of this unit is very poor. There are cracks and chips in the plaster on the walls and ceilings. This unit is heated by an oil stove. According to the tenant he pays \$25.00 a month and pays his own heat and utilities. The second floor of this building is entered by a doorway in the center of the building which opens to a stairway leading directly to the upstairs. The first floor units do not have their entrances off this stairway. The entrances for the first floor are on each end of the outside of the building. The walls and the ceiling in the stairway to the second floor are badly cracked and some of the plaster is falling off. The upper East unit consists of two bedrooms, living room and kitchen, and a toilet only. This unit is heated by an oil space heater. The floors here also have a definite sag. The condition of this apartment is very, very poor. There are cracked walls and ceilings and the plaster is chipped. This unit is badly in need of decorating. According to the tenant he pays \$22.00 a month rent and furnishes his own heat and utilities. The upper West unit contains two bedrooms, living room, kitchen and toilet only. The condition of this unit is very poor. The plaster on the walls and ceiling is badly cracked and chipped. This apartment is much in need of decorating. There are hardwood floors on the second floor in both units. The upper West unit is heated by an oil space heater and according to the tenant he pays \$22.00 a month rent and pays his own heat and utilities. This tenant

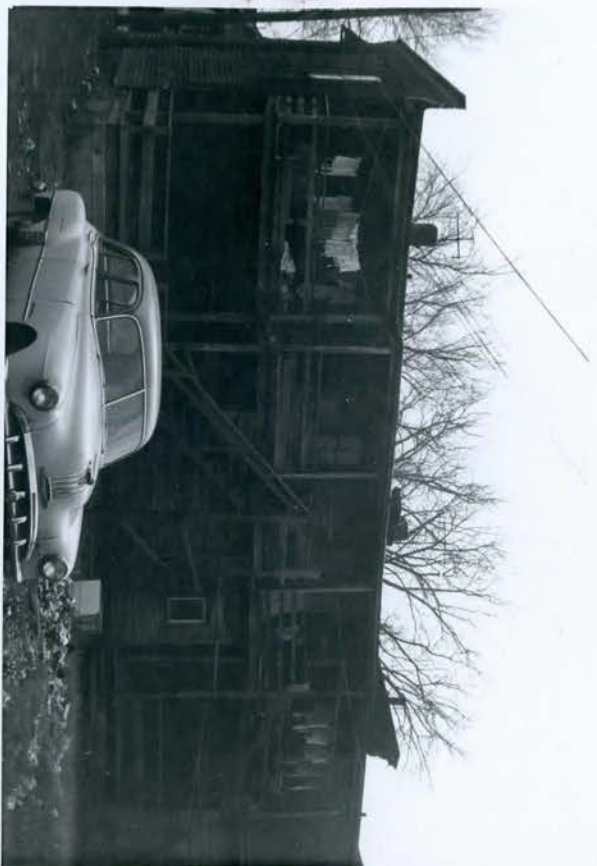
Rear View of Main Building

stated that he has lived in the building for fifteen years. There is a full basement with a stone foundation and a dirt floor. The North wall of the basement has been partially repaired with concrete block. There is a trap door on the back porch which is the entrance to the basement. At the Northwest corner of the rear of the lot, there is a very dilapidated shed. This shed has no value and no utility.

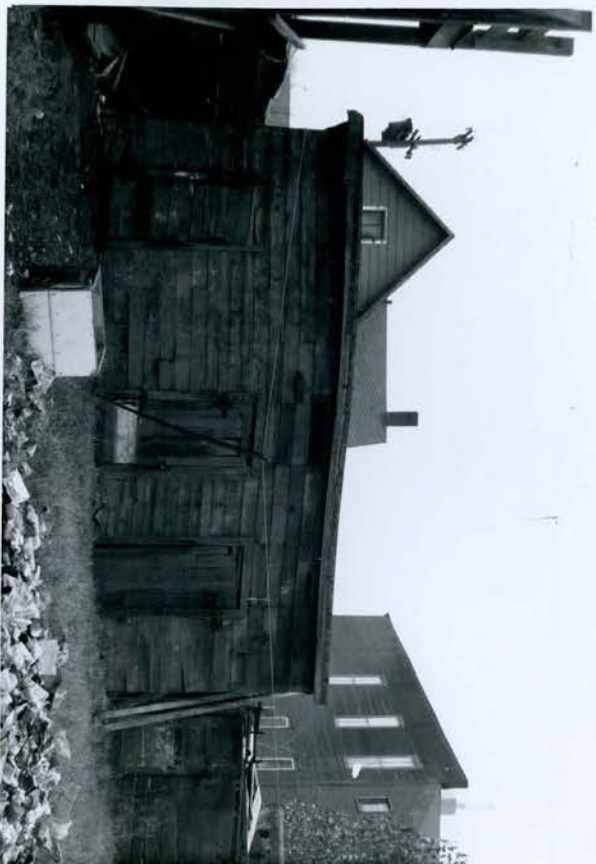
View of Sheds
