Collection: Port Authority of the City of Saint Paul.
Records.

Project Area 1B
Parcel No. 216
145 East Indiana

Project Area 1-B
Parcel No. 216

Address: 145 East Indiana
Owner: Royal Realty Company

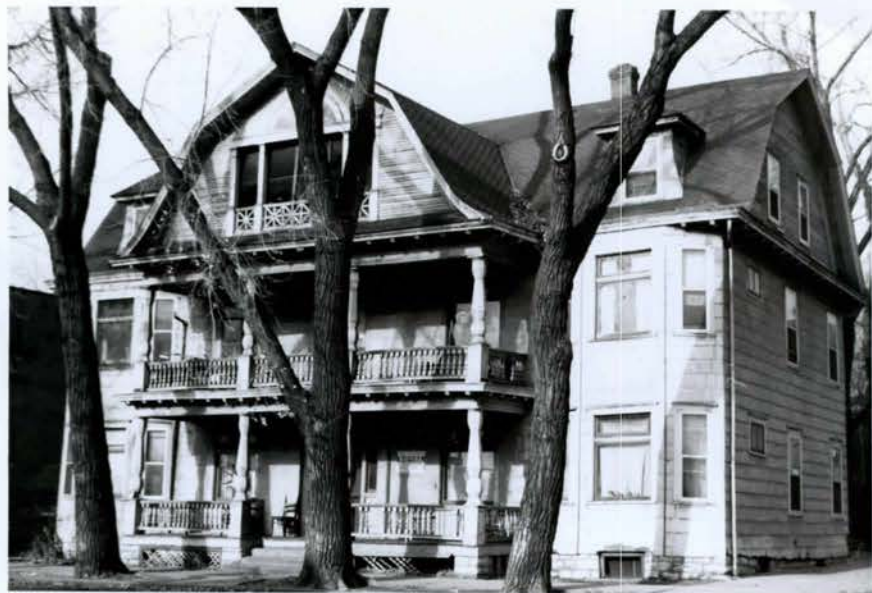
Front View

This property is located on the Northwest corner of Eaton Avenue and East Indiana. It is bounded on the West by Robert Street, on the North by East Fairfield. There is a two foot set back on East Indiana and there is no set back on Eaton Avenue. The building is a rectangular three story apartment structure containing six rental units. The exterior is asbestos siding with a composition roof. The front porch is leaning towards the main building and is sagging and in very poor repair. The building has suffered severe settlement, having sagged about two feet in the rear part. The exterior siding is cracked and chipped. There are combination storms and screens on first, second and third floors. There are two bays on the front of the building. There is an open two story pillar porch on the front of the building. There is also an enclosed three story stairway on the rear. There is a two story addition on the rear. The back yard is all cemented and blacktopped, and this makes it ideal for a laundry area. The lot is level with the street. There is a central entry way in the front of the building providing the entrances to the apartments and a central stairway to the second and third floors. The lower east unit is known as apartment one. This apartment consists of two bedrooms, living room, dining room, kitchen and full bath. There are hardwood floors. Because of the severe settling of the building, the floors are all severely tilted towards the rear. The caretaker indicated that the tenant in this apartment pays \$57.50 a month and they pay their own utilities. This apartment is generally in very poor repair and is very badly in need of decorating. The plaster is in very poor condition. The lower West apartment is known as apartment two. This apartment consists of two bedrooms, living room, dining room, kitchen and full bath. Again the floors are very badly sloped and tilted towards the rear. The tenant indicated that they pay rent of \$57.50 per month and pay their own utilities. This apartment is again in very poor condition and in very bad need of decorating. The walls and the ceiling are badly cracked. The floors are hardwood. The second floor (east apartment) known as apartment number four consists of two bedrooms, living room dining room, kitchen and full bath. The tenant in the apartment indicated that she pays \$45.00 a month rent and pays her own utilities. There are hardwood floors and again the sagging is very severe. The walls and the ceilings are very badly cracked and the apartment is very much in need of decorating. The second floor West
