Minnesota.  
Department of Conservation.  
Photographs of State Parks, Monuments,  
Recreational Areas, and Staff.

LAC QUI PARLE

PRINTS WITHOUT NEGATIVES

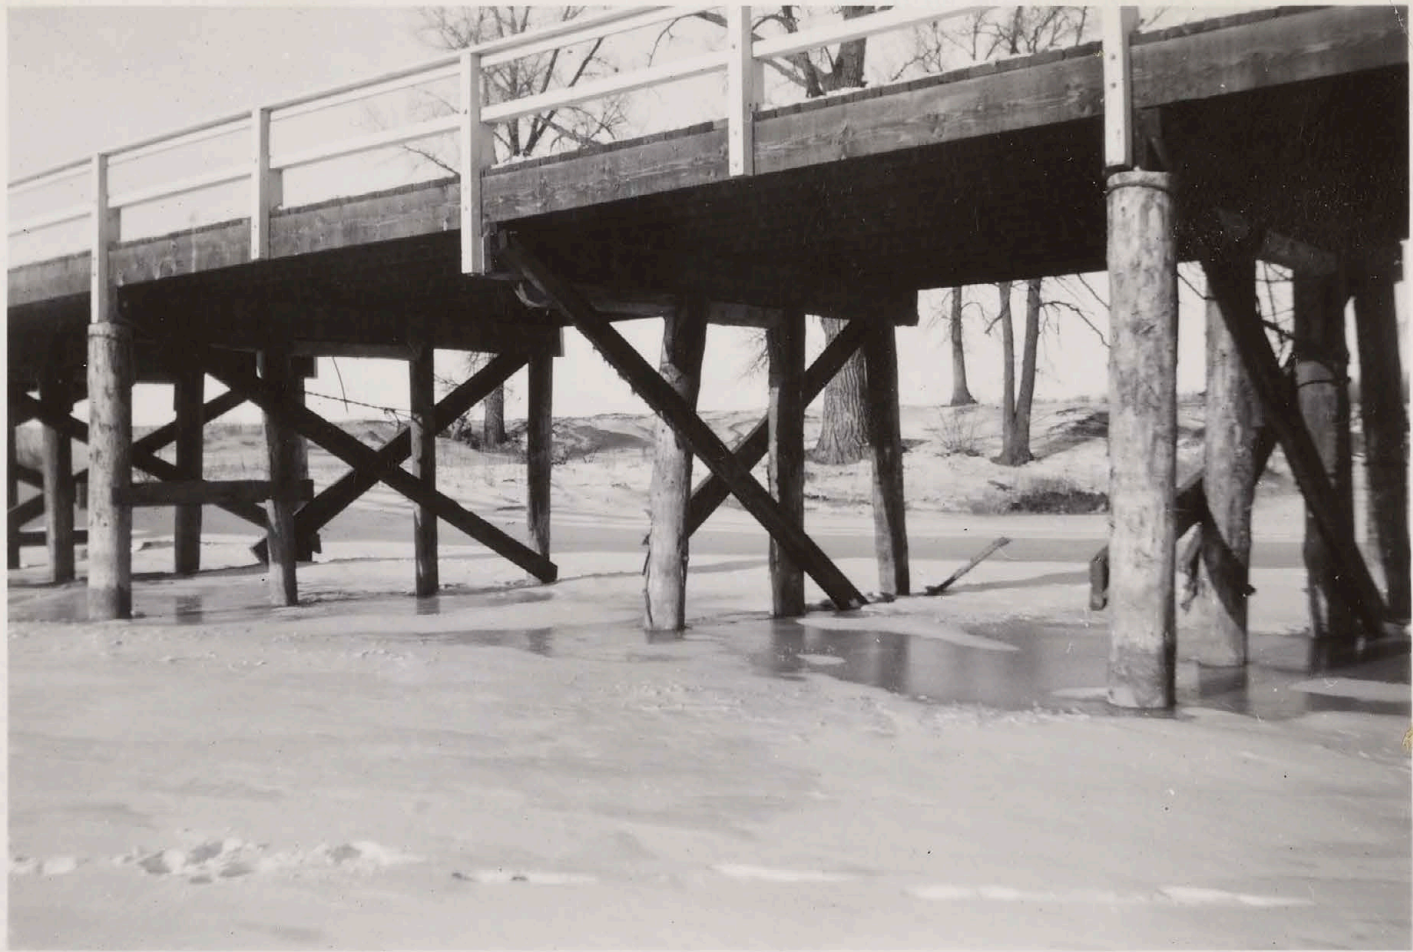
Piling taken out by ice in spring of 1940.

Note: Pile bent on either side weakened by ice impacts making it necessary to hold piers in place with cables.

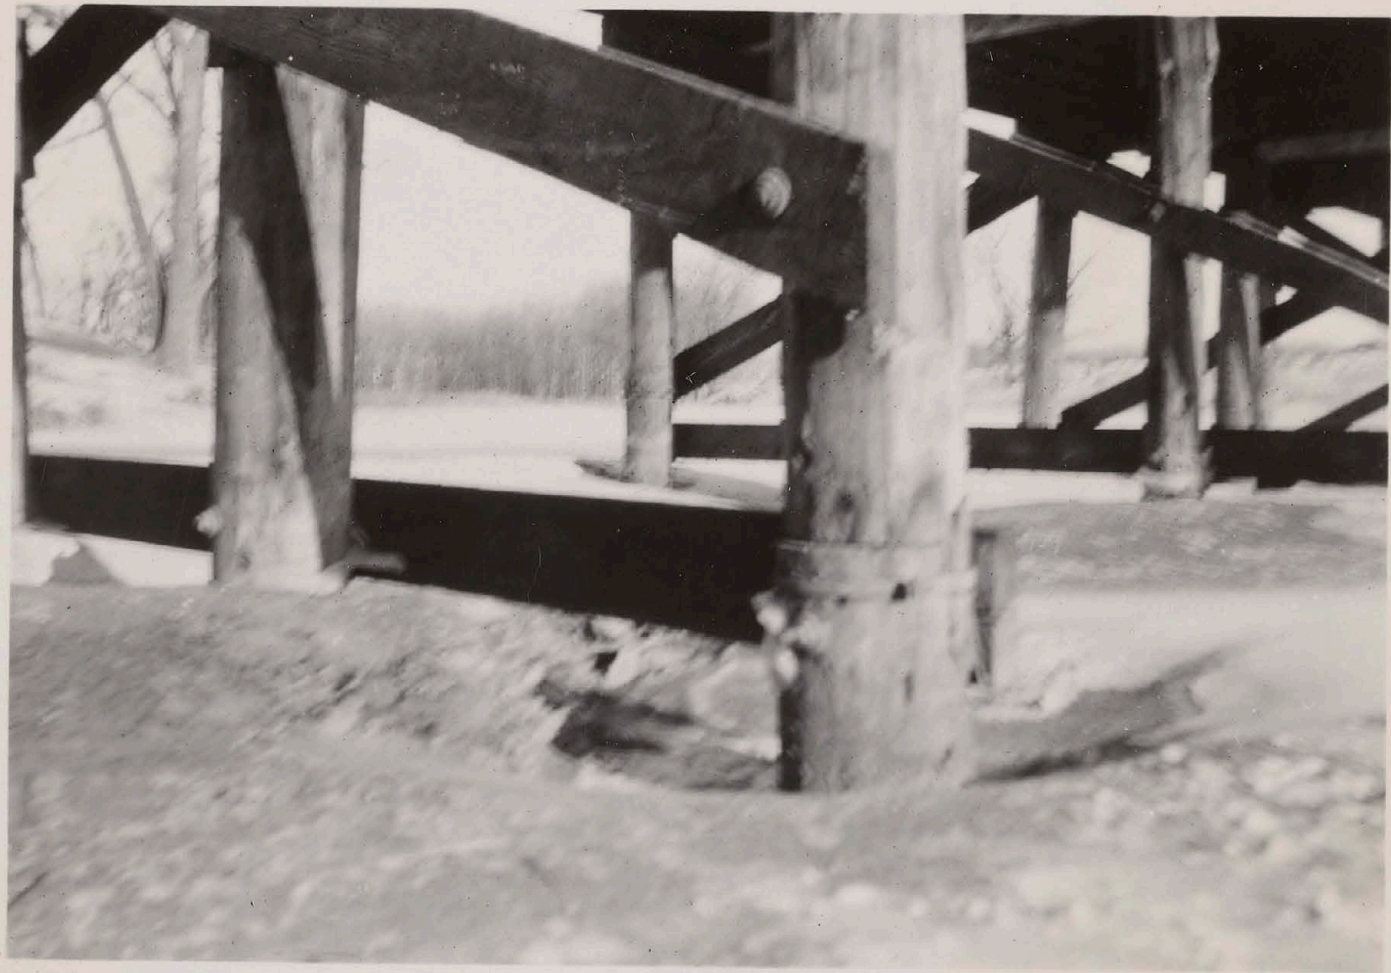
68

Piling in pier sheared off by ice  
which were later spliced.

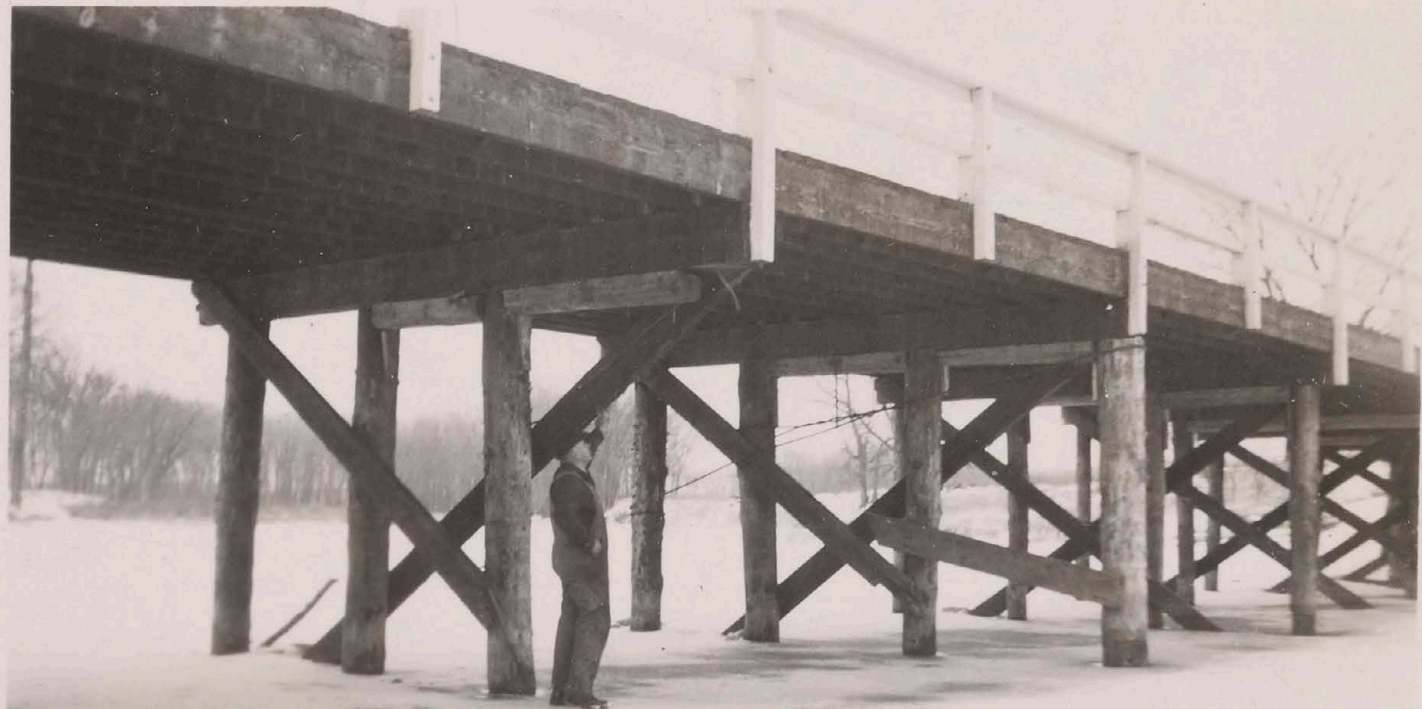
E 4 2

Piling taken out by ice in spring  
of 1940.

Note pile bent on either side weakened  
by ice inpacts making it necessary  
to hold piers in place with cables.
