# MISSISSIPPI RIVER BRIDGE

SHOWING METHODS AND PROGRESS OF CONSTRUCTION.

1925 — 1926 .

C. R. HANSEN,

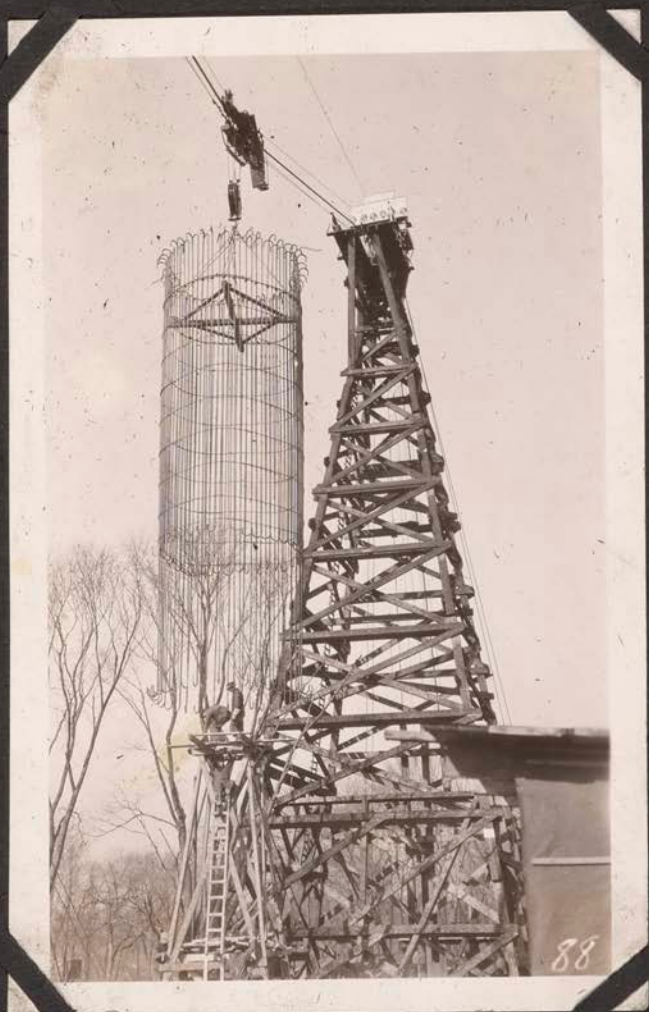
Assembled Caisson Reinforcing.

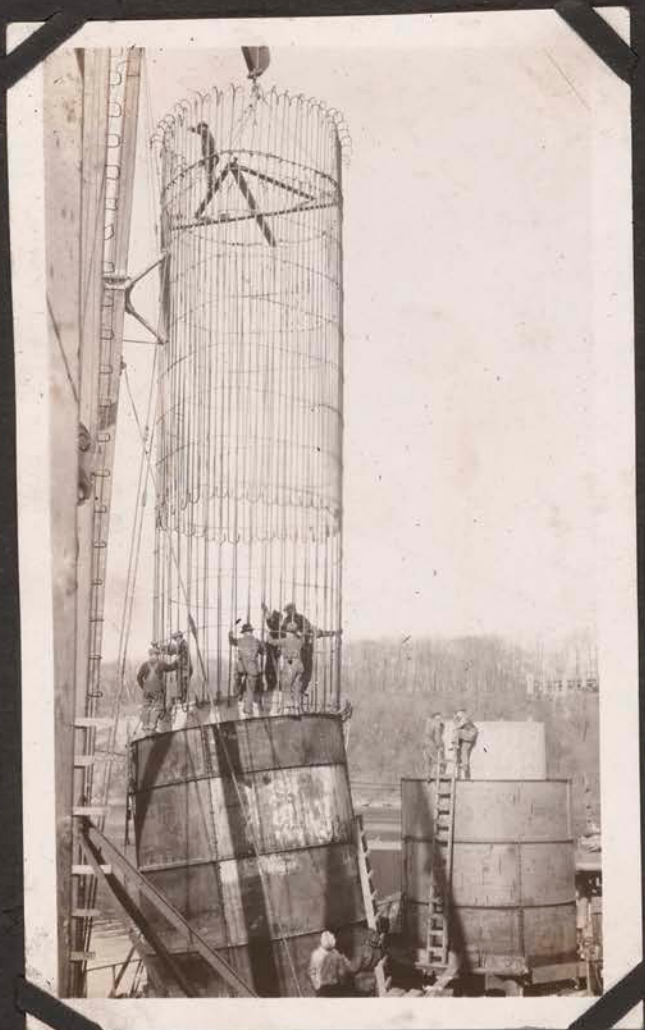
Placing Caisson Reinforcing Pier 9

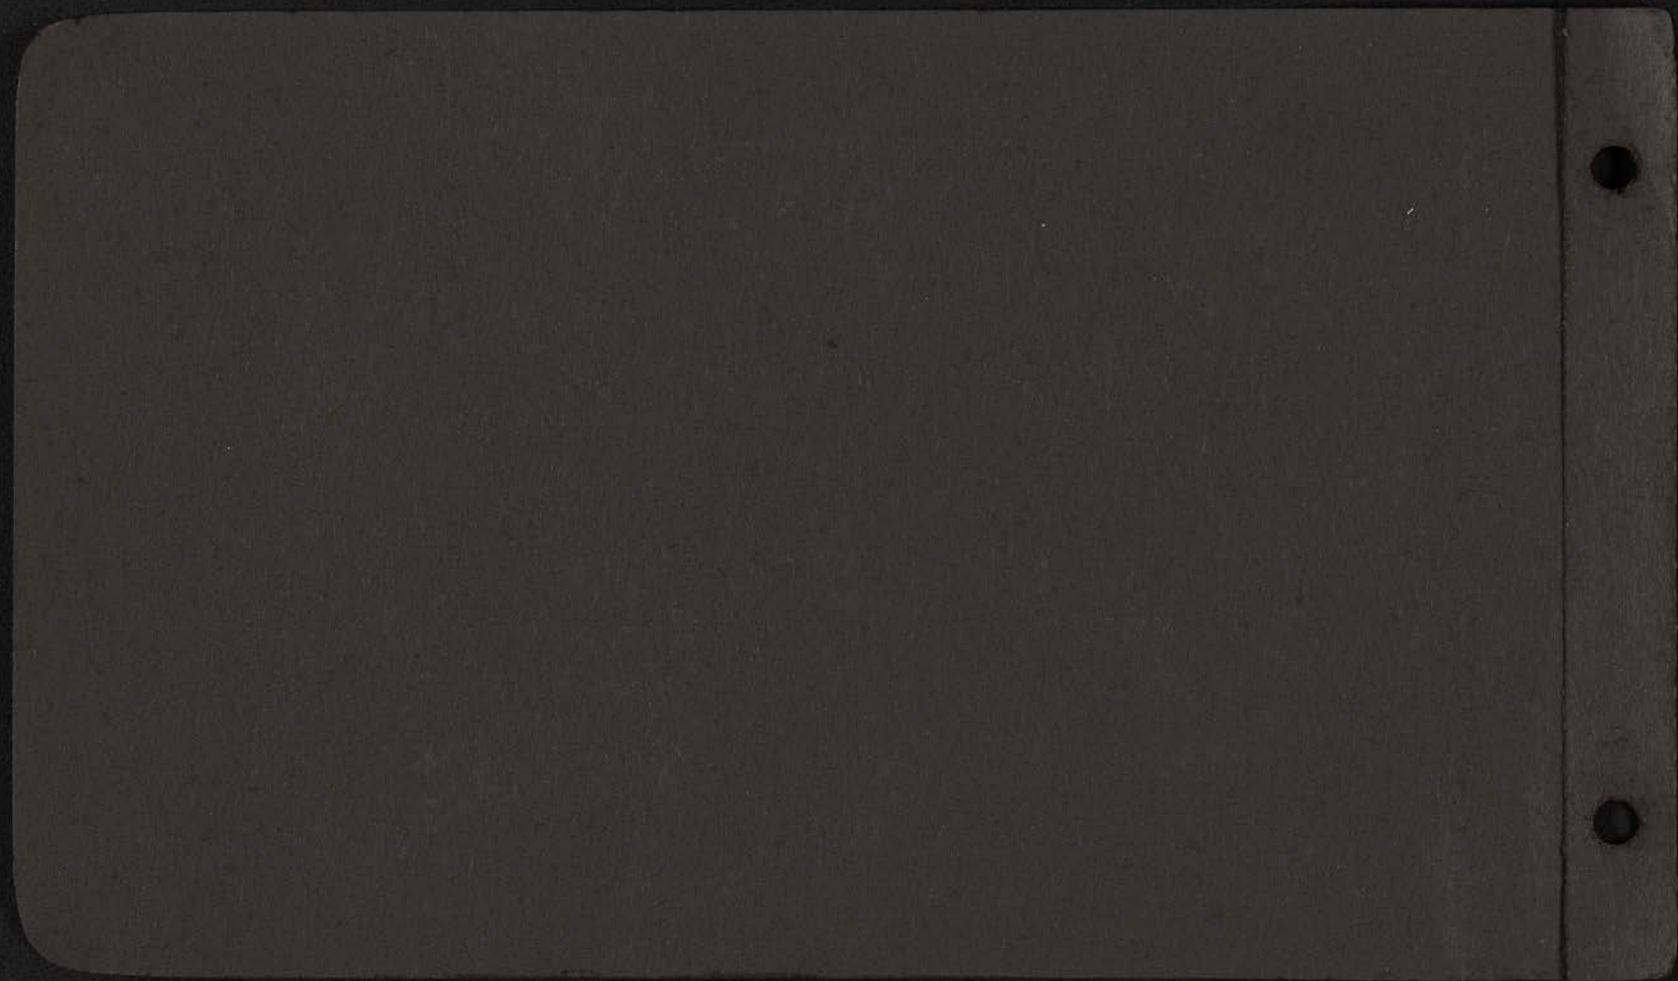
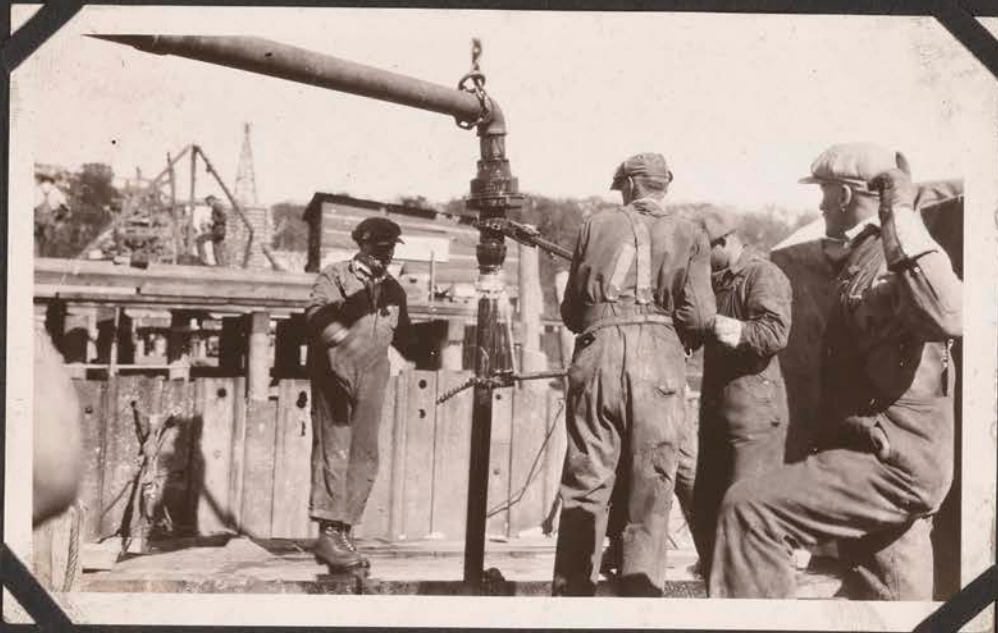
Sinking Caisson by Jetting

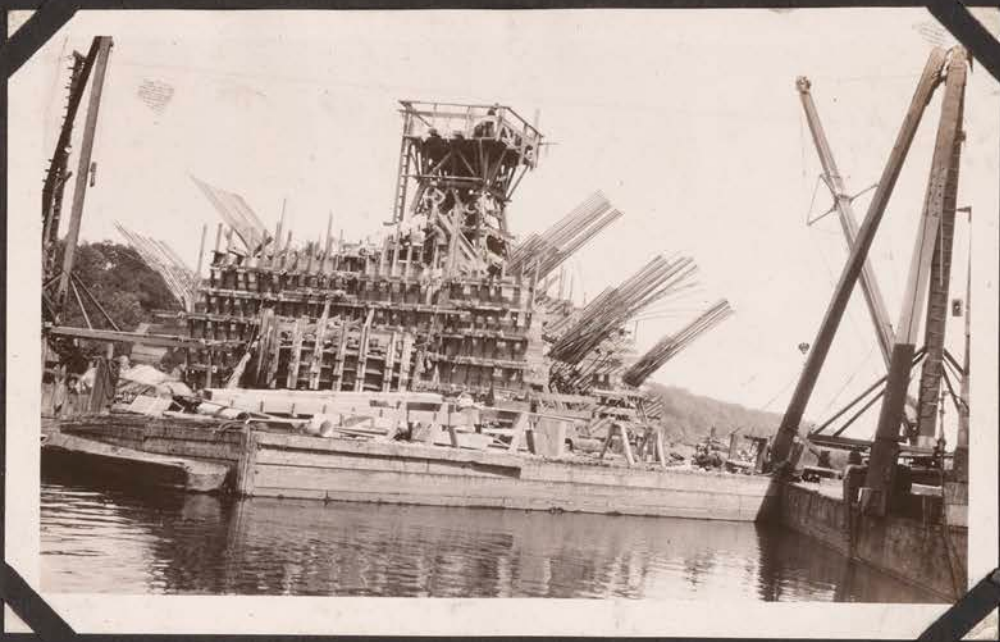
Pouring Haunch Section, Pier 9, June 26, 1926.

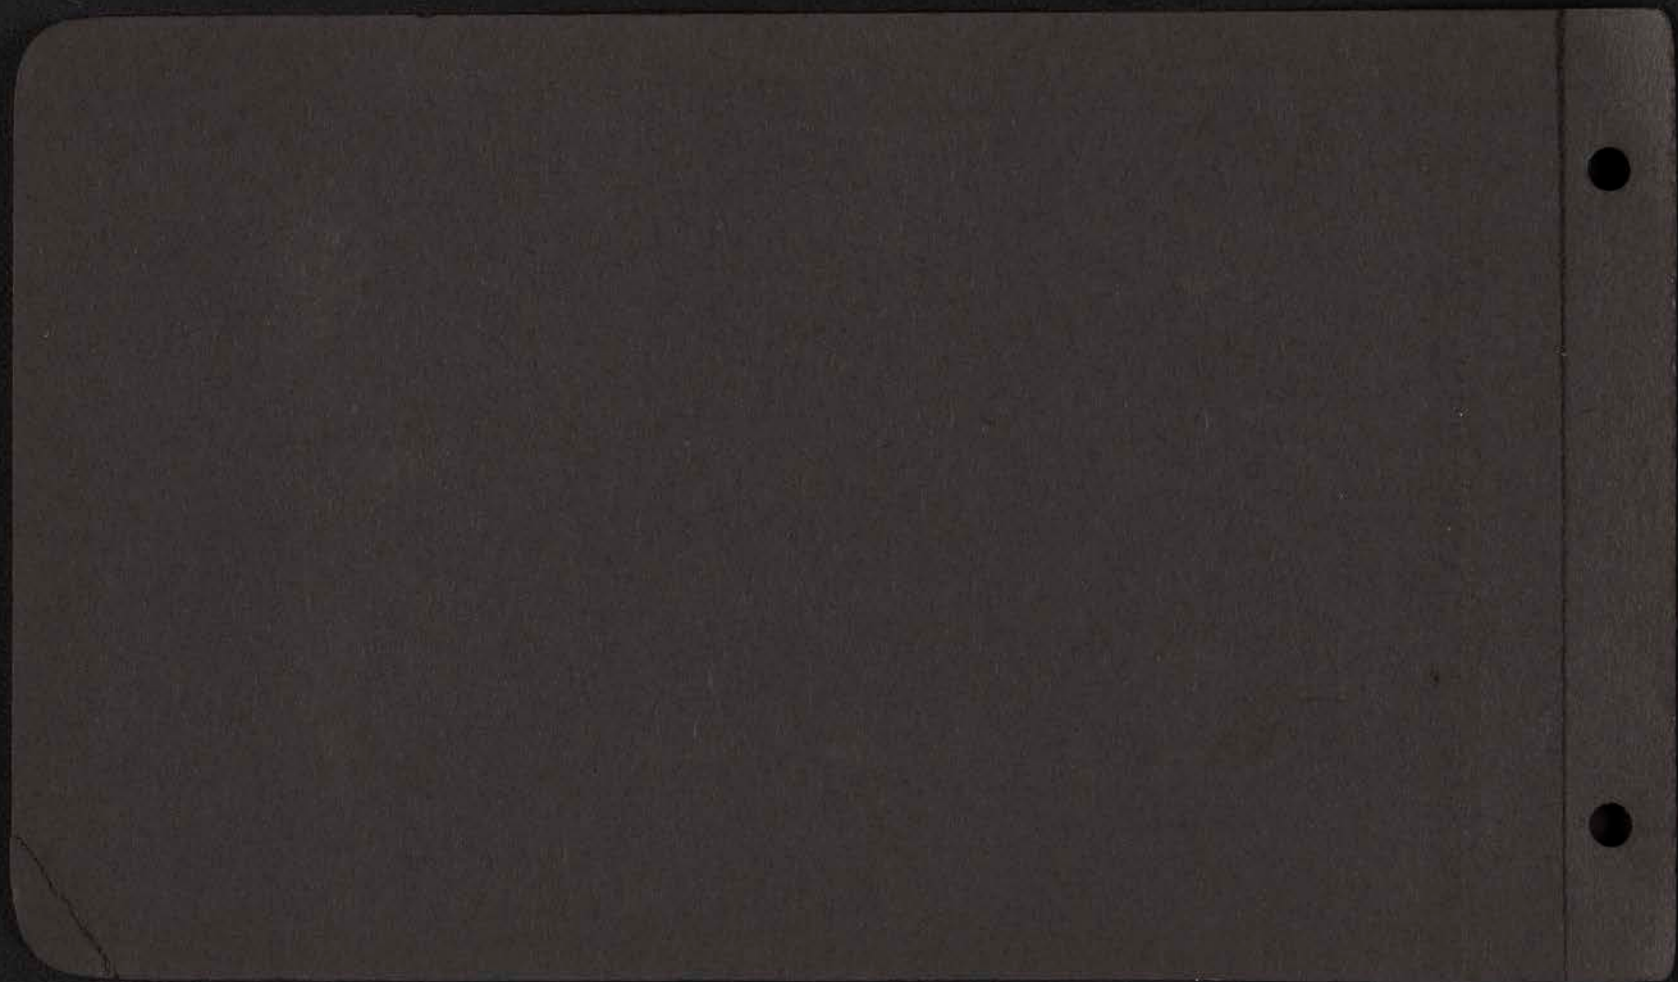
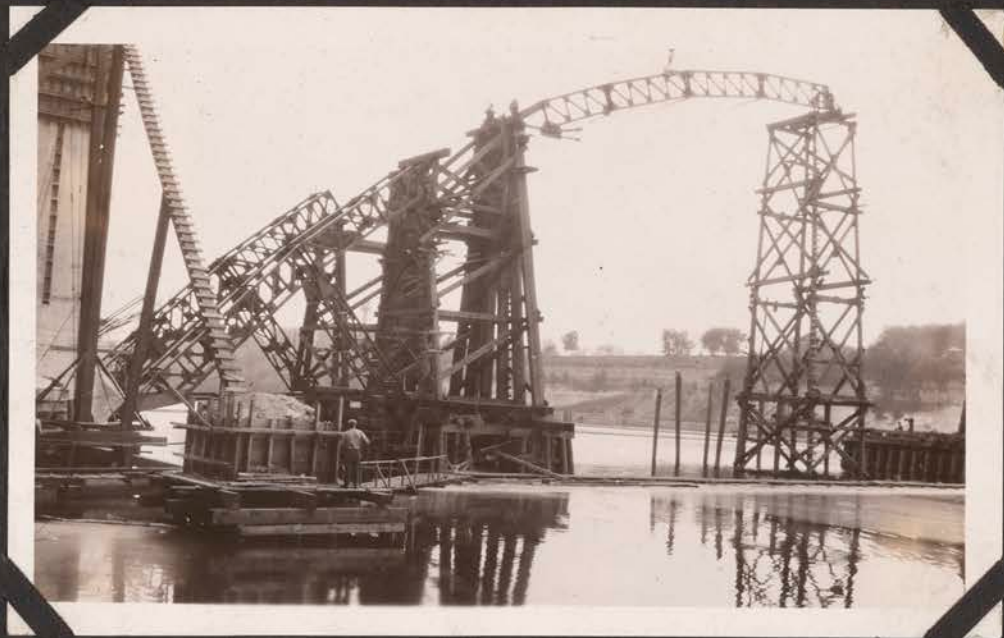
Erecting Arch Centering May 12, 1926.

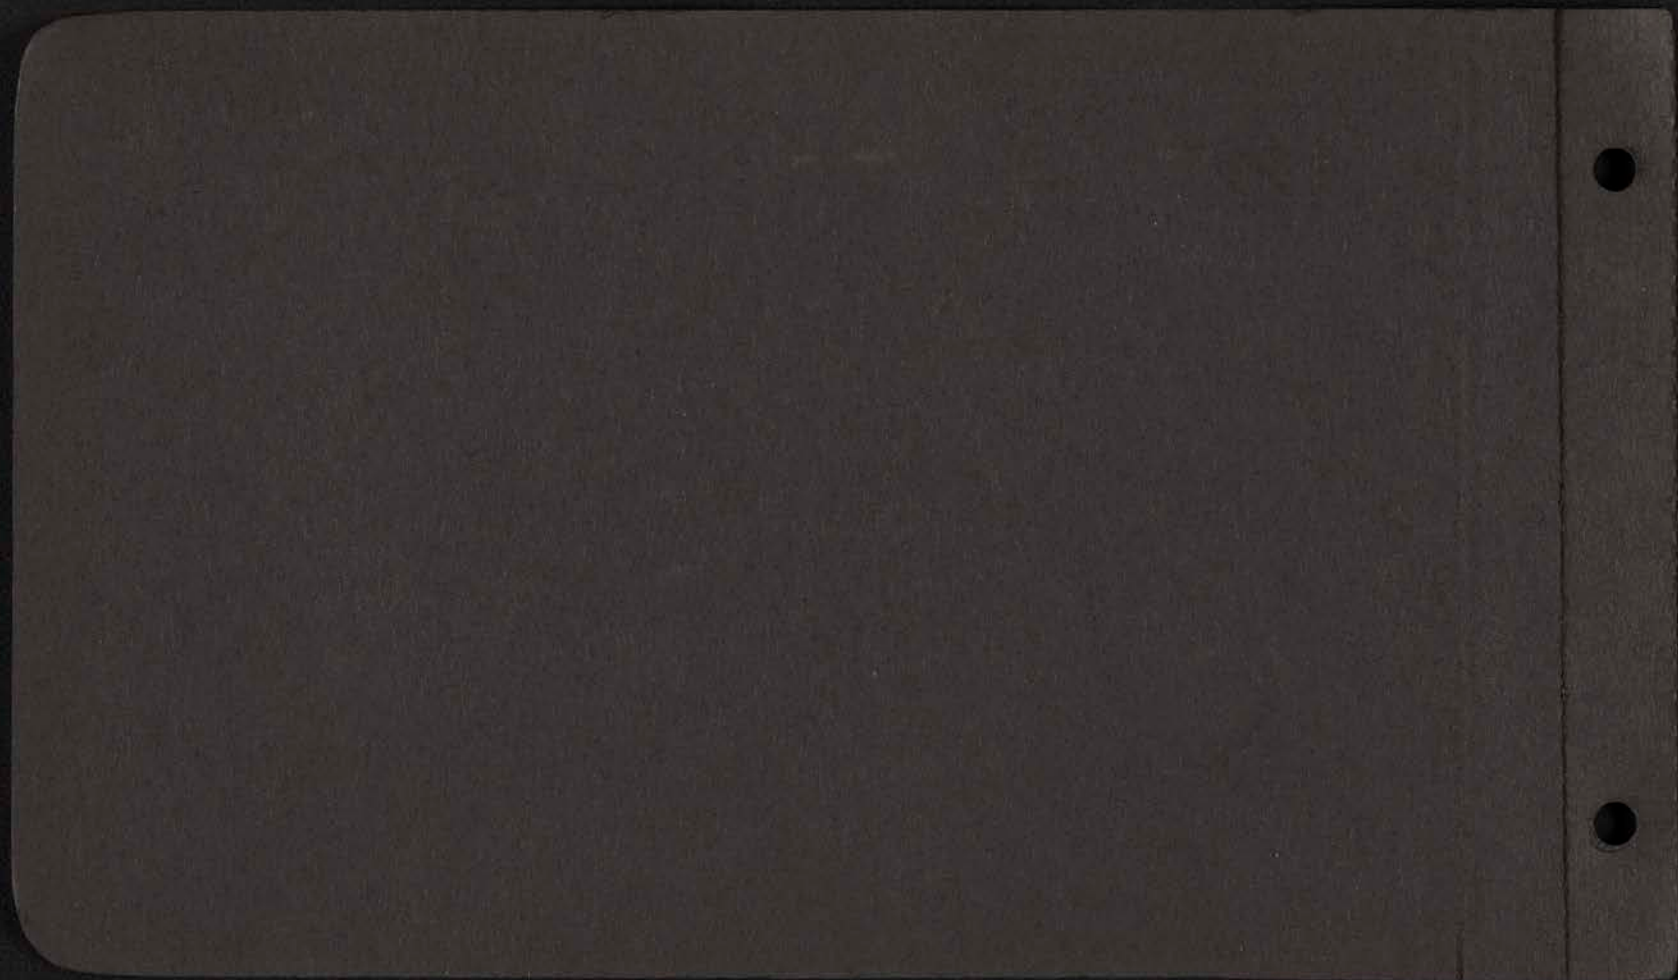
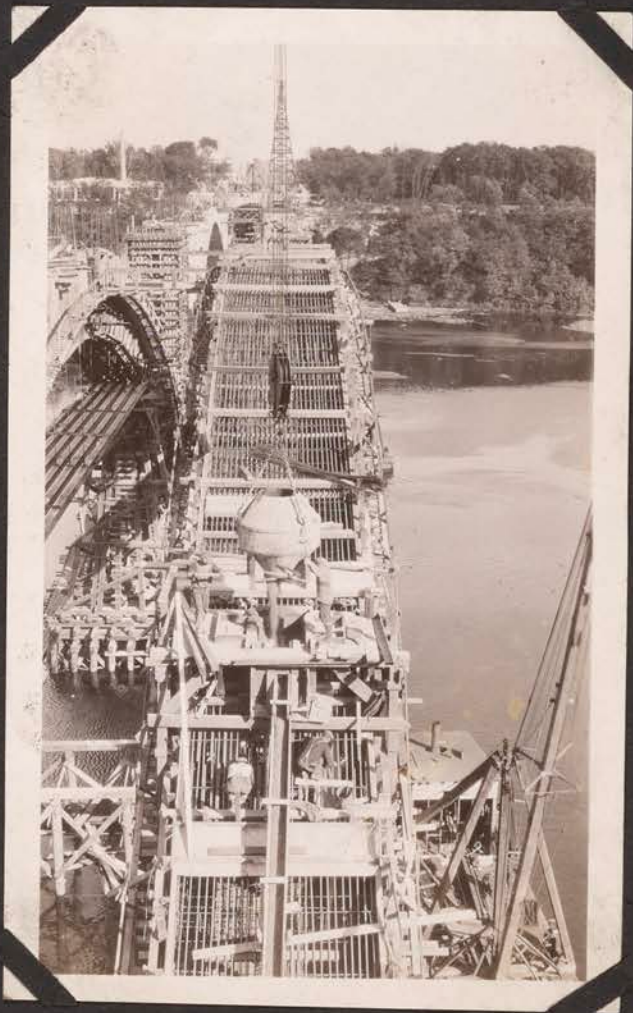
Pouring Concrete in Rib

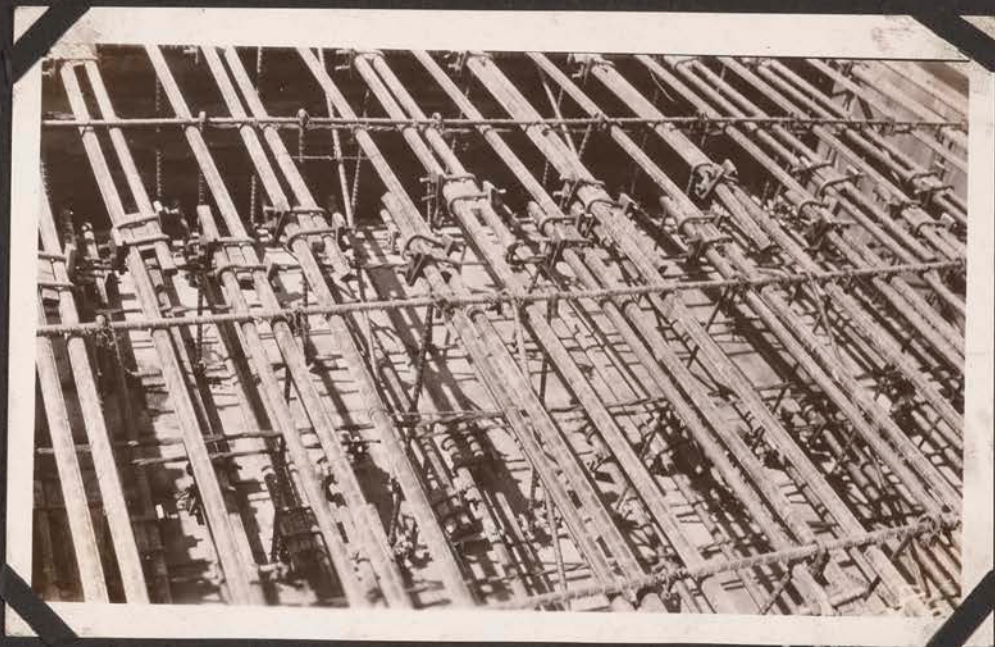
Typical Splice in Arch Rib Reinforcing.

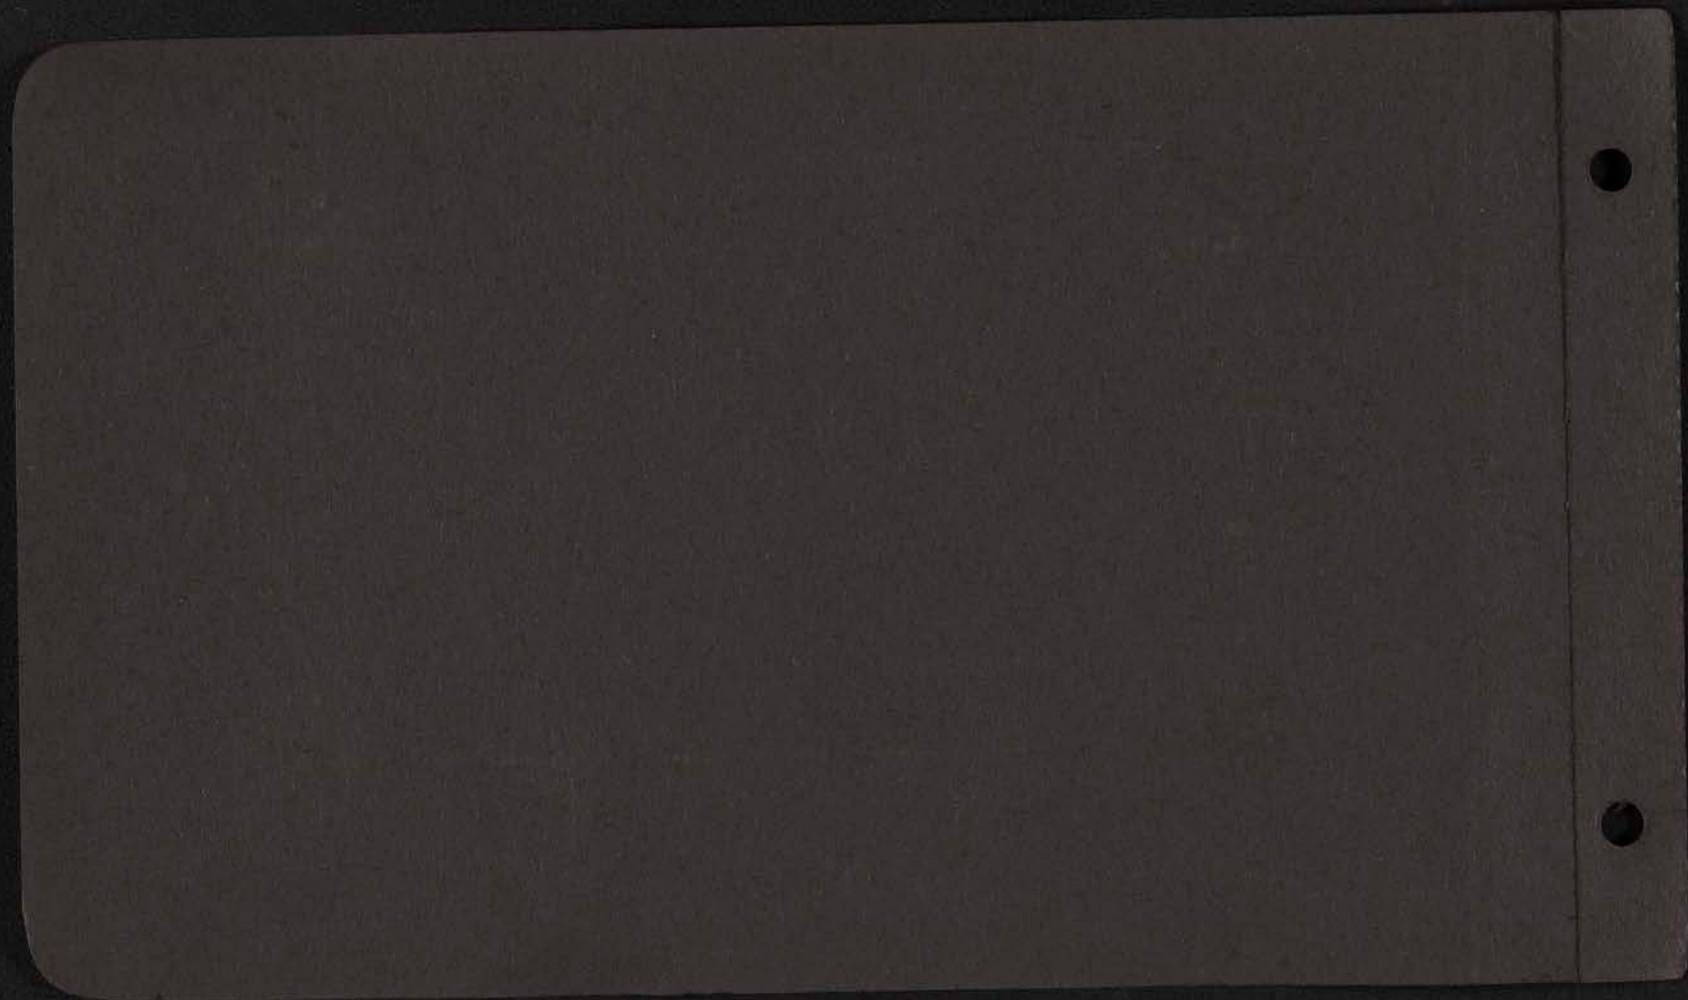
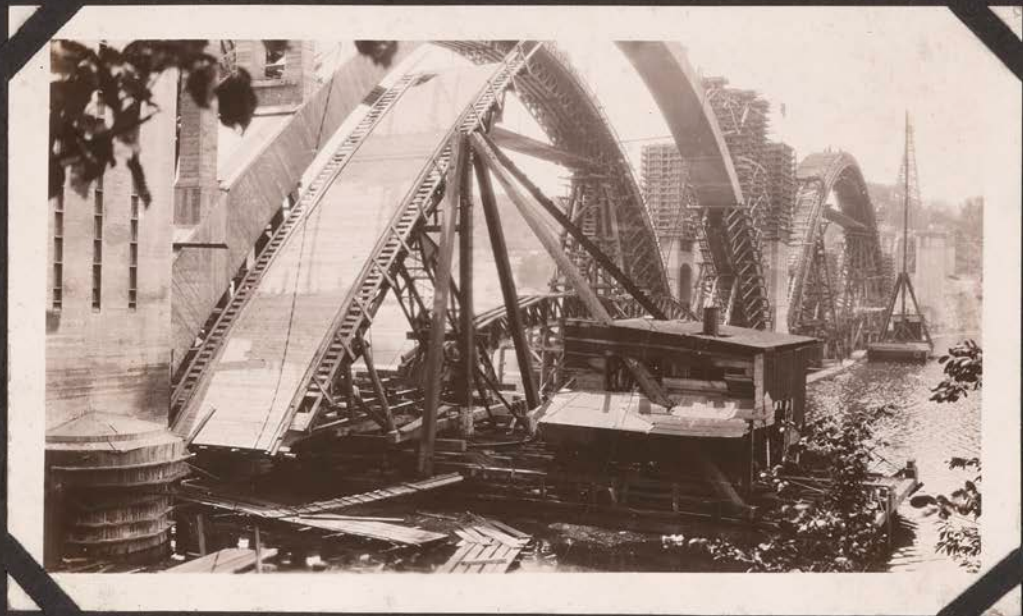
Removing Arch Centering

July 31, 1926.

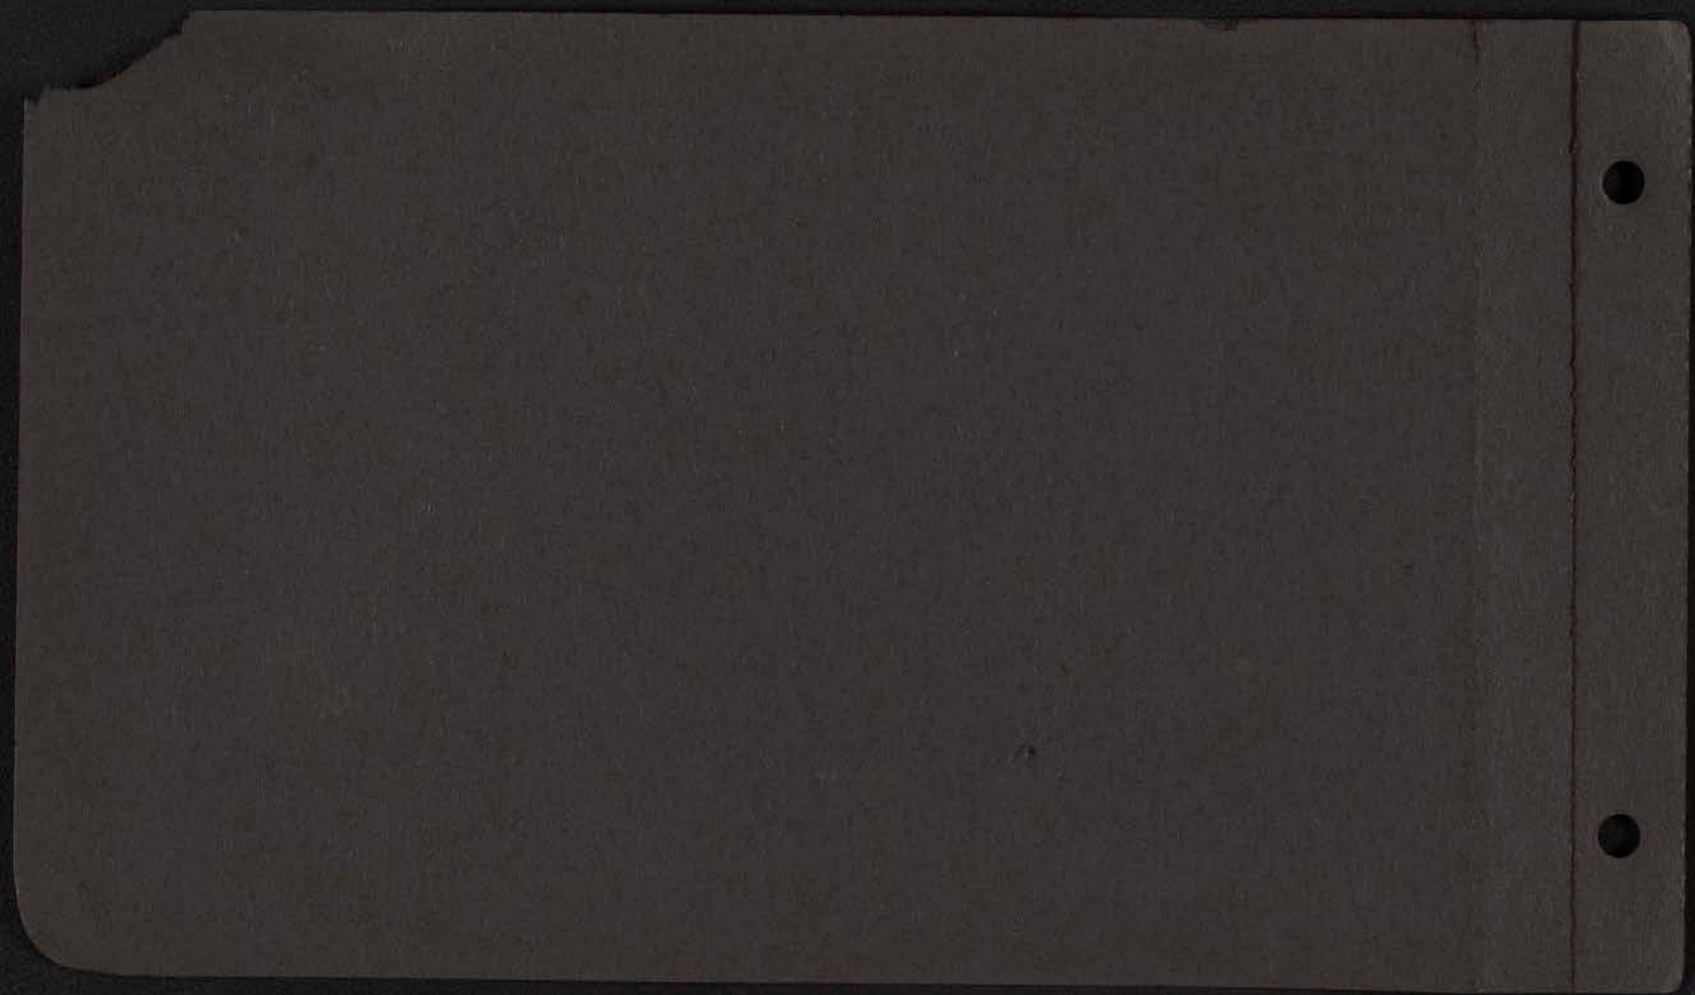
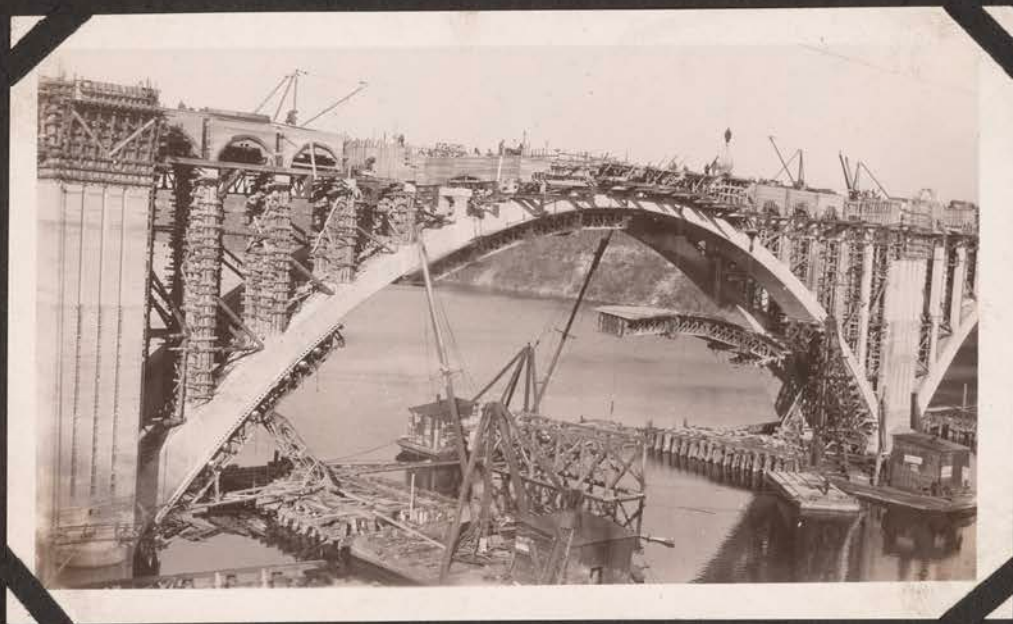
Lowering Steel Centering S. Rib Span 9.

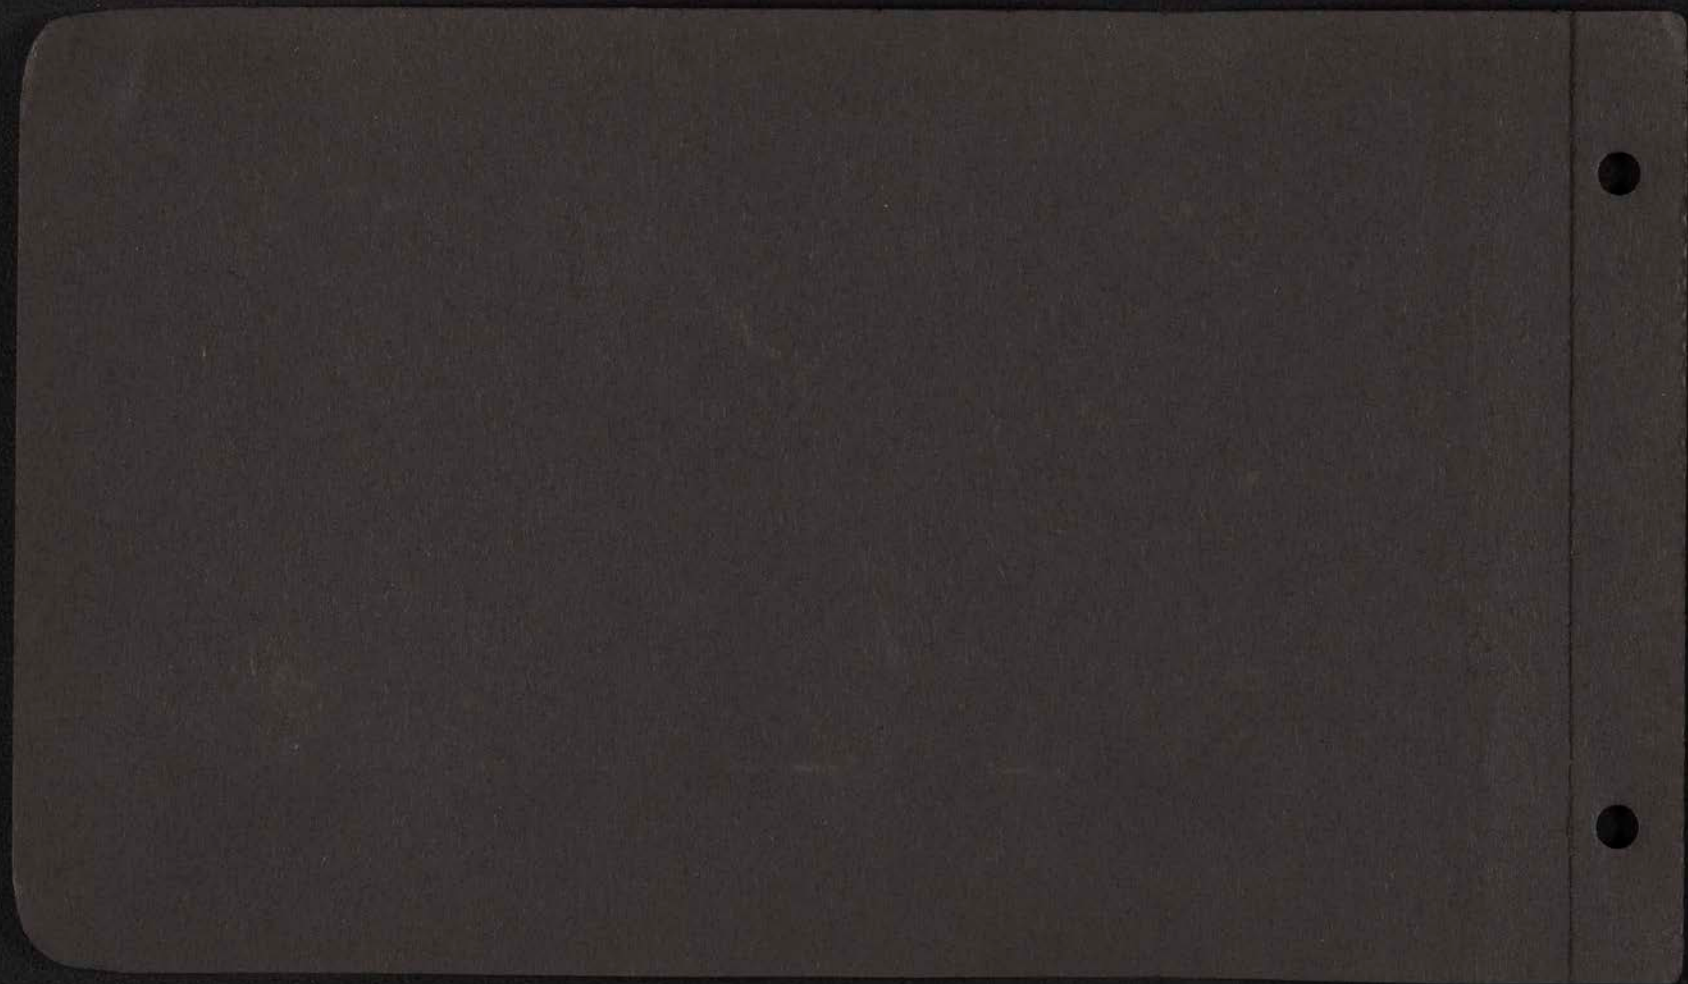
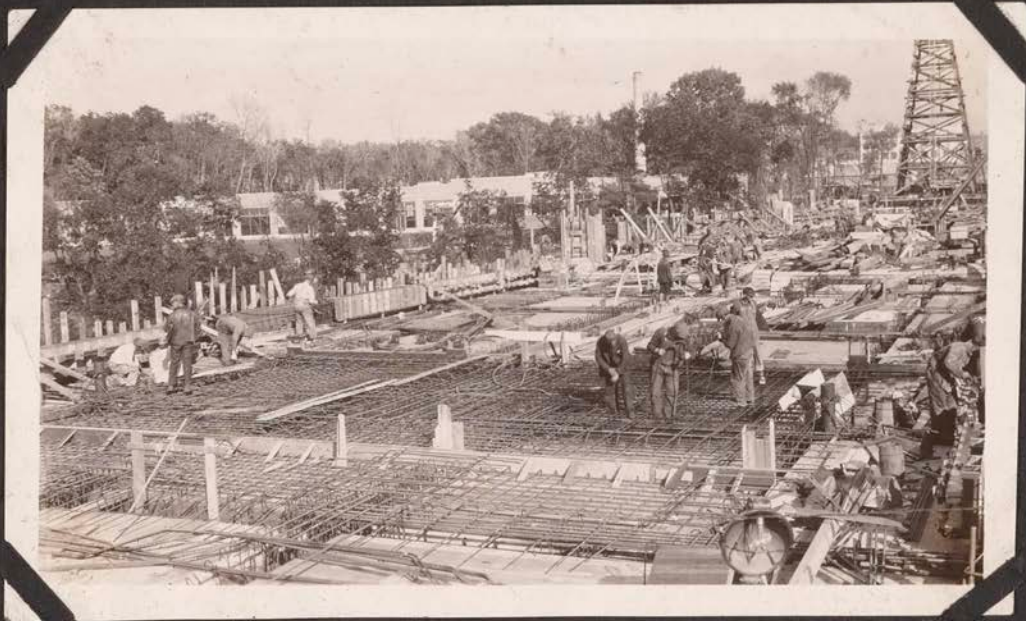
Typical Slab Reinforcing

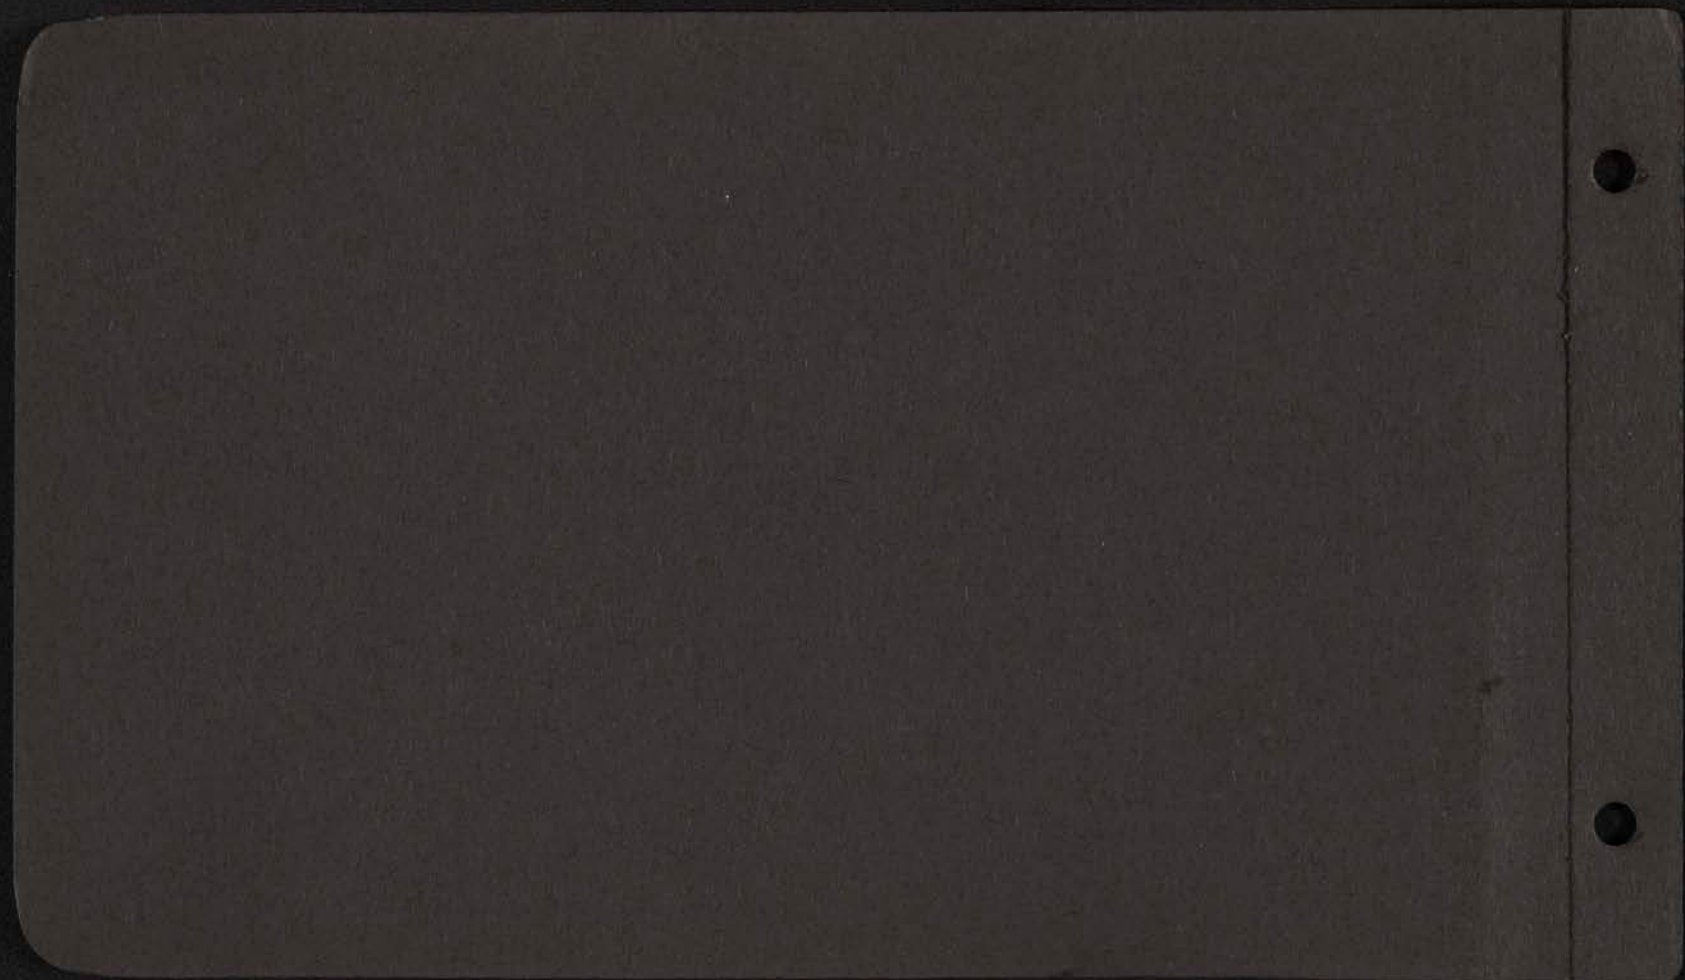
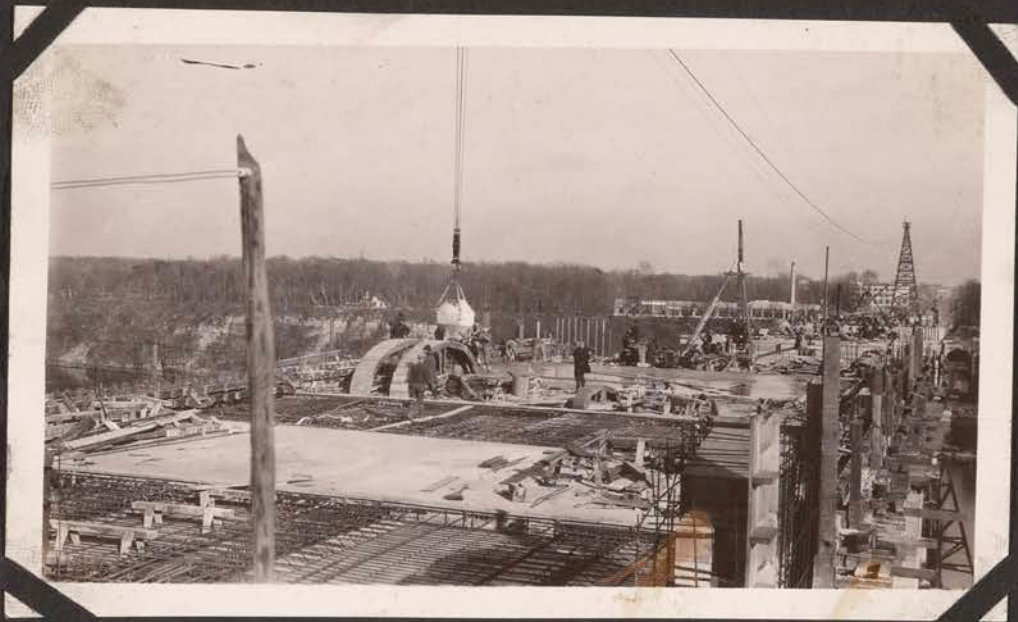
Pouring Slab . Span 10 . Oct. 26, 1926.

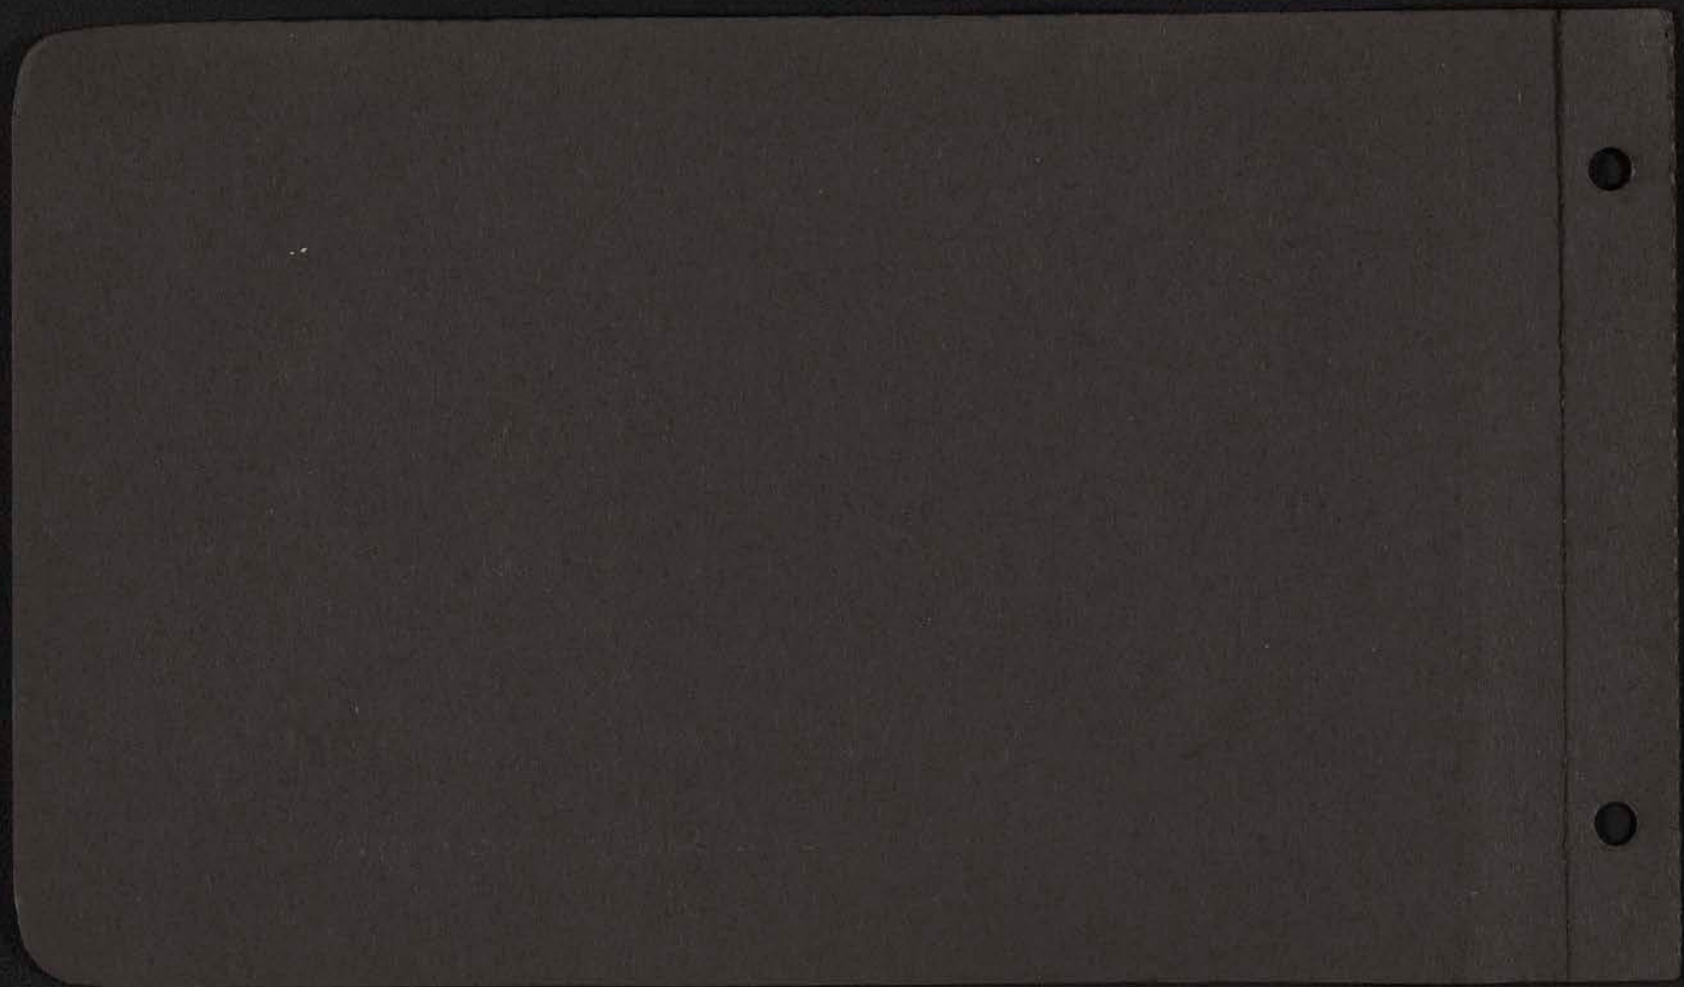
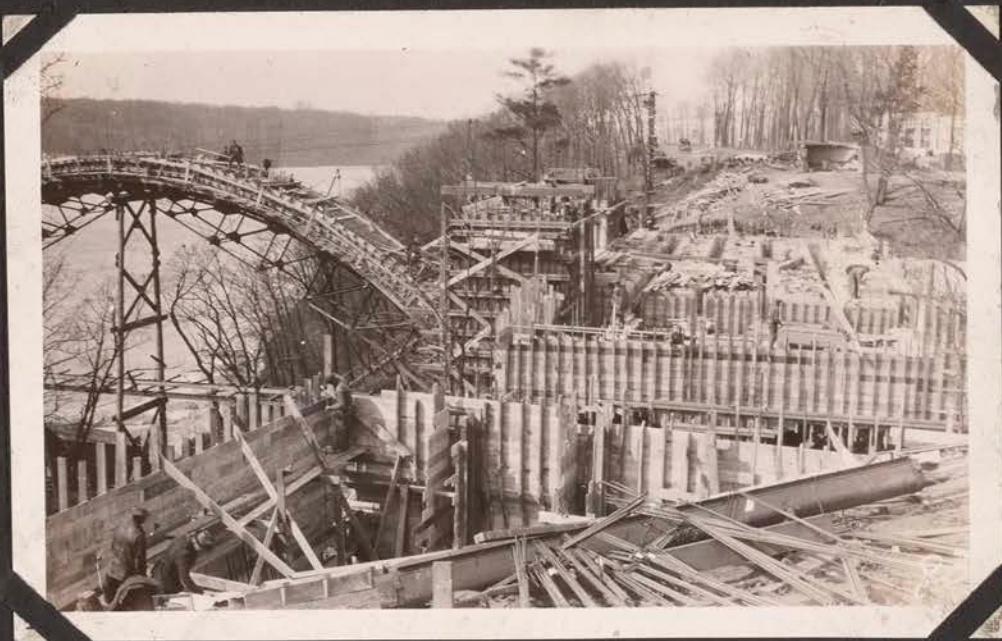
Building Forms For Under-Crossing Apr. 2, 1926.

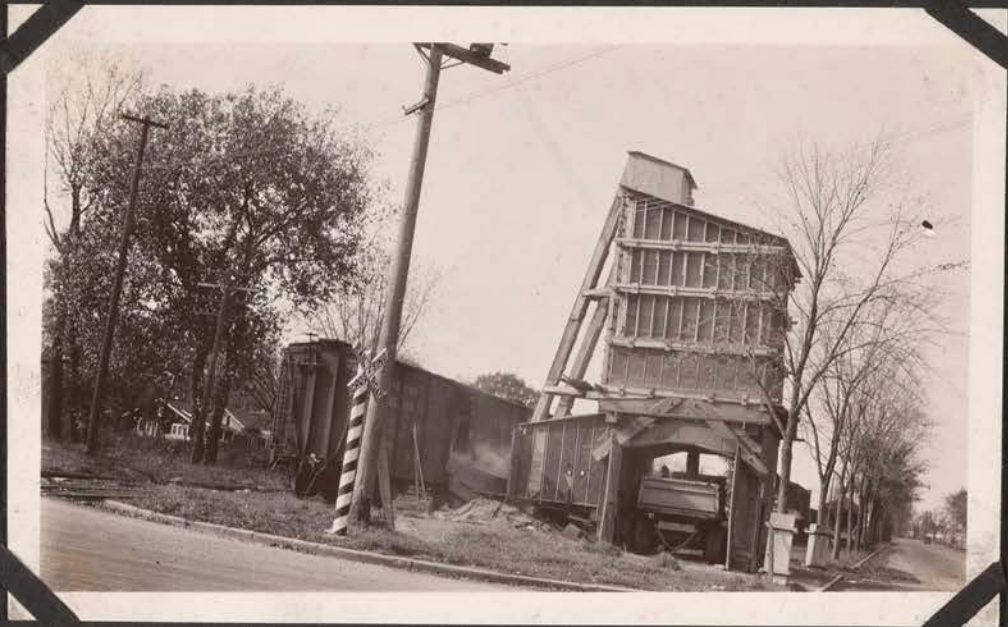
Bin for Handling Bulk Cement from Box Car to Truck.

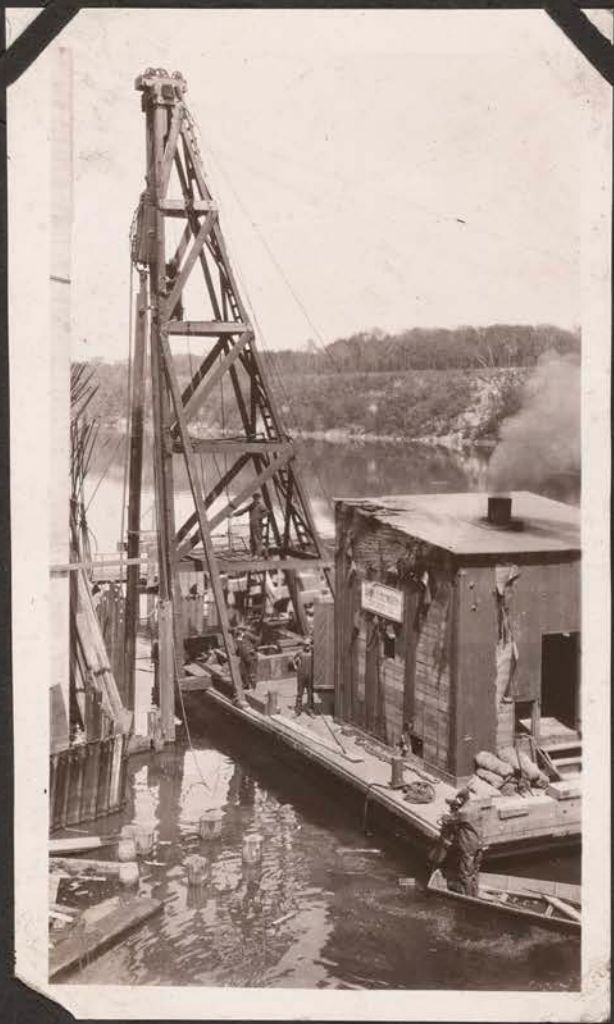
Pulling Sheet Piling with a  
Steam Hammer Inverted.

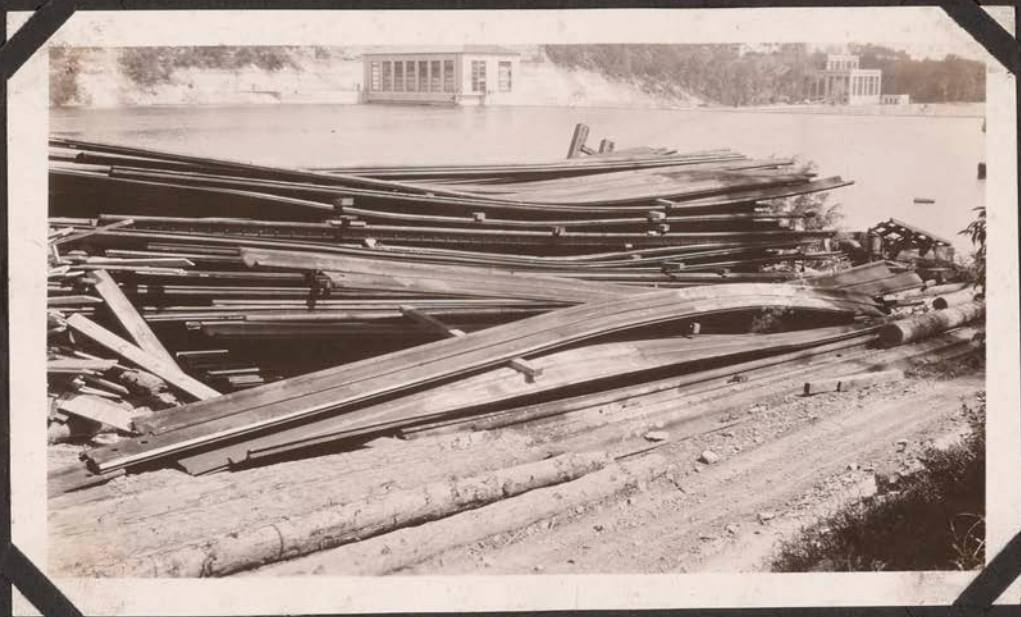
50ft. Sheet Piling pulled from Cofferdam.
