RECONSTRUCTING

OLD FORT SNELLING

Loren Johnson

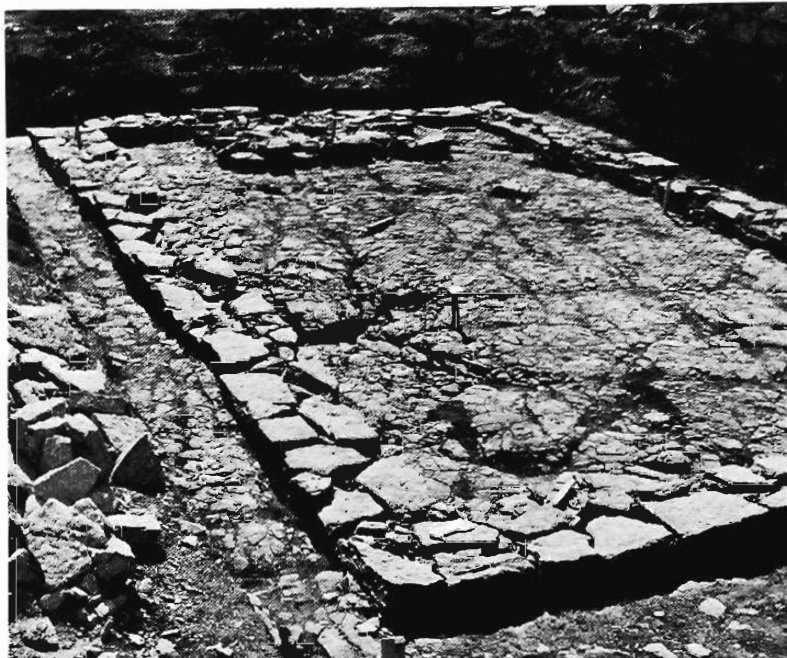
CAREFUL EXCAVATION of the schoolhouse foundation revealed the location and horizontal dimensions of the fireplace which was laid at the east end of the structure (visible at the top of the picture).

THE SCHOOLHOUSE was the third structure to be reconstructed. As already noted, the reconstruction drawings prepared from McClure's report had to be corrected after the archaeological examination revealed the true fireplace location.

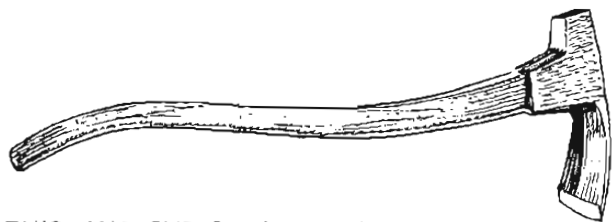
THIS ANCIENT hand tool, the adze, produced the rough-hewn look of beams used by soldier-builders on the frontier in the 1820s.

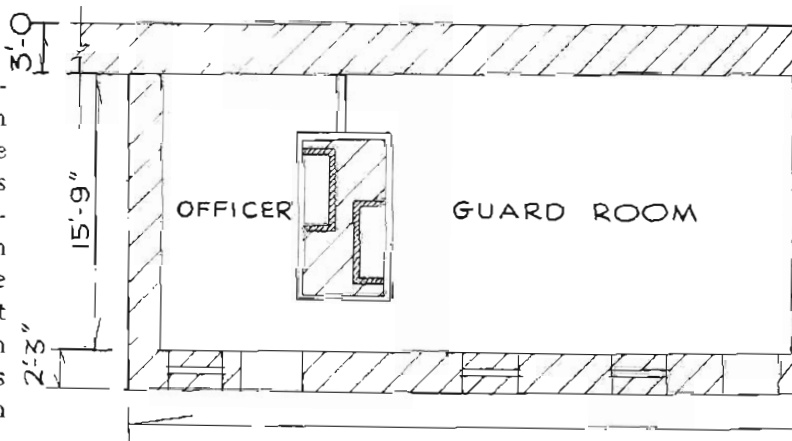
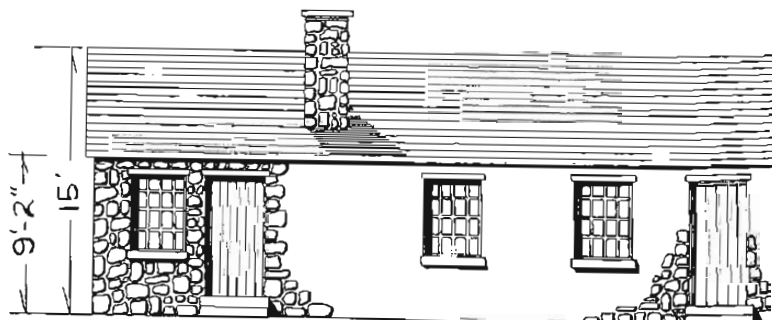
GUARD HOUSE

THE ARCHITECT DREW a floor plan and front and end elevations of the guardhouse. The end elevation reveals the outside wall's cement core and the raised walkway used by patrolling sentries.

THE SECOND STRUCTURE to be restored in 1966 was the guardroom complex—a row of rooms attached to the wall of the fort. These chambers, as identified by McClure, were the officer of the guard's room (at the east end of the row next to the gate), guardroom, prison room, two cells, a coalhouse, and the limehouse. Manuscript dimensions for the complex vary widely, the length being given at anything between 67 feet and 81 feet in length. The width is uniformly given at 21 feet. Excavation of the officer of the guard's room, the guardroom, the prison room, and cells showed an initial length of 52 feet. The addition of the coalhouse brought the length to 69½ feet, and with the final excavation of the limehouse the extant foundations measured 81½ feet.

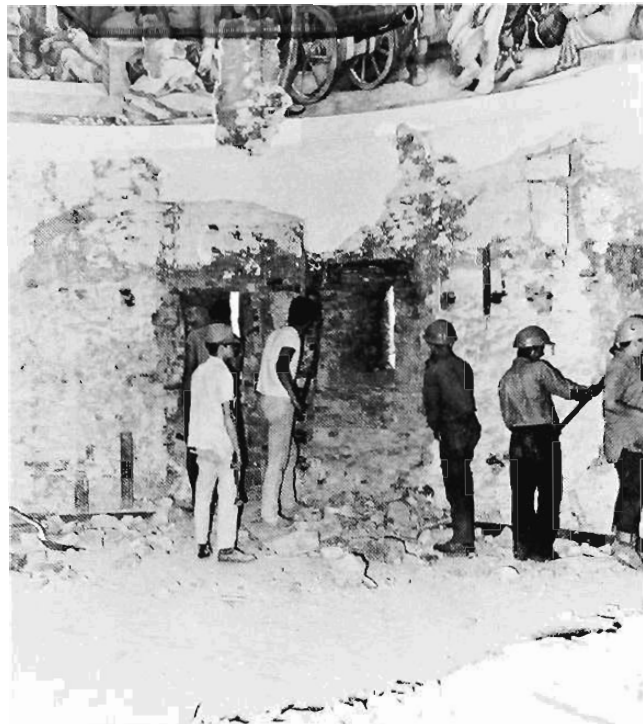
INSIDE THE ROUND TOWER crews chipped off the plaster (including, unavoidably, the Richard Haines mural) and opened the long-blocked gun slits as a prelude to the actual restoration.

Research for the present restoration included tracing back the numerous modifications to establish how the interior of the tower looked originally. While examining the walls for any additional structural information, the author discovered the burned ends of seven floor joists still in the original joist sockets. The beams were not original to the structure, as they were rotary-sawn. In 1835 McClure had recommended the replacement of roofs and floors in a number of the post buildings because of the poor state of preservation. A great deal of this work was done by 1845, including the rebuilding in stone of the officers' quarters and the long barracks. The original wood, being unseasoned, apparently deteriorated quite rapidly and had to be replaced after a time. The account books of carpenter William R. Brown for the Civil War period indicate that he worked installing new floors in the barracks at Fort Snelling.⁹ Close examination of the joist sockets showed that the beams had been installed in a radial pattern. The outer ends were on approximately 7-foot centers and the extant beam ends were 6 inches by 8 inches. The spacing indicated a total of 16 beams.

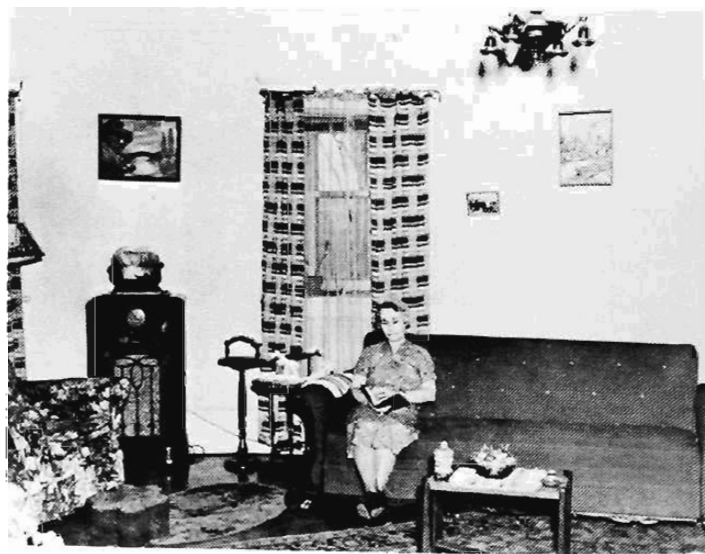
AFTER WORLD WAR I the Round Tower housed offices and quarters before it was converted into a beauty shop and family residence. The post electrician and his wife lived in full 1930s comfort within the curved walls.

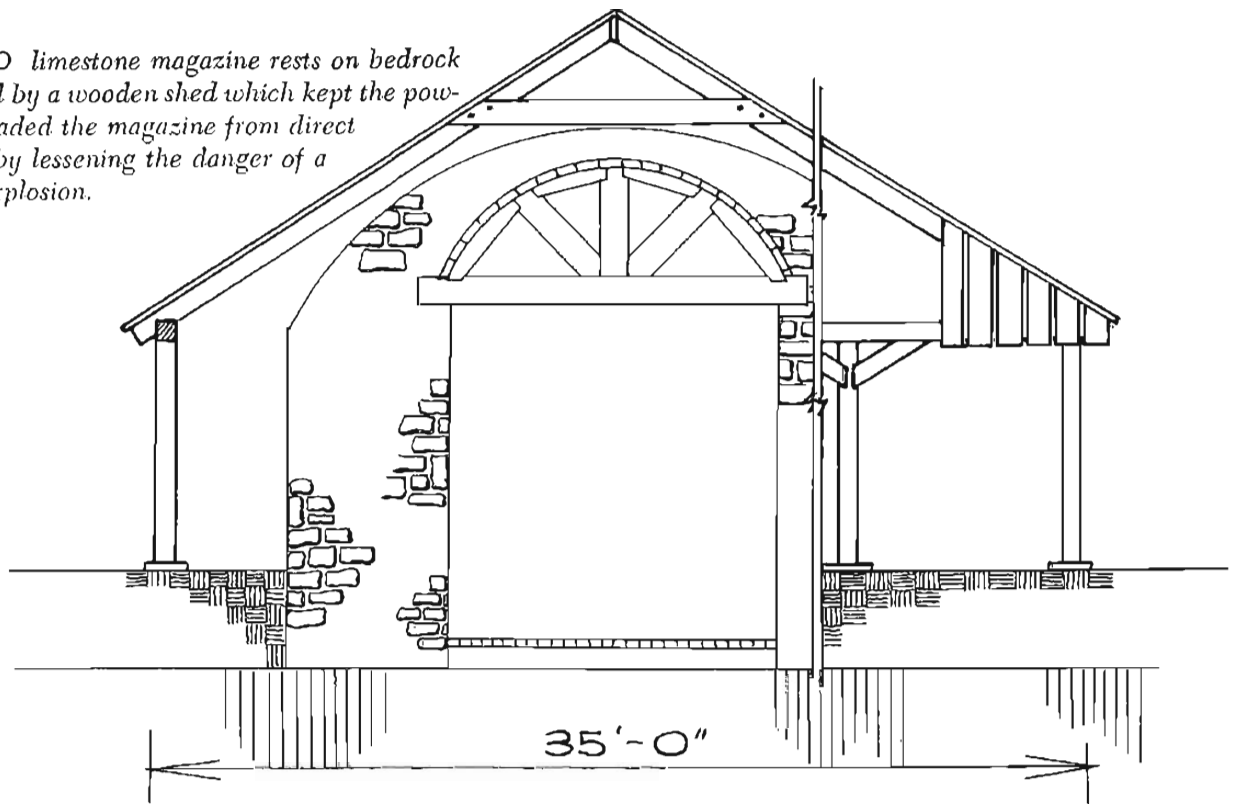
THE VAULTED limestone magazine rests on bedrock and is sheltered by a wooden shed which kept the powder dry and shaded the magazine from direct sunlight, thereby lessening the danger of a spontaneous explosion.

The magazine at Fort Snelling was built of Platteville limestone in random ashlar-rubble stone, patterned after the stonework in the Hexagonal and Round towers. Perhaps the most interesting structure at the post, the magazine was designed to store gunpowder and other ordnance supplies. Black powder of the type once stored at Fort Snelling is a chemically unstable mixture that has to be kept dry and at as uniform a temperature as possible. The shed roof keeps the sun from beating on the stone building and, being raised above the structure, allows for free circulation of air for additional cooling.

As mentioned previously, the magazine's walls are six feet thick to support the barrel vault roof. At the center the vault is about eighteen inches thick. This is one of the safety features designed into the building, as is the small semicircular blast chamber through which one enters. If an explosion had occurred within the magazine, the first force of the explosion would have gone outward through the door, which is the weakest part of the building. It would then have been deflected upward by the semicircular wall which is covered only by the shed roof, some distance above the height of the wall. As the force of the explosion continued to build within the structure, the top of the vault, being thinner and weaker than the walls, would have been blown upwards. Thus, the main force of the explosion, having been contained by the thick walls, would have been forced to go straight up. This protected any soldiers in the open from the immediate blast effect, and presumably they could have put their hands over their heads and run for cover before things started coming down again.

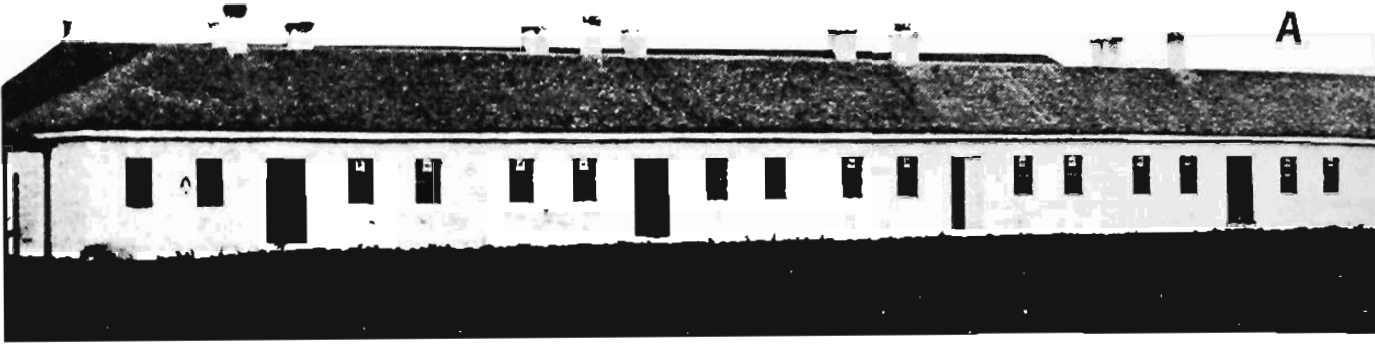
THIS 1863 PHOTOGRAPH was used extensively in the restoration. Although the Round Tower (e) appears with a conical roof added during the Civil War, the hospital (a), guardhouse (b), schoolhouse (c), and sutler's store (f) were essentially unchanged. Included is the best existing view of the magazine (d).

"Only one photograph, dated 1863, showing the entire structure of the magazine has been found. Another taken from the top of the Round Tower about 1861, and a drawing dated 1855 made from the same point, show the roof of the magazine in the foreground, but from these we learn only that the building had a gabled roof covered with shingles. Maps indicated, and the excavations subsequently disclosed, that the magazine was rounded at the southeast end. No reason for this semicircular shape was discovered, and no conjectures will be offered.

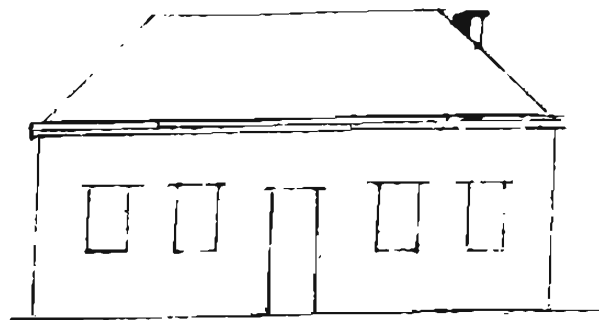
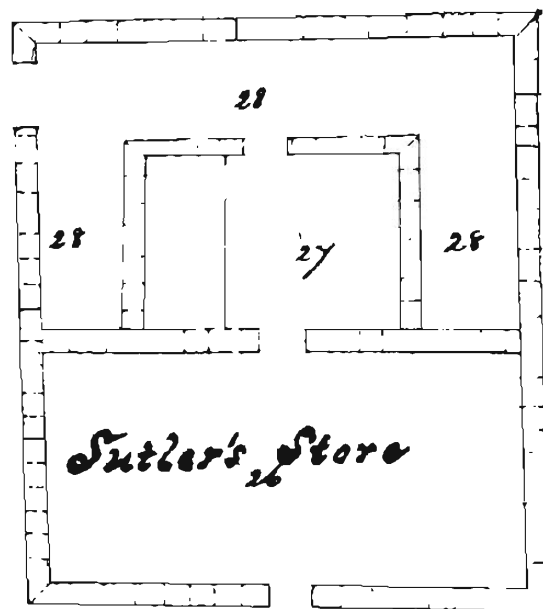
THIS ELEVATION AND PLAN of the sutler's store were taken from McClure's 1835 report, which proved helpful despite the misplaced fireplace.

A stone threshold approximately 3 feet by 6 feet was found centrally located along the facade of the building. This correlates with the door location as shown both by the McClure drawing and the afore-

mentioned photograph. The facade bore a center door flanked by two windows to either side. The door opening appears to have been 3 feet 3 inches by 7 feet 3 inches, while the windows were approximately 3 feet by 4 feet 9 inches. Spacing appears to have been regular.

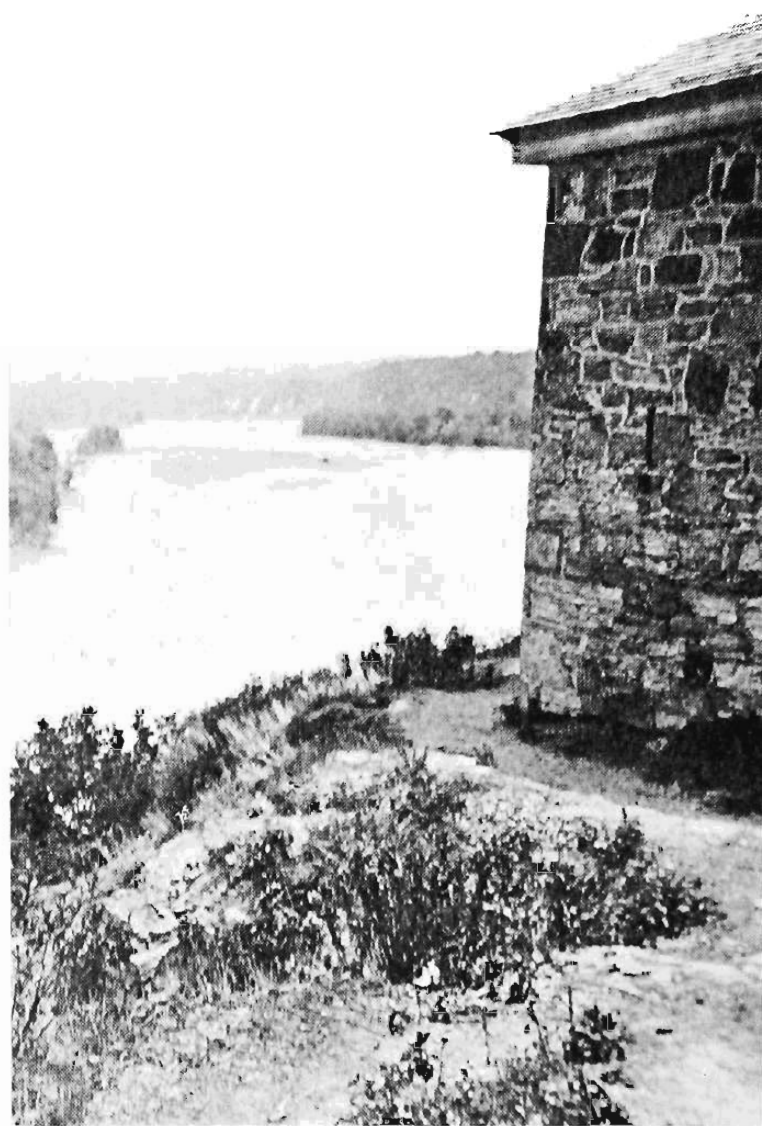
THIS NINETEENTH CENTURY scenic panorama, perhaps only incidentally including a close-up of the Pentagonal Tower, provided otherwise unknown information about roof pitch and placement of gun slits.

THE PENTAGONAL TOWER was reconstructed in the 1969 season. This structure had as little documentation as the magazine. There is only one close-up photograph of the tower in the historical society's collection. The picture was erroneously titled "Valley of Minnesota," as it was taken from a position just up the Mississippi River bluff from the Pentagonal Tower and only shows the Minnesota River confluence at the extreme downstream end of Pike Island. The picture does, however, yield much valuable information. It shows the outer part of the tower and reveals the following points: the cannon ports were not sited to provide anything but enfilade fire down the fort's walls; the two facades facing outward across the Mississippi were provided only with musket slits; the amount of batter or inward slope to the walls of the structure; the angle of pitch and amount of overhang in the roof; the appearance of the cave soffits; and the random ashlar-rubble stonework.

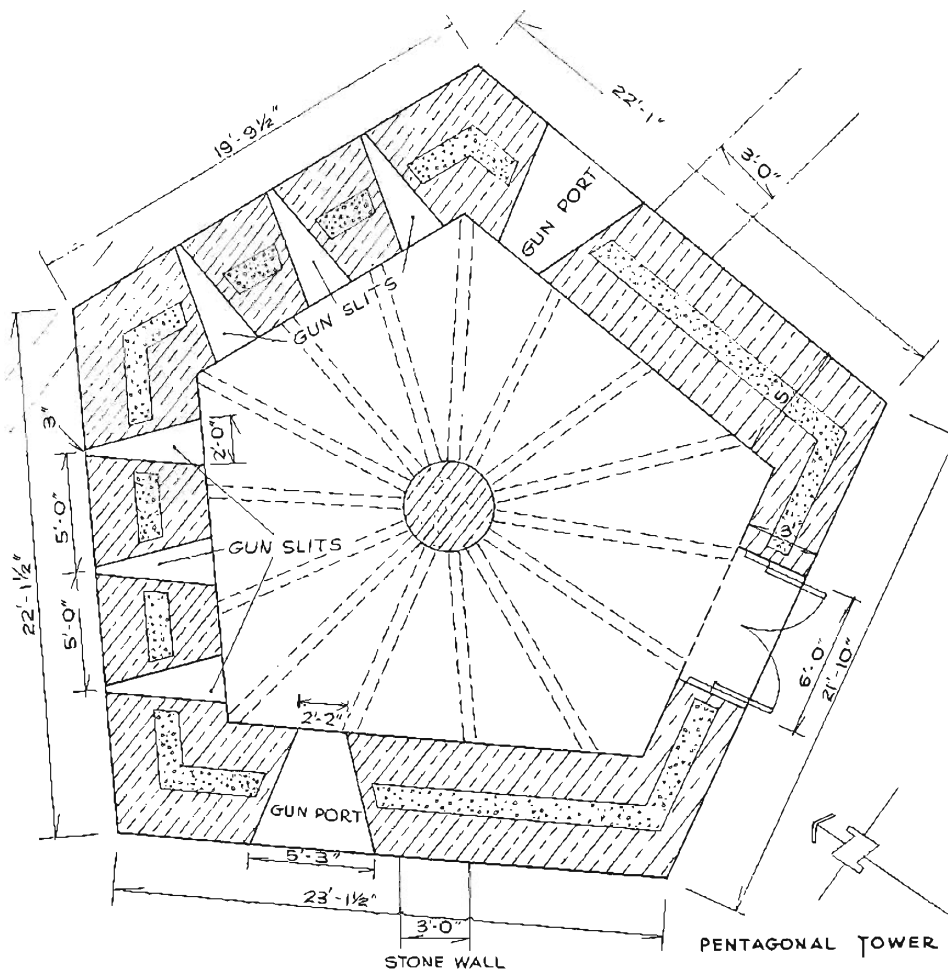
A PLAN of the Pentagonal Tower adapted from the architect's drawing

Because the Mississippi River bluff had eroded a number of feet since the original tower had been built, Mr. Cavin provided massive reinforced concrete footings with a reinforced concrete central spine to furnish additional structural integrity to the building. The footings are the full width of the structure's walls, 5 feet, with the exception of the wall with the door open-

ing which was archaeologically verified as being only 3 feet thick. The concrete wall spine was heavily reinforced and firmly anchored to the footings.

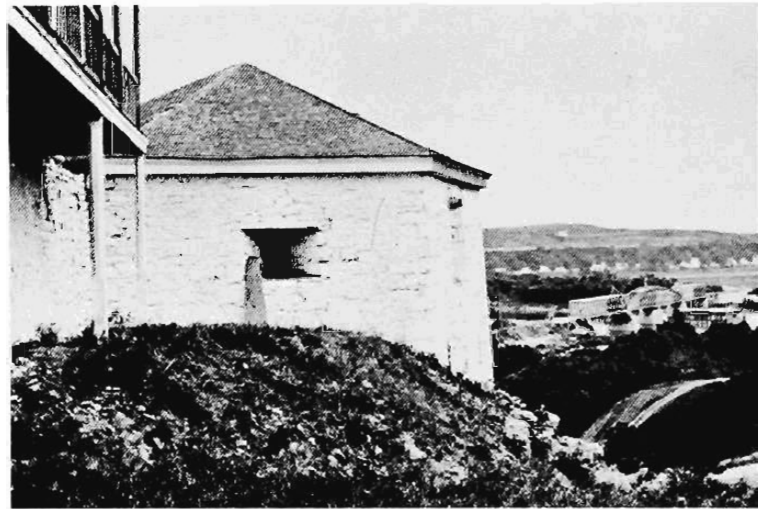
THE HEXAGONAL TOWER'S west gun port was copied for the Pentagonal Tower ports. It was constructed differently from the other ports because of the ground level over which it was to fire.

All early photographs of the Hexagonal Tower indicate that the gun port lintels were squared timbers. In 1969, while the building was being prepared for restoration and the installation of the roof, the discovery was made that the original timbers had been removed. The wooden lintels had been replaced with sections of railroad track that were covered with stucco. During replacement of the original lintels, the masonry above them had been torn out and supplanted and the one gun port on the west wall of the tower had been reconfigured to match the other four apertures. The gun ports have been rebuilt with wooden lintels adzed to the original configuration. The roof pitch and soffit treatment are patterned after photographs, which regrettably date after the first reroofing of the Hexagonal Tower. Because of an absence of earlier drawings or
